Isle of Man Ship Registry

Casualty Investigation Report No. CA 111

M/V VIRTUSU

Fatal accident

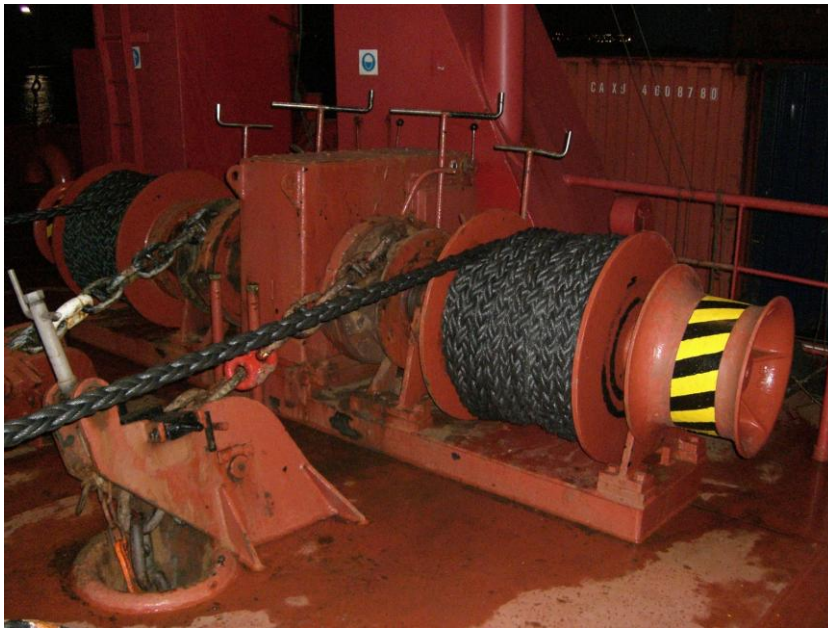
Normal stowage of ropes on the port drum (these pictures show the new ropes), the forecastle deck extends forward from the windlass position in the direction of the rope (where they would normally be laid in preparation for mooring or changing the ropes).

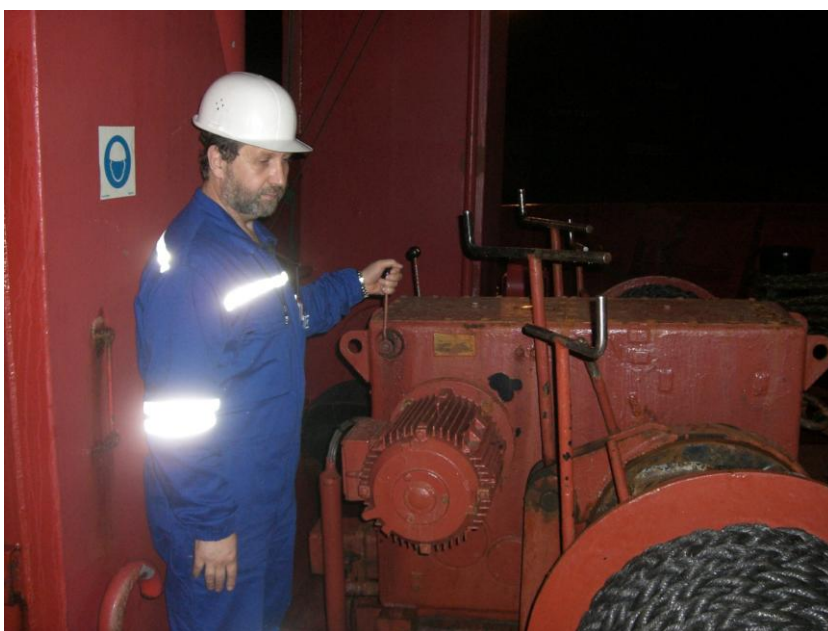
There is a control lever either side of the gearbox to allow the operator (shown on the starboard lever) to control either the port or the starboard drum independently

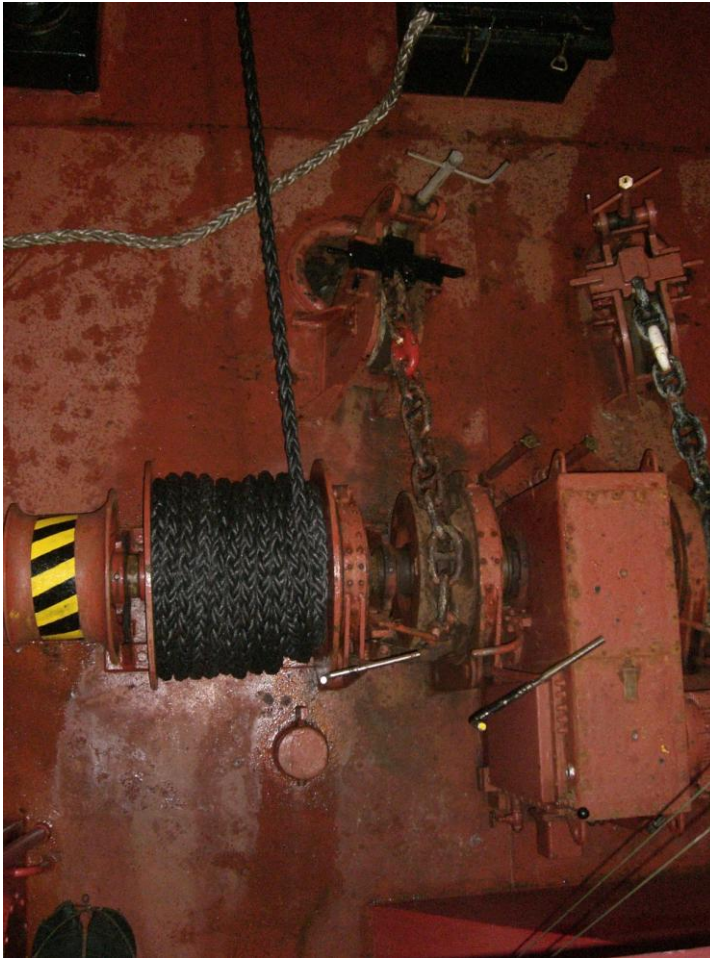
Aerial View of the accident area/forecastle deck showing the normal lead of the mooring rope.

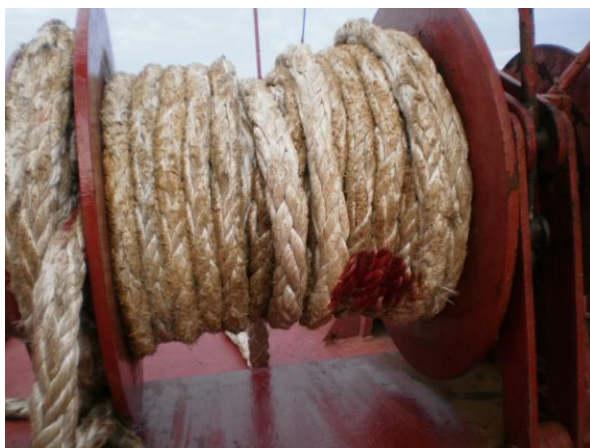
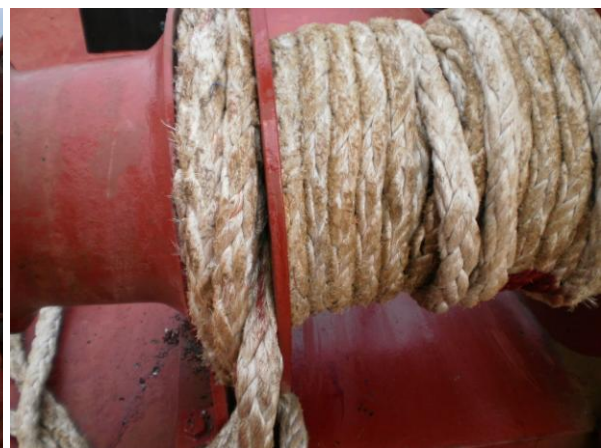
It is surmised, that at this point the free end of the rope became snagged between coils still on the drum and snatched the rope back towards the drum again and commenced heaving rather than slackening, giving very little

time for the Bosun to either release his grip or jump clear. Another possibility is that the Bosun had unknowingly stepped inside a bight (a loose loop of rope) which got caught around his leg, either way he was dragged back into the rope drum. It was difficult to determine if he was pulled in hand first or leg first since he made at least three revolutions incurring severe physical damage with the winch foundations and drum/coils before the electric motor became stalled by other coils of rope around the mooring drum axle itself.

Actual ropes/drum, note that the free end is between coils approximately centre of the rope drum in the left hand picture, in the right hand picture see also loose turns caught around the drum axle which eventually stalled the electric drive motor.

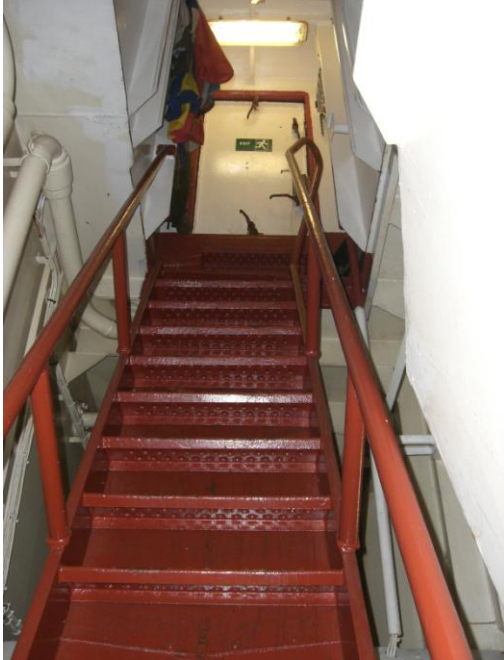
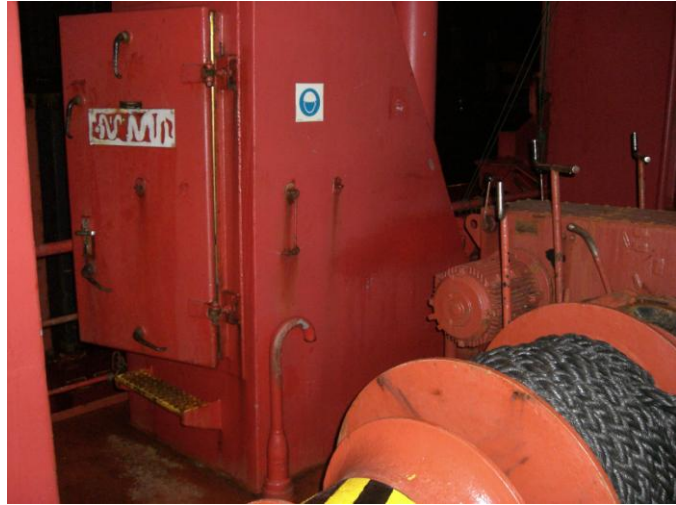
View of the exit to the forecastle space and view of the exit from the forecastle deck, the exit partially obstructs the view of the control levers from the bridge.

The complicated navigational situation had the Chief Officer's full attention; no-one had contacted him regarding working on the forecastle so he wasn't expecting any such activity. As the winch is placed directly in front of the exit from the forecastle space itself, the actual winch control levers are partially hidden from view from the bridge so he wouldn't be able to see if there was a second person there or not.

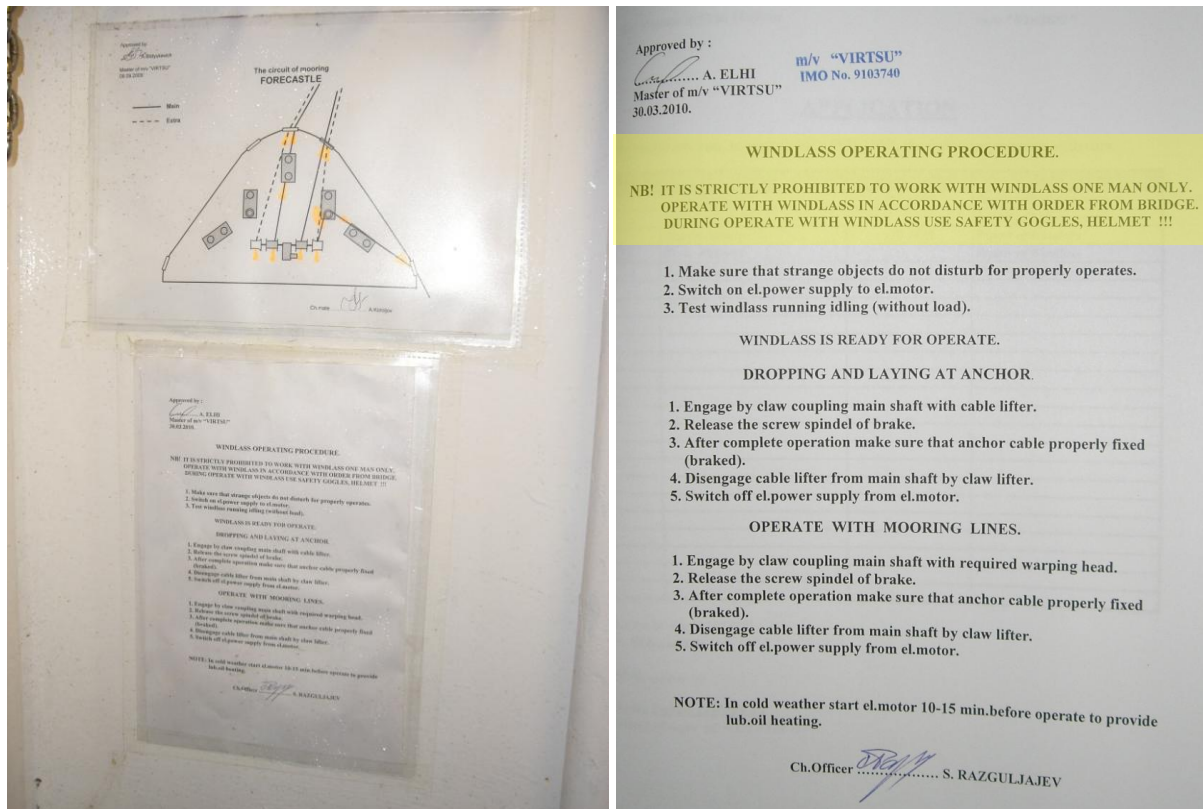
The SMS includes a procedure for anchoring and mooring operations that states this should not be done alone and under instructions from the bridge, unfortunately this was not followed.

Left picture - mooring procedure posted beside the start switch for the windlass motors. Right picture - showing mooring operation instructions, both are updated with new master signature and dated 30.03.2010 (highlighted section only in this report for emphasis)

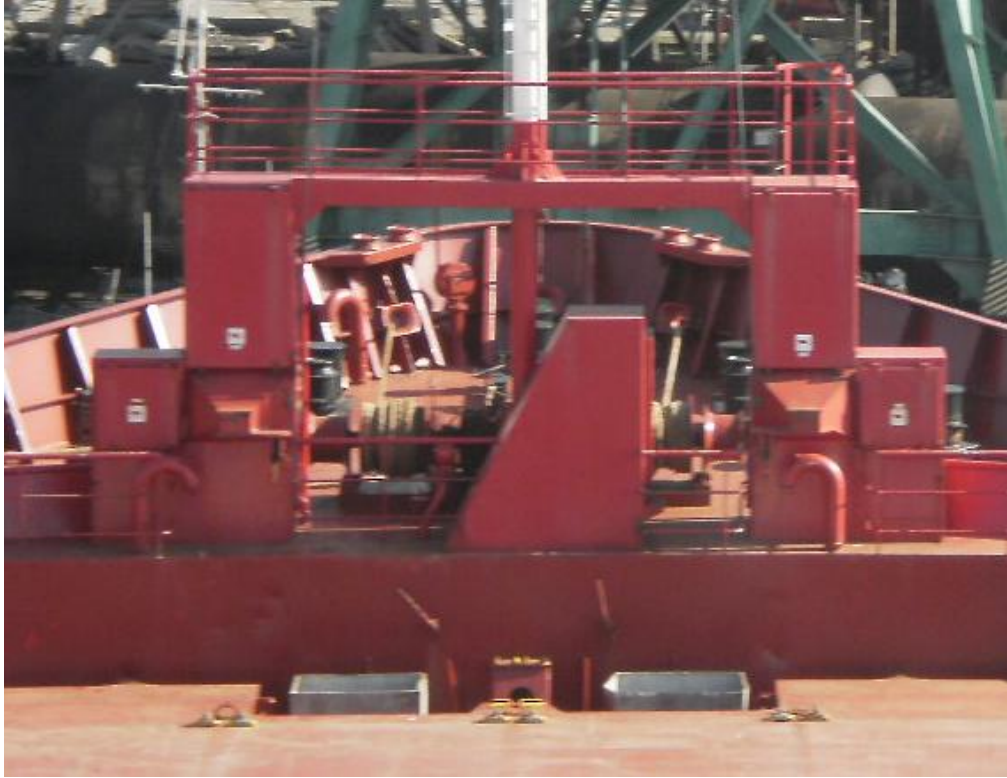
View of the windlass from the bridge, control levers are partially hidden by the steps from the forecastle space.

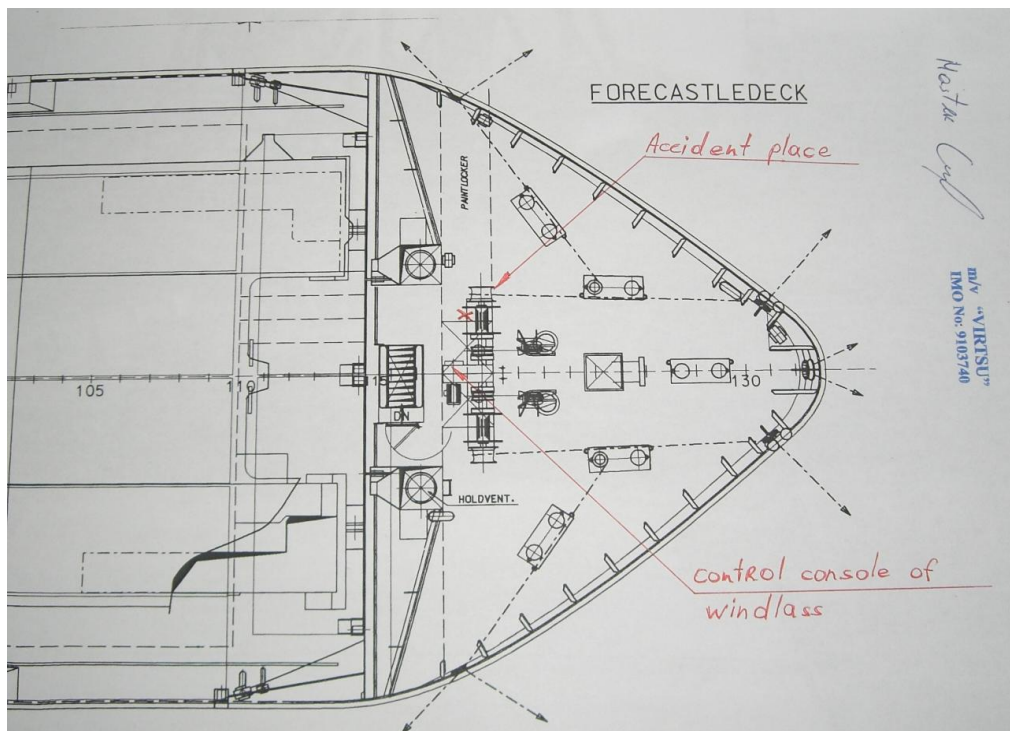
Layout of the forecastle deck showing accident location and control lever location

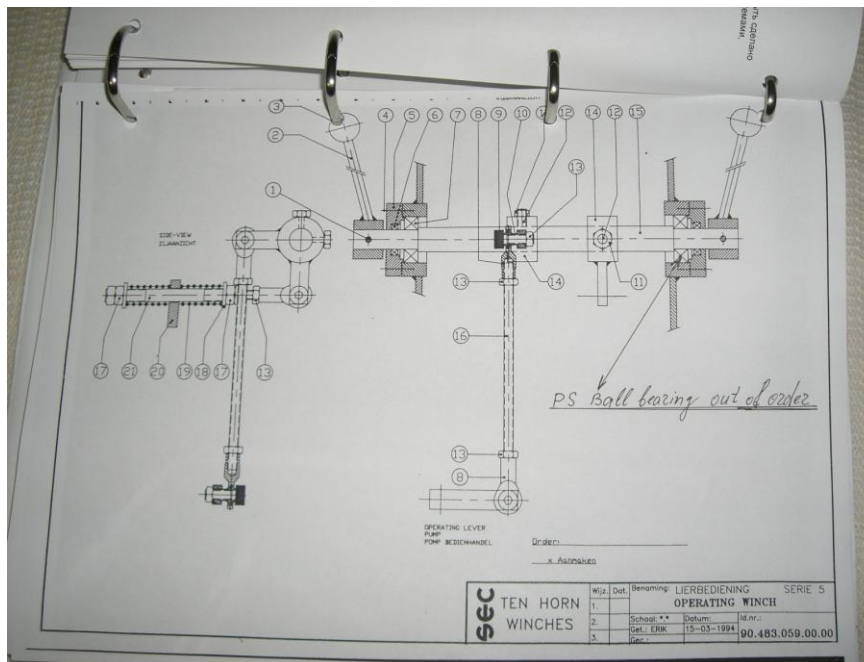
Working diagram of the winch control levers.

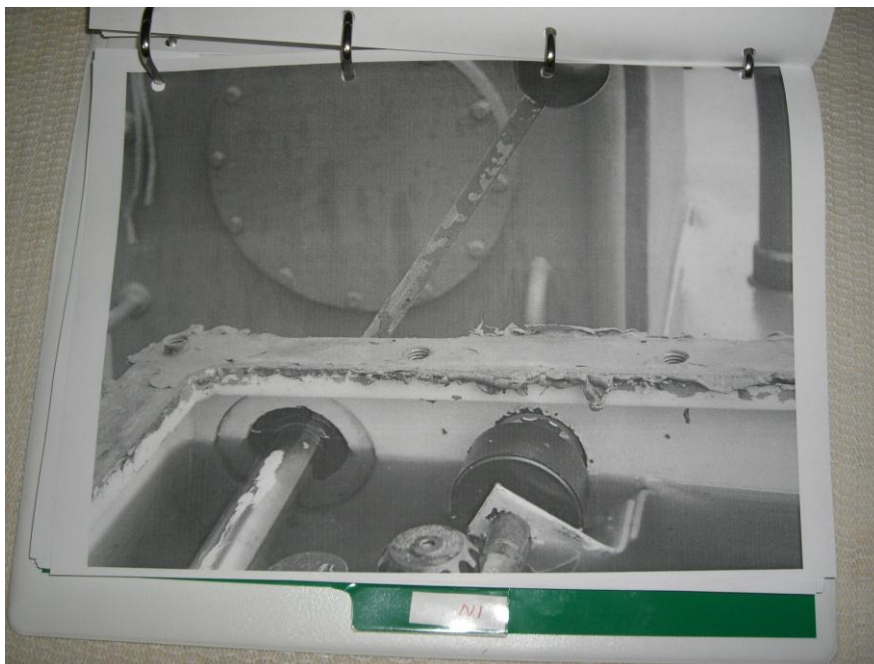
Ships engineers undertook to examine the winch control system after the accident and whilst it was determined the port lever bearing had partially collapsed and was partially seized, it was still operational (since AB1 put it into the neutral position to stop the winch) and still required a conscious movement to put into the slacken (or heave) position.

Internal view of the winch controls levers after examination.
