Isle of Man Ship Registry

Casualty Investigation Report No. CA102

Collision between the Tanker British Cygnet and
Container ship Vera

2nd December 2006

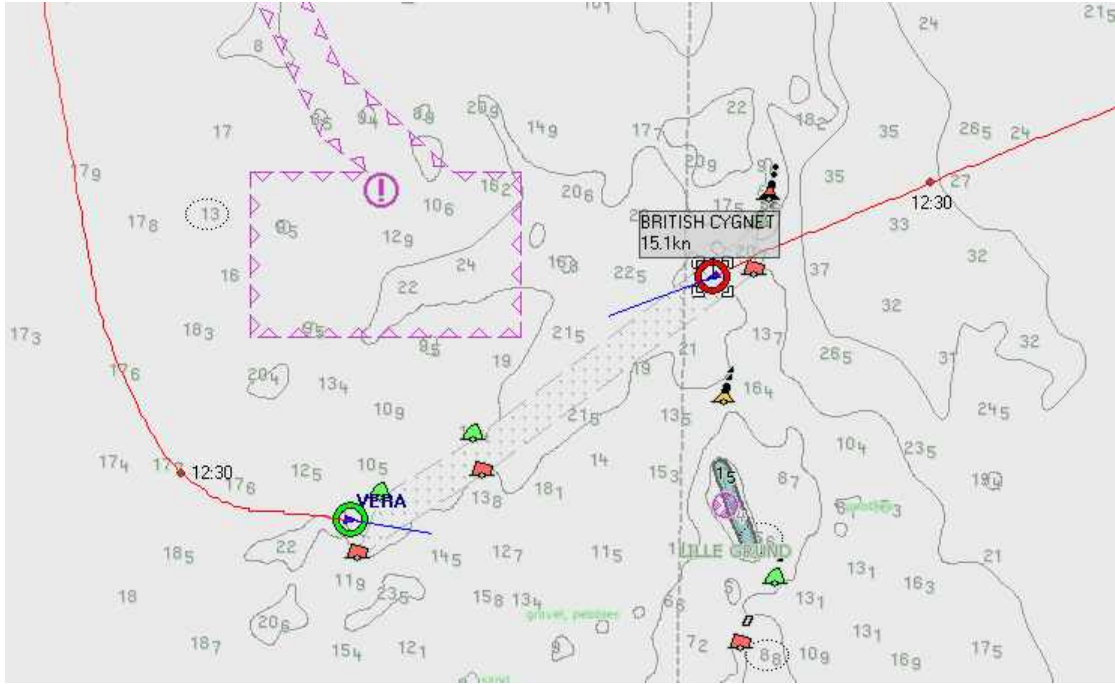
11.34 UTC Image from AIS record. (The Royal Danish Administration of Navigation and Hydrography)

- 11.33.26 The British Cygnet entered the northeast end of the deep water channel north of Fynshoved on a course over the ground of 250.8 degrees and a speed over the ground of 15.1 knots.

- 11.34.45 The Vera entered the south western end of the deepwater channel north of Fynshoved on a course over the ground of 101 degrees and a speed over the ground of 11.5 knots. The Second Officer was alone on the bridge. The ship was in manual steering. The Second Officer intended to enter the channel and remain on the starboard side. However the rate of turn was not sufficient to keep the Vera within the channel and she entered the channel between the two buoys at the south western end, then passed out of the channel across its southern boundary.

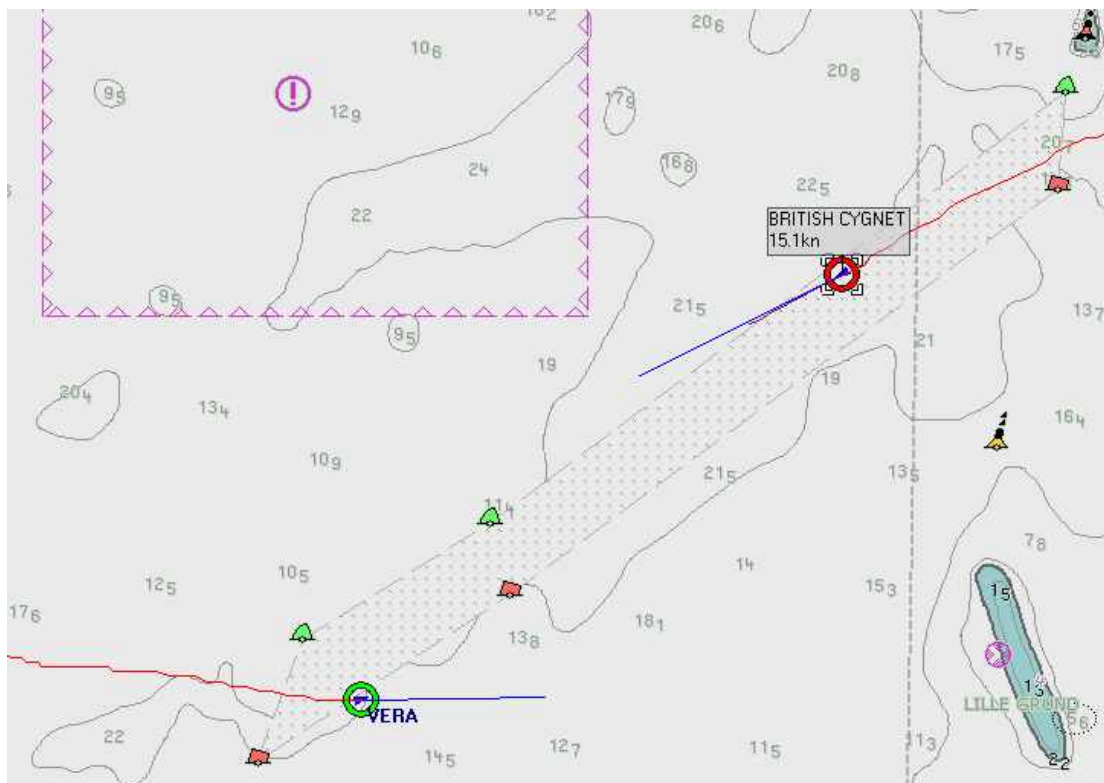
11.35 UTC Image from AIS record. (The Royal Danish Administration of Navigation and Hydrography)

- 11.35.35 The Vera passed out of the deep water channel over the southern boundary. Her course was easterly at 083 degrees and her speed was 12.3 knots.
- 11.36.14 Onboard the British Cygnet there was a brief conversation between the Master and Pilot about the vessel approaching the south western end of the deep water channel. This concluded with the assumption the vessel would remain outside of the deepwater channel. The Vera's easterly course was clearly indicated visually, by radar plots and on ECDIS and AIS.

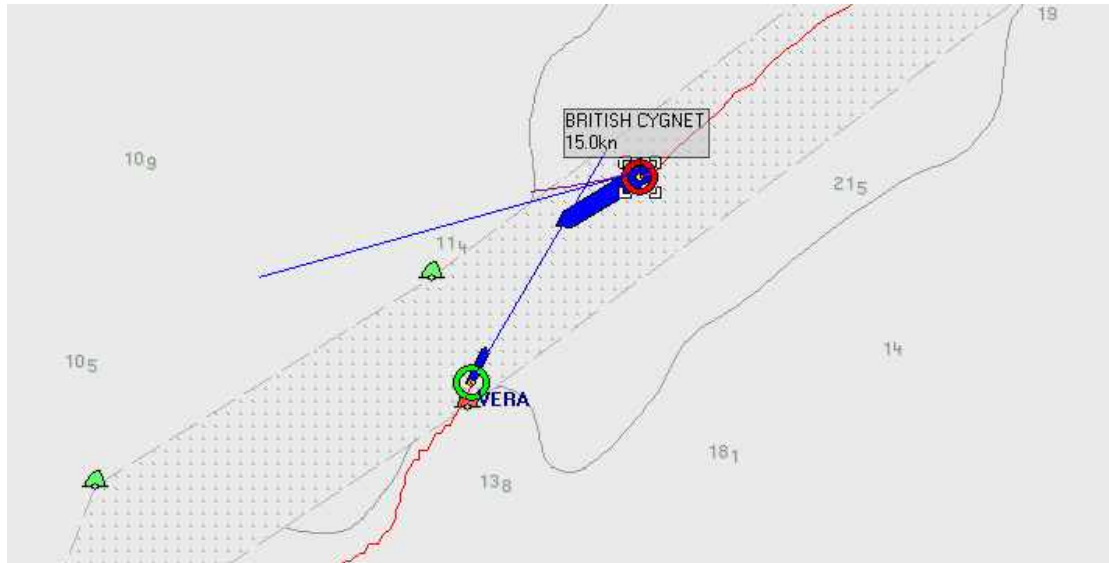
11.38 UTC Image from AIS record. (The Royal Danish Administration of Navigation and Hydrography)

- 11.37.48 The pilot on the British Cygnet makes a call on the VHF “you have to come to port, come to port please” This is not heard by the Second Officer on the Vera.
- 11.37.54 The pilot on the British Cygnet gives 5 helm orders in quick succession finishing with Hard a Port.
- 11.38.19 On board the British Cygnet the Master orders Hard a Starboard. The Pilot also orders Hard a Starboard and then requests a signal and orders Stop Engines.
- 11.38.39 On board the British Cygnet the Master orders the General Alarm to be sounded.
- 11.38.49 The Point of Collision between the British Cygnet and Vera. The Vera’s bow struck the British Cygnet amidships on her port side at an angle of approximately 60 degrees leading aft. The collision stopped Vera instantly and she passed along the British Cygnet’s port side as the tanker continued to make way.

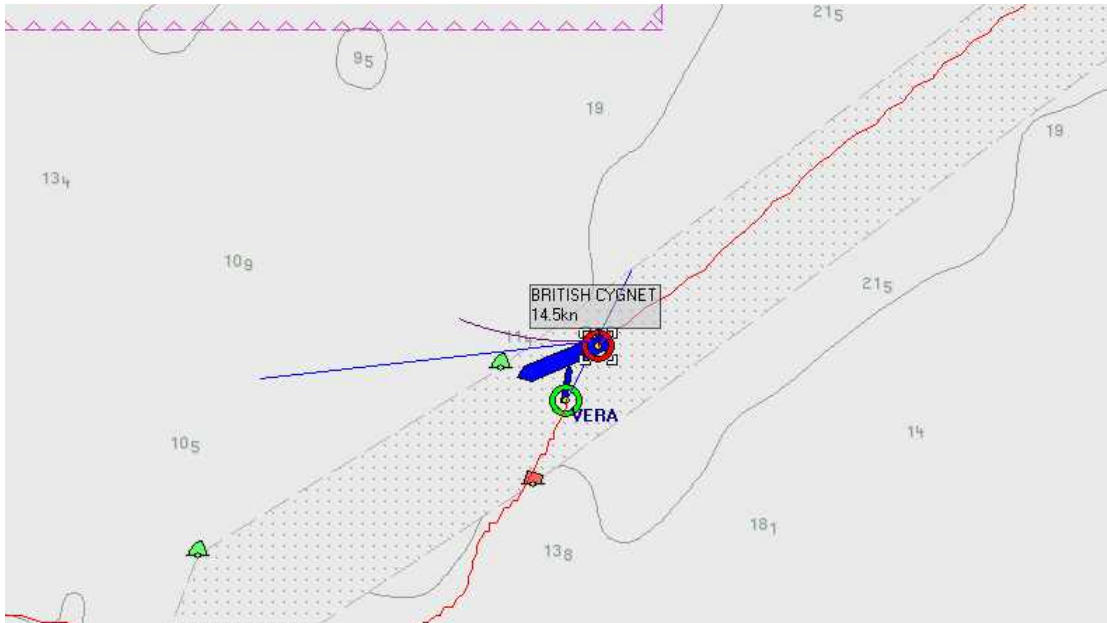
11.38 UTC Image from AIS record. (The Royal Danish Administration of Navigation and Hydrography)

11.38.54 Onboard the British Cygnet a public address system announcement was made stating Emergency - Collision and the crew were called to Muster Stations.

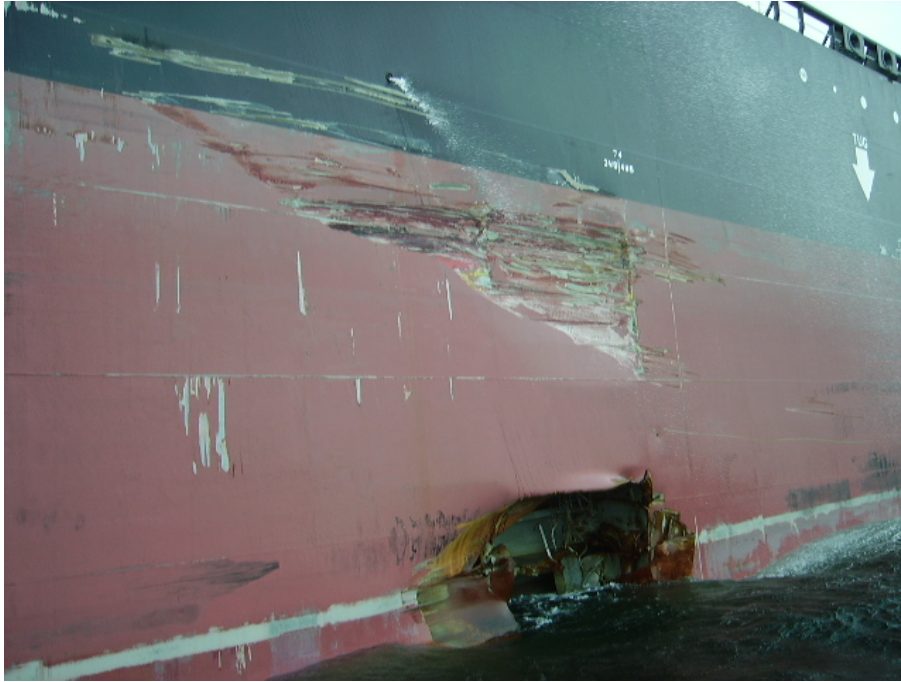
2.19 **Damage to British Cygnet**

Two water ballast tanks on the port side were breached and open to the sea. The cargo tanks were empty and inerted and were not breached.

Damage to MV British Cygnet (Isle of Man Ship Registry)

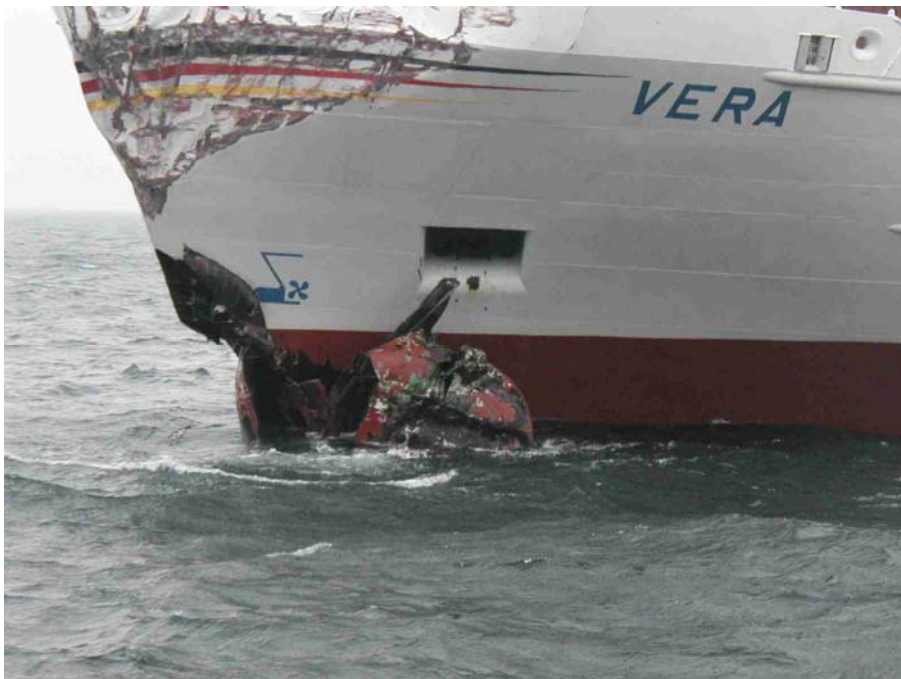
2.20 **Damage to Vera**

The stem, bulbous bow and upper part of the side shell were damaged.

Damage to MV Vera
