**Serious injury on board Manx-registered fishing vessel Constant Friend (PL 168)**

## Isle of Man Ship Registry Casualty Report

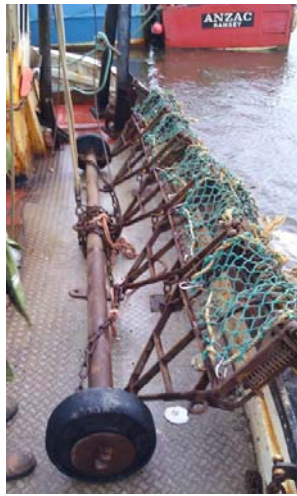
Port tow bar attached to five frames/bellies

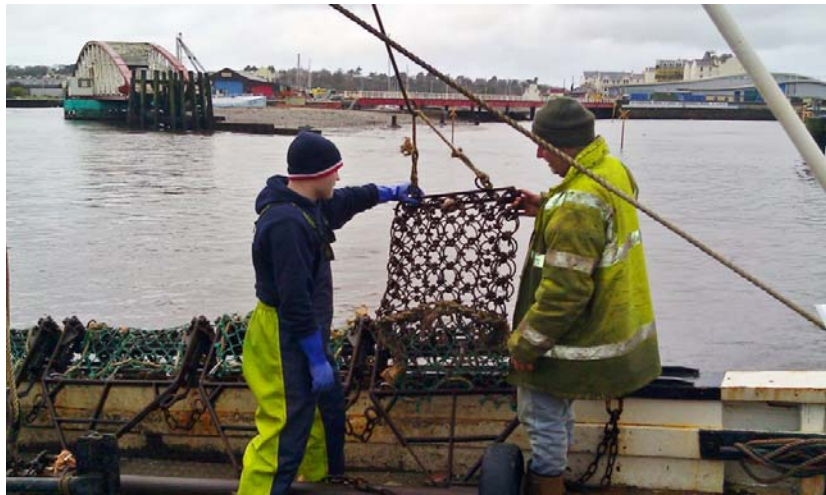
Port forward belly raised for emptying onto deck

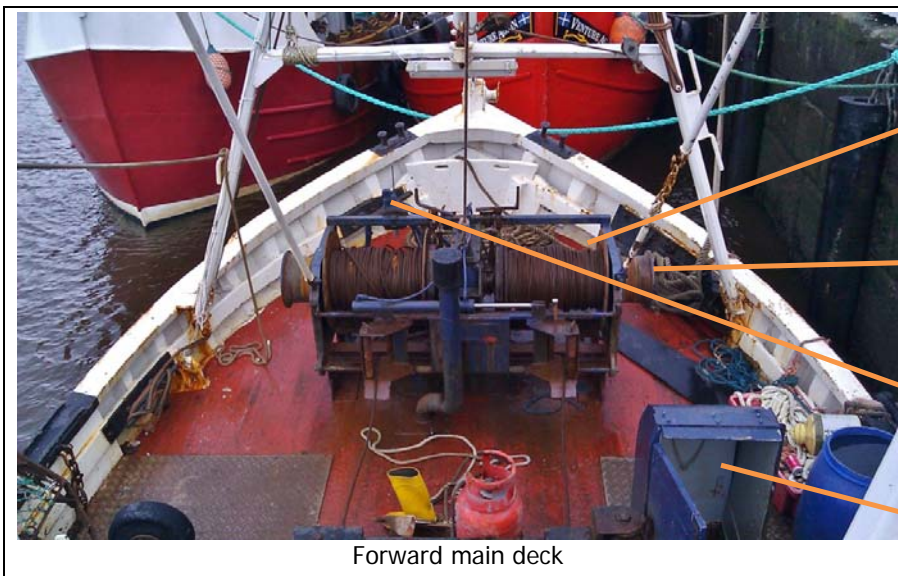
Forward main deck

Starboard steel wire winch drum

Winch drum end

Winch operation lever position

Entrance to crew accommodation

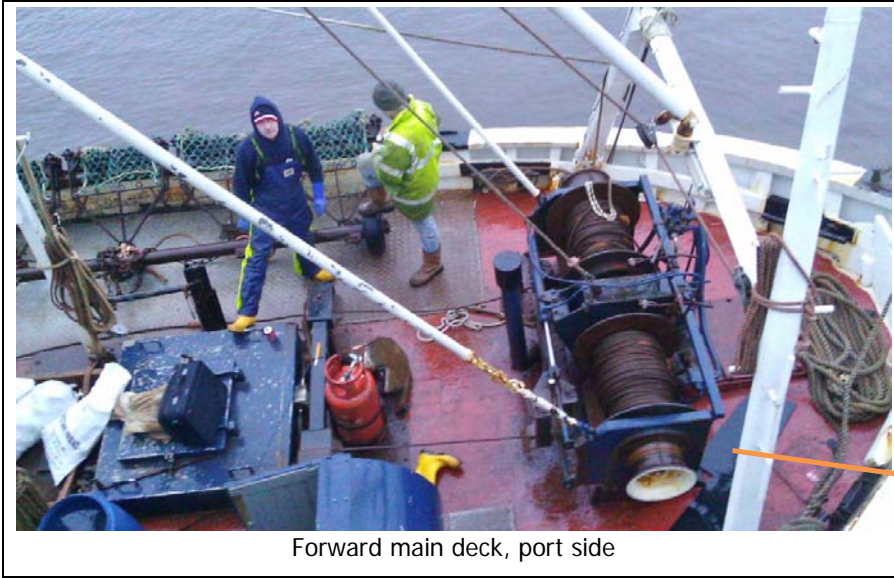
Position where Deckhand 2 was standing when accident took place

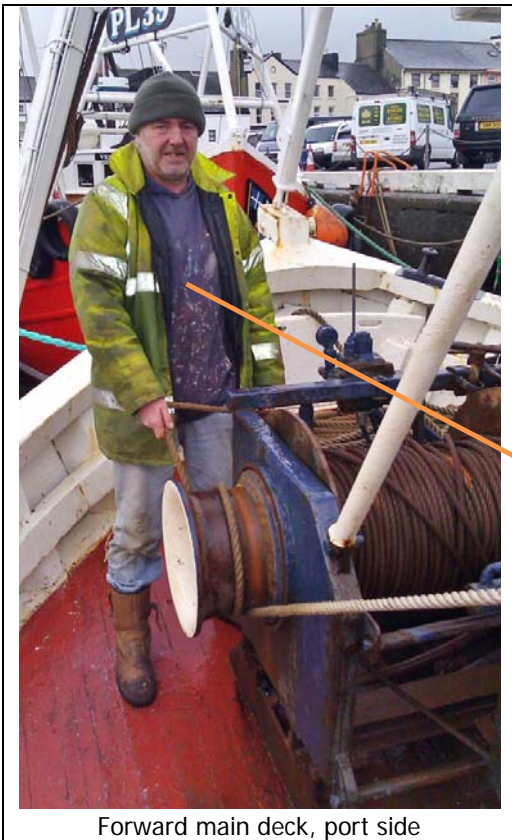
Crew member's typical working position (on port side), handily adjacent to winch operation handle.  
Accident took place on starboard side.

The vessel's forward winches are controlled from a single non-spring-loaded handle provided adjacent to the port winch drum end. This handle can be left in the forward or aft position and needs no hand pressure to maintain powered winch rotation. While a crew member engaged in rope handling duties on the port side is easily able to reach the operation handle, and hence able to maintain one hand on the handle and another on the rope, this handle cannot be easily reached from the starboard side. A crew member handling the rope on the starboard side needs to move frequently between handle and rope-holding position. In the event of a problem, such as the occurrence of a riding turn in way of the starboard drum end (see example photograph), the crew member handling the rope around the drum end will not be able to stop the winch machinery from turning without making a long step to port. The temptation will therefore not be to immediately release the rope, reach for the handle and stop the winch but to attempt to manually rectify the problem, particularly in view of the potential danger were the raised belly to drop on the heads of the crew member(s) engaged in emptying it.

1. The vessel's forward winches are controlled from a single non-spring-loaded handle provided adjacent to the port winch drum end. This handle can be left in the forward or aft position and needs no hand pressure to maintain powered winch rotation. It is recommended that, as a minimum, the winch control lever be repositioned such that it is operable from adjacent to both the port and starboard winch drum ends. To permit this, it may be necessary for dual controls to be provided. Alternatively, the provision of roller leads, or another means to run a rope from either side to a common operating position adjacent to the winch control lever, may be an option. Another possibility is the provision of an extension bar to the operating lever suitably supported and arranged to permit operation from two different locations.

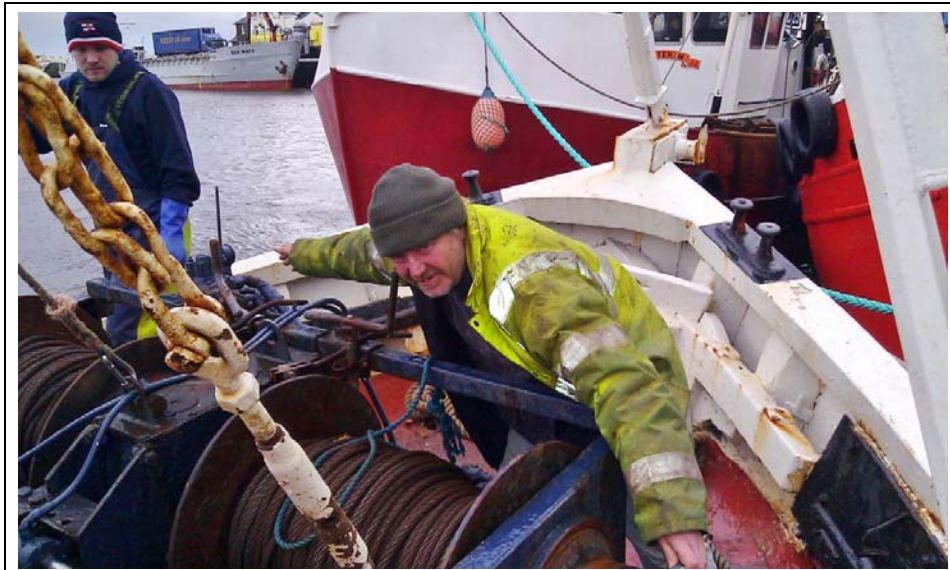
Crew member simulating working with starboard drum end, unable to reach winch operating handle

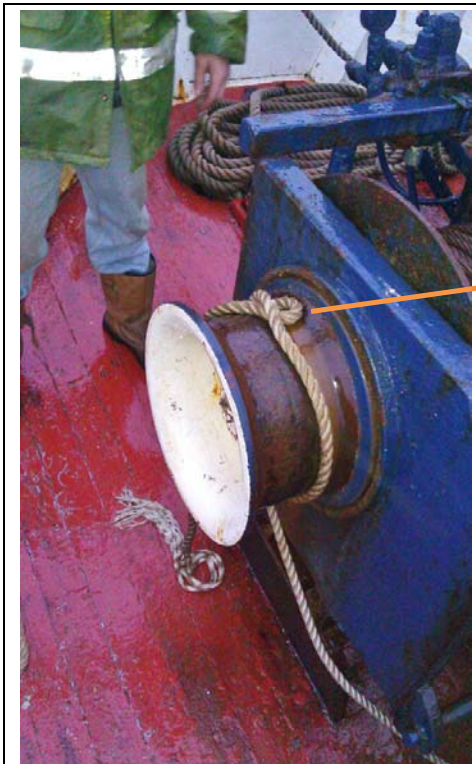
Port winch drum end

A 'riding turn', resulting in the drum end pulling both ends of the rope onto the winch at the same time.

Unless the tangle can be flicked out quickly, further rope handling is impossible without stopping the winch and manually untangling the rope.
