Isle of Man Ship Registry

Casualty Investigation

Report No. CA124

Isle of Man Registered “Hanjin Green Earth”

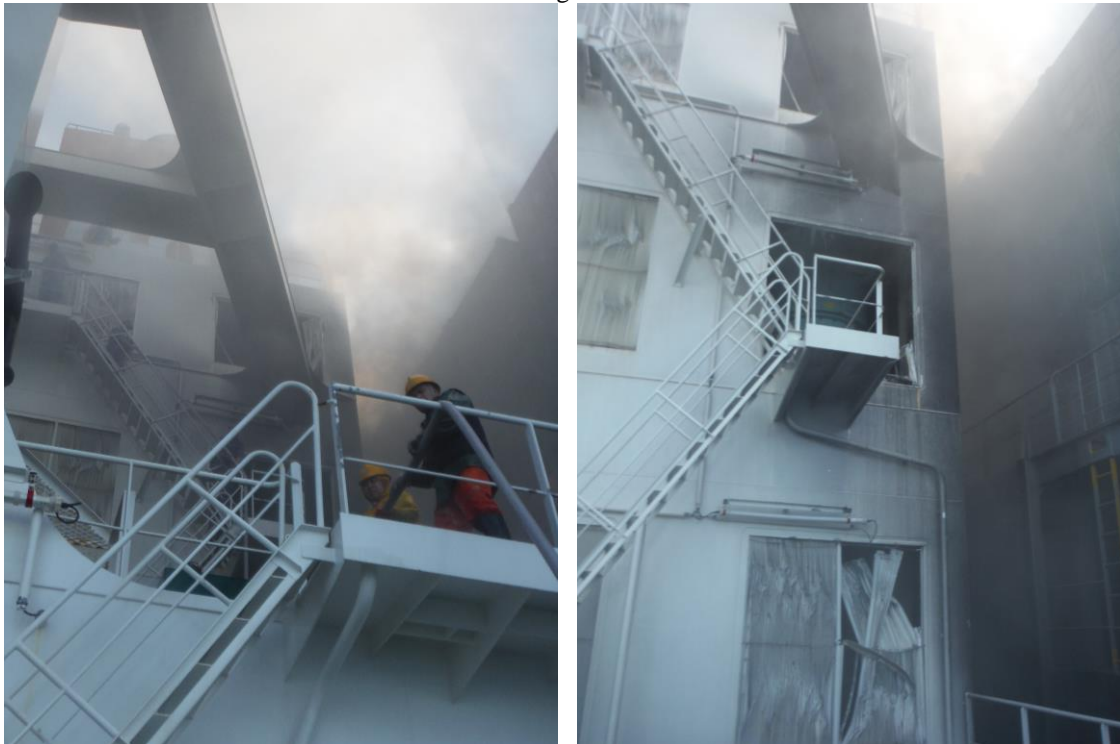
Figure 11

The water pressure from the tug on the stbd side had damaged the water catchers on the outside of the stbd ER fan room and emergency generator room. This resulted in firefighting water entering the fan room and the engine room through the fan trunking. The water was causing high levels in the bilges and thus required to be pumped out.

Egyptian Fire Team preparing hoses on stbd side of fan room casing and second image shows damage to the water catchers from the FiFi tug water monitors

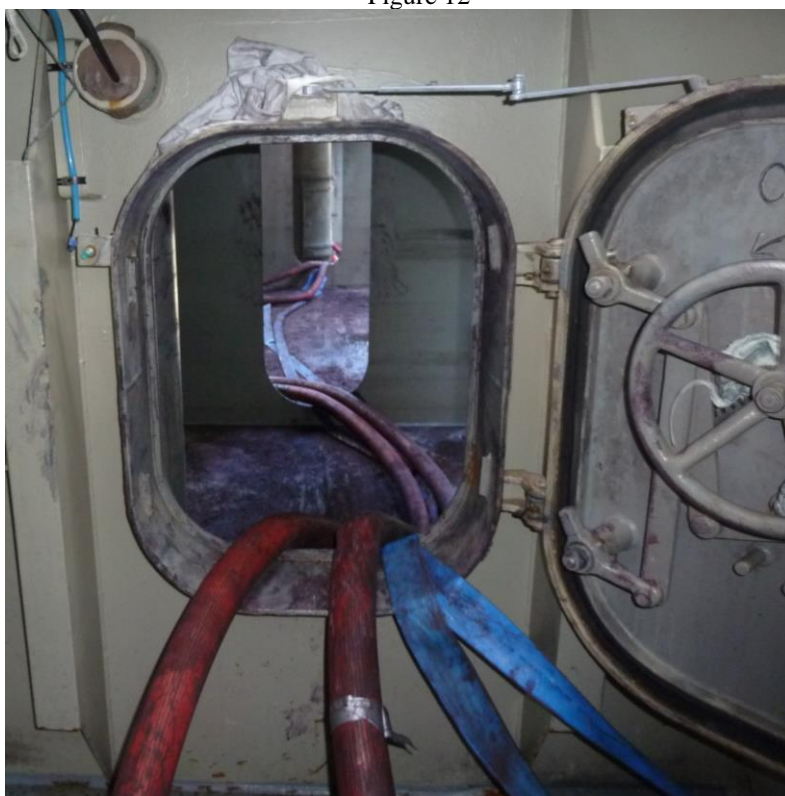
Figure 12

The WT door (frs59-60) was opened slightly using the central hand wheel that operates the 4 cleats (dogs). Witnesses stated that when the draining operation was started water was noted coming from around the bottom part of the door. This meant the door could not be fully opened to put the portable wilden pump into the hold so they started draining the leakage from the hold into the tarpaulin which directed the leakage into the ballast tank manhole openings (2 x No 9 SWBT (S)) in the immediate vicinity.

WT door (frs 59-60) from stbd side deck 2 underdeck passageway, looking through to CH 9

After monitoring the WT door (frs 59-60) draining CH 9 it was noted that the level behind the door was rising due to the leakage around the door moving up over time eventually it was spraying out all around the door seal.

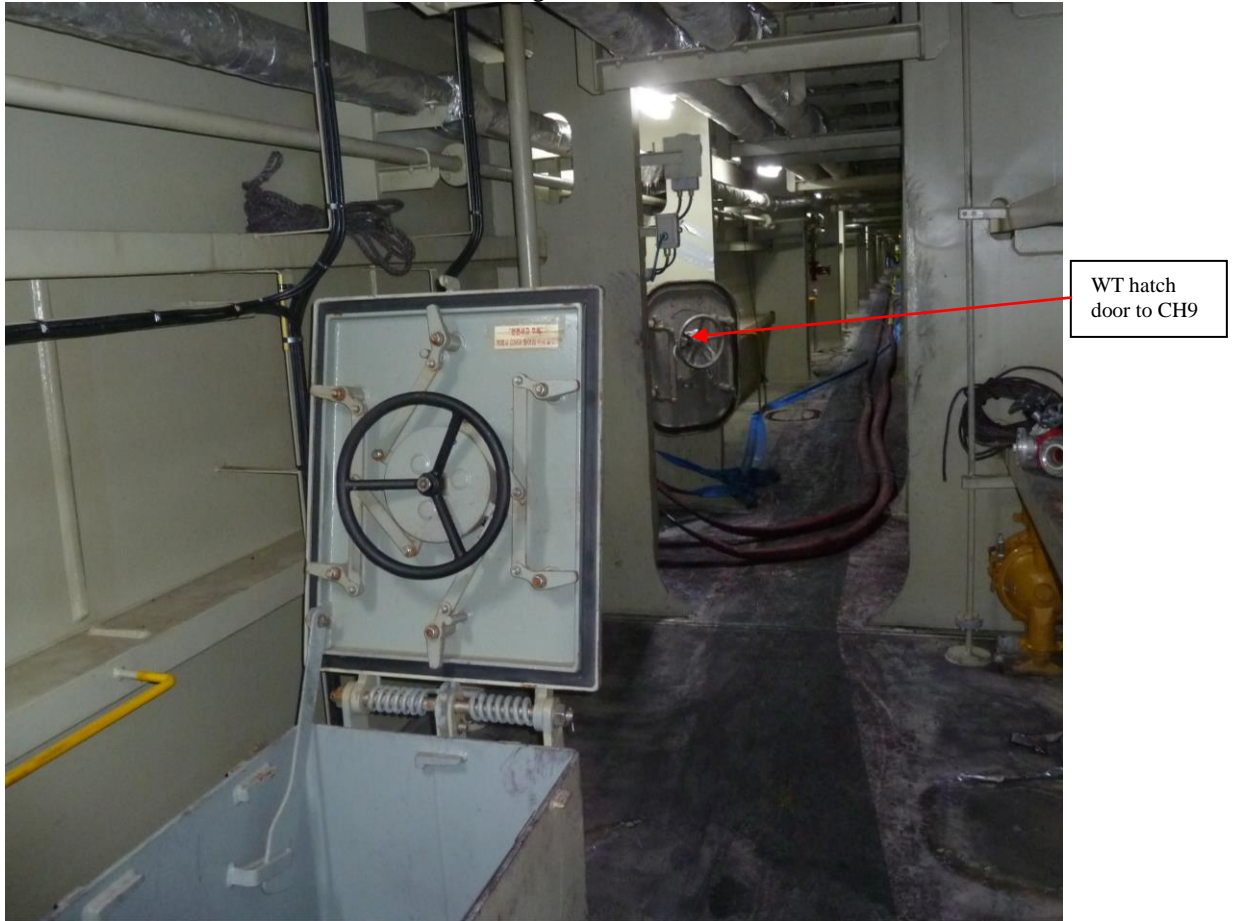
Figure 13

Raised access hatch to stbd bunker station (frs 55-56) in foreground and further behind can be seen the open WT hatch door (frs 59-60) to CH 9.

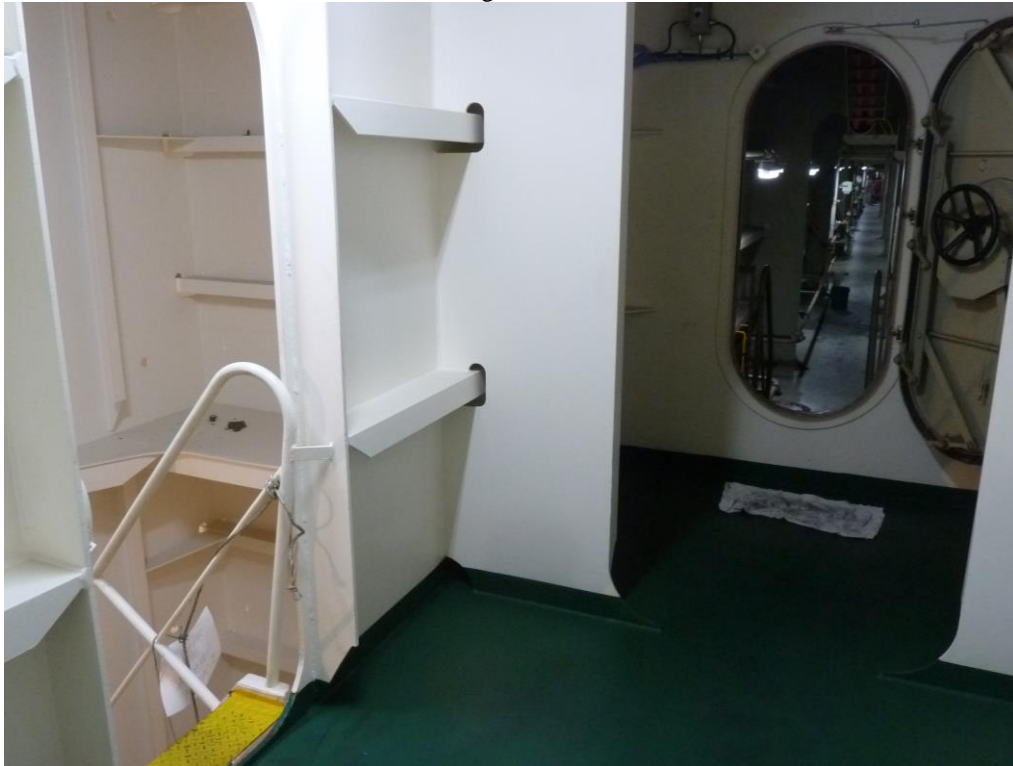
Figure 14

They could see water running down the stbd stairway into the open void stbd side of the steering gear. They went up this stairway and then managed to close the aft WT door (fr 12) (leading into the deck 2 underdeck passageway) to stop any further leakage into the steering gear compartment.

Aft WT door (fr 12) at the end of the stbd deck 2 passageway, water flooded above this level and down the stairwell in the foreground into the steering gear compartment.

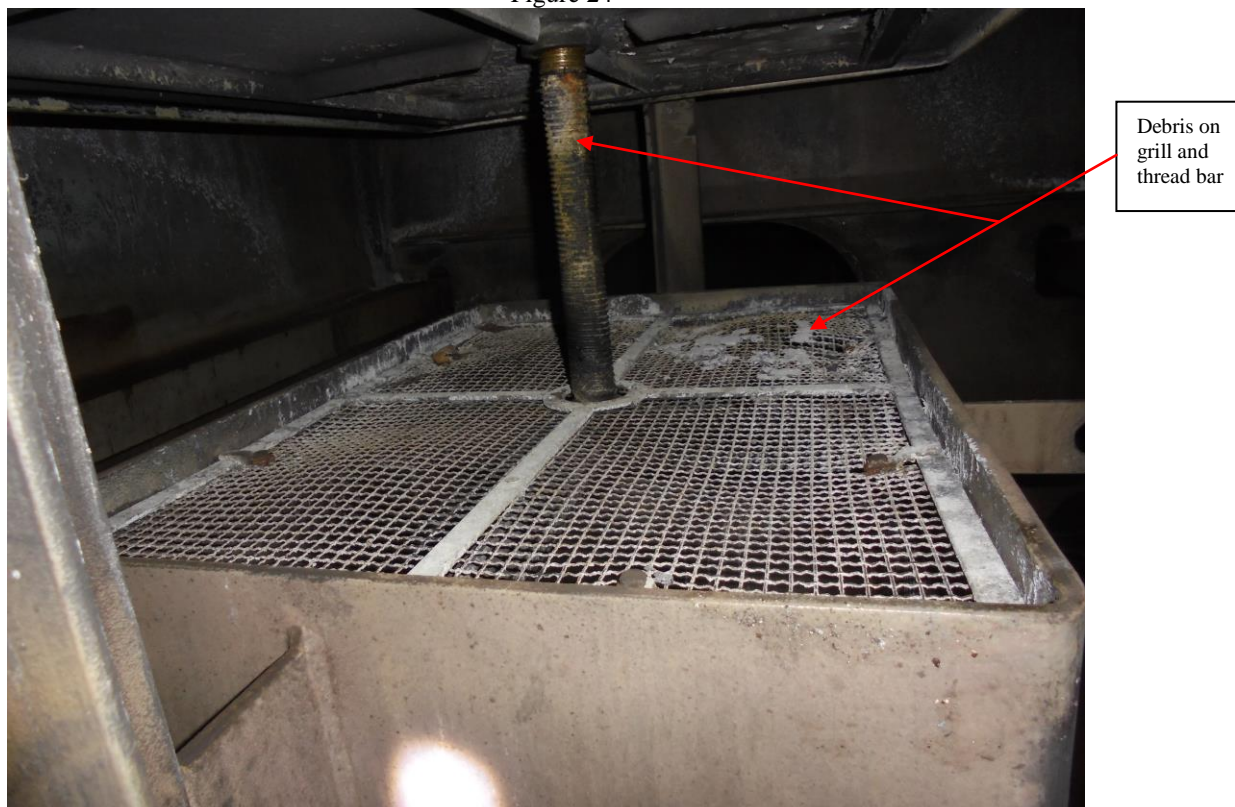
Figure 24

It could not be established if the screw down lids for the 2 hold ventilation supply trunkings were fully shut by the firefighting crew tasked with the job.

Open ventilation trunking referred to above

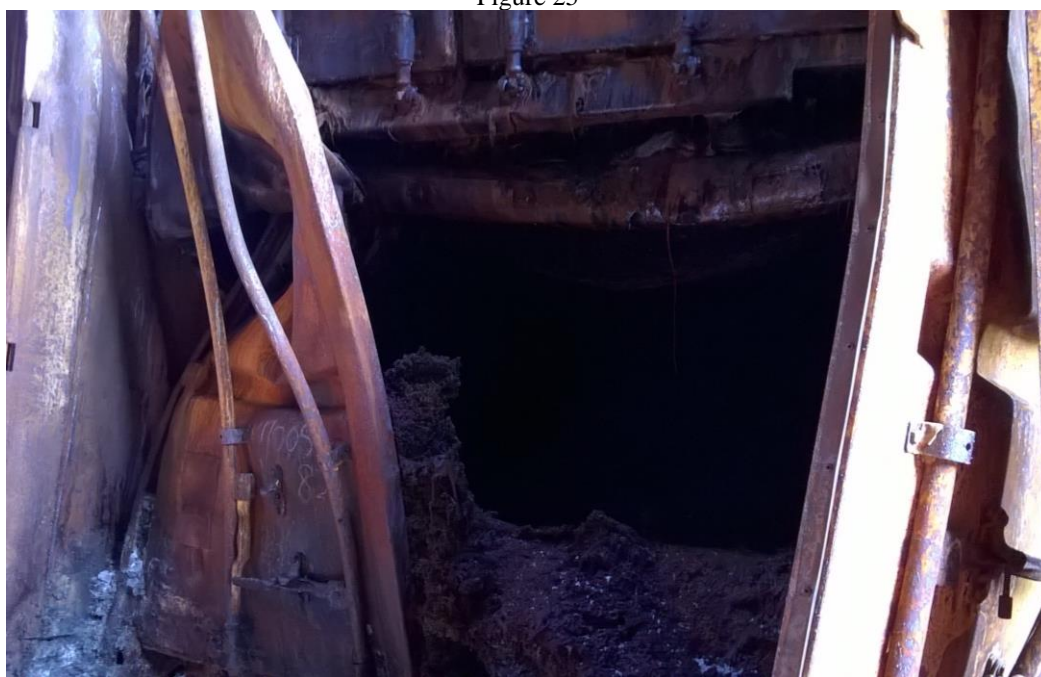
Figure 25

Container 700582 containing polypropylene ruptured at the aft end causing fire damage to ER casing fwd bulkhead, lashing bridge above and surrounding containers

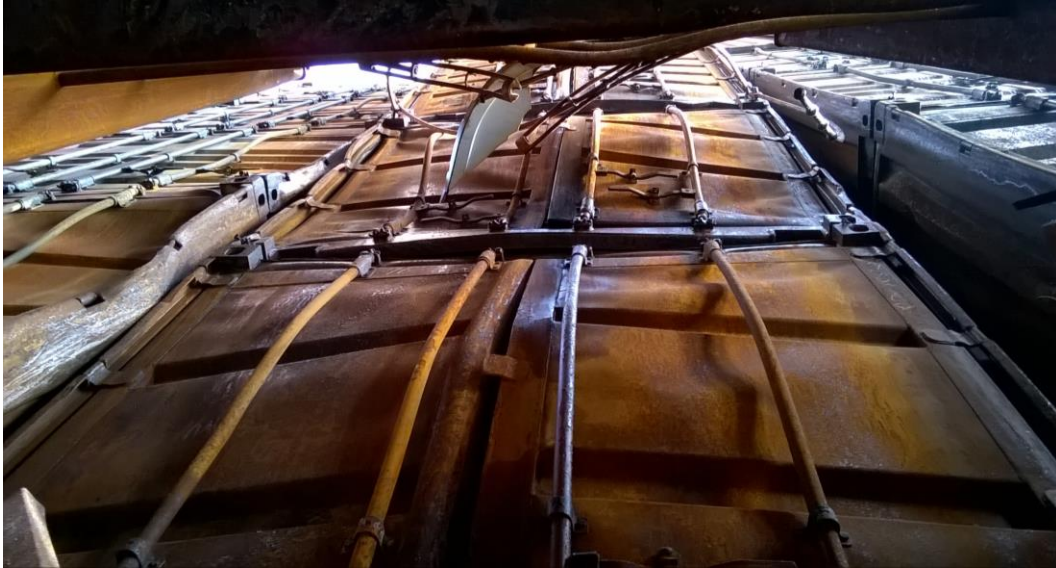
Figure 26

Damage to containers above and surrounding 700582

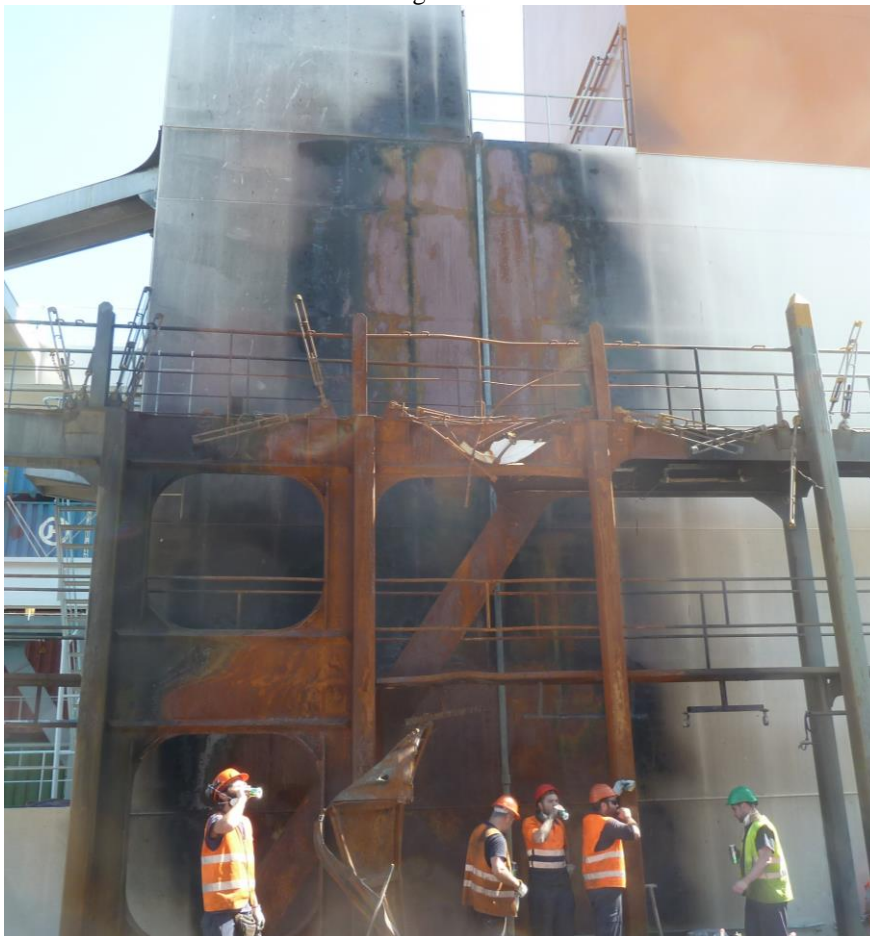
Figure 27

Damage to the lashing bridge in the foreground and to ER casing fwd bulkhead behind

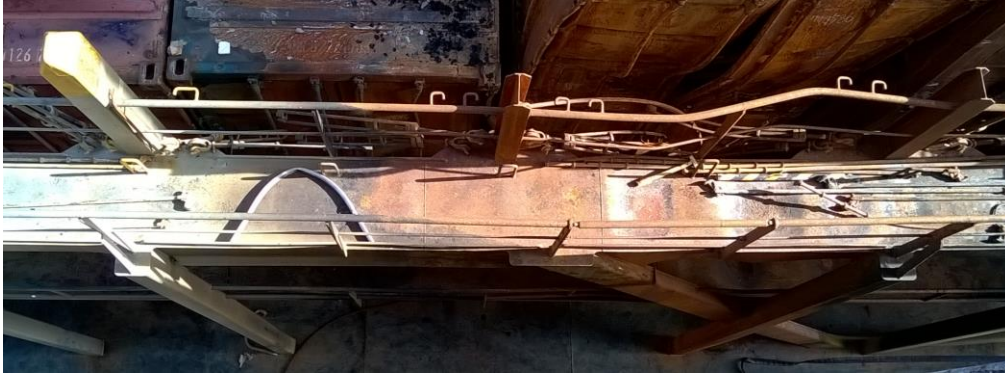
Figure 28

Damage to Lashing Bridge

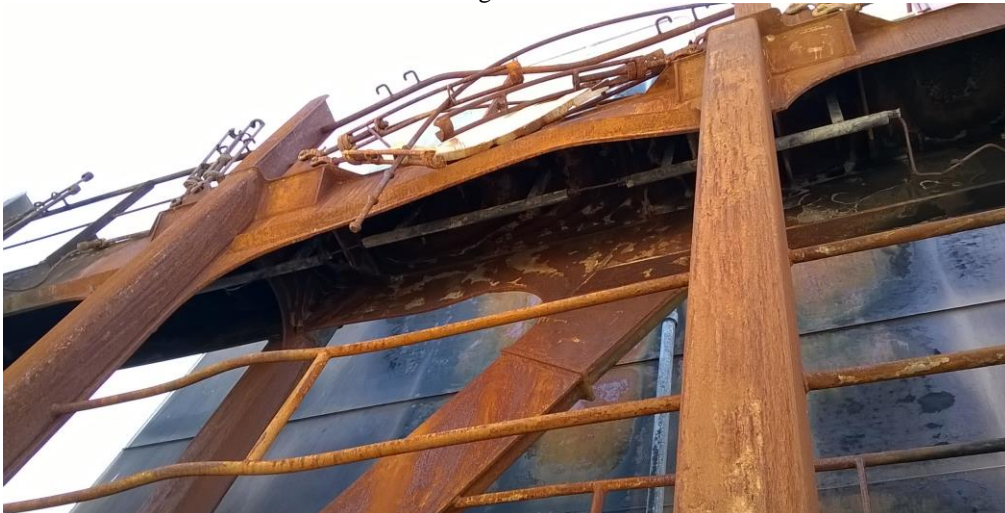
Figure 29

Damage to lashing bridge

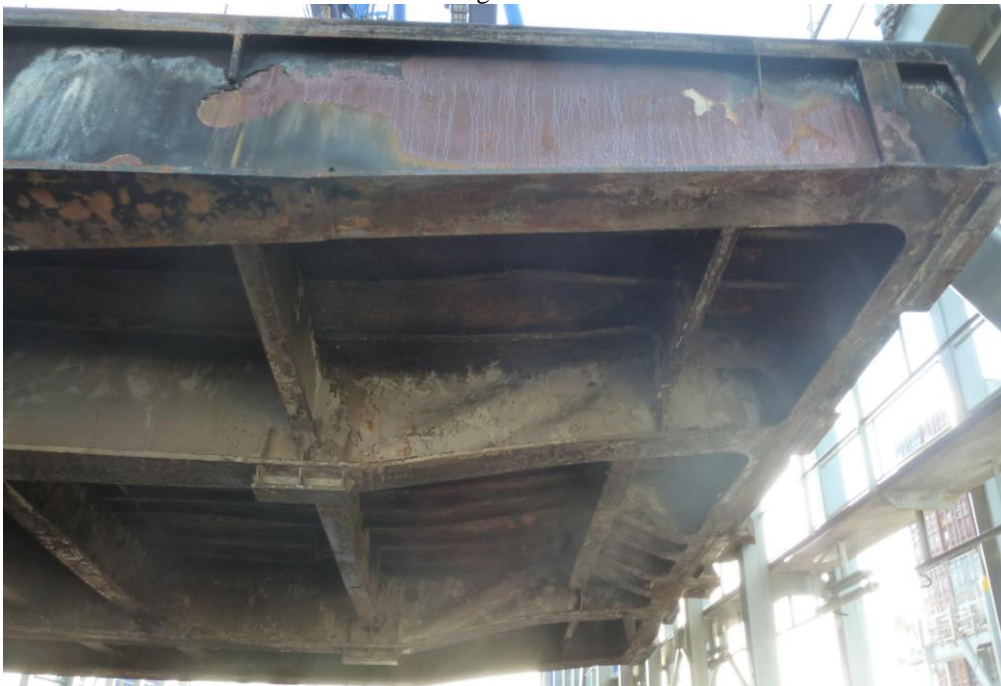
Figure 31

Once the containers on top of the 4 hatch covers had been removed it could be seen that there was significant damage to the 2 inner hatch covers. The deformation of some of the large structural members of the hatch covers could easily be seen as could the deformation of the steel plating on top of the hatches.

Bay 70 stbd inner hatch cover showing deformation due to heat damage

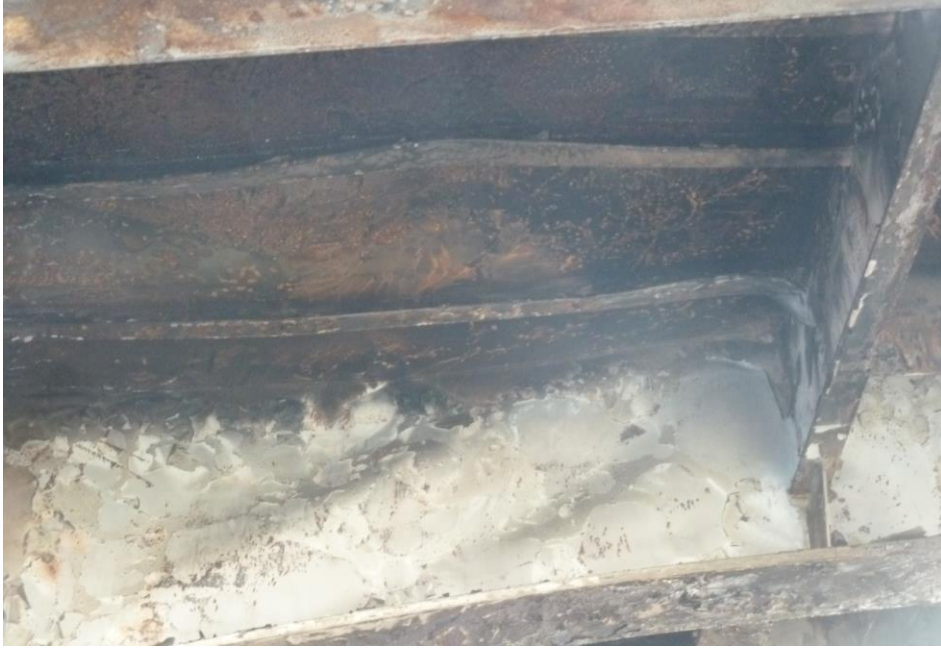
Figure 32

Heat damage to stbd inner hatch cover

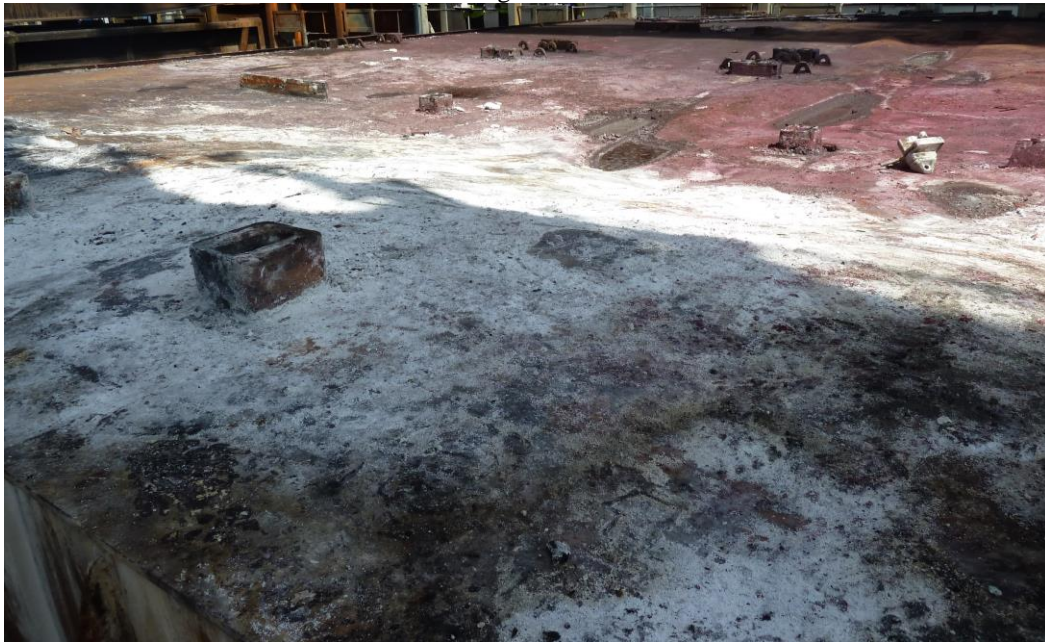
Figure 33

Distortion on top of stbd inner hatch cover

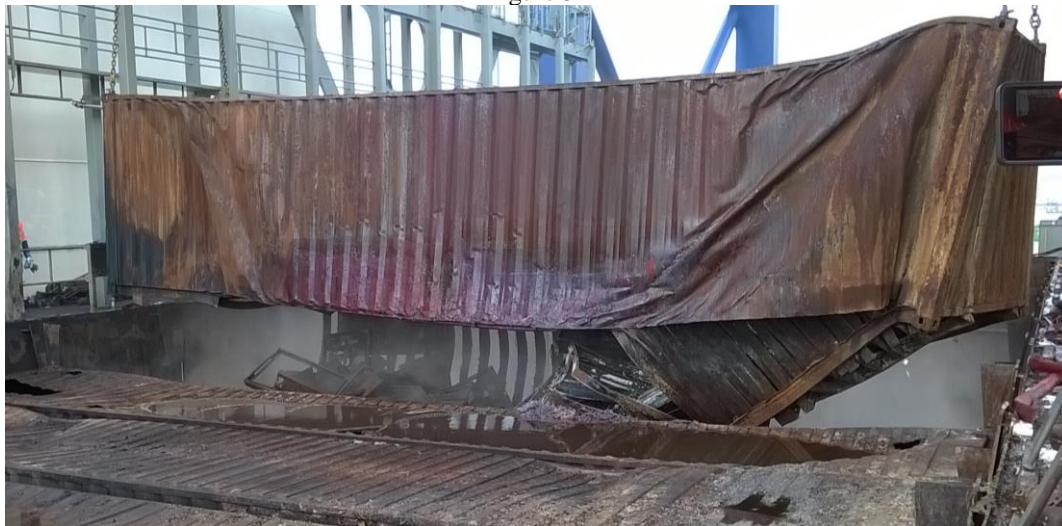
Figure 34

Container loaded directly above 700220 being lifted out loses the remnants of its contents which fall on top of 700220

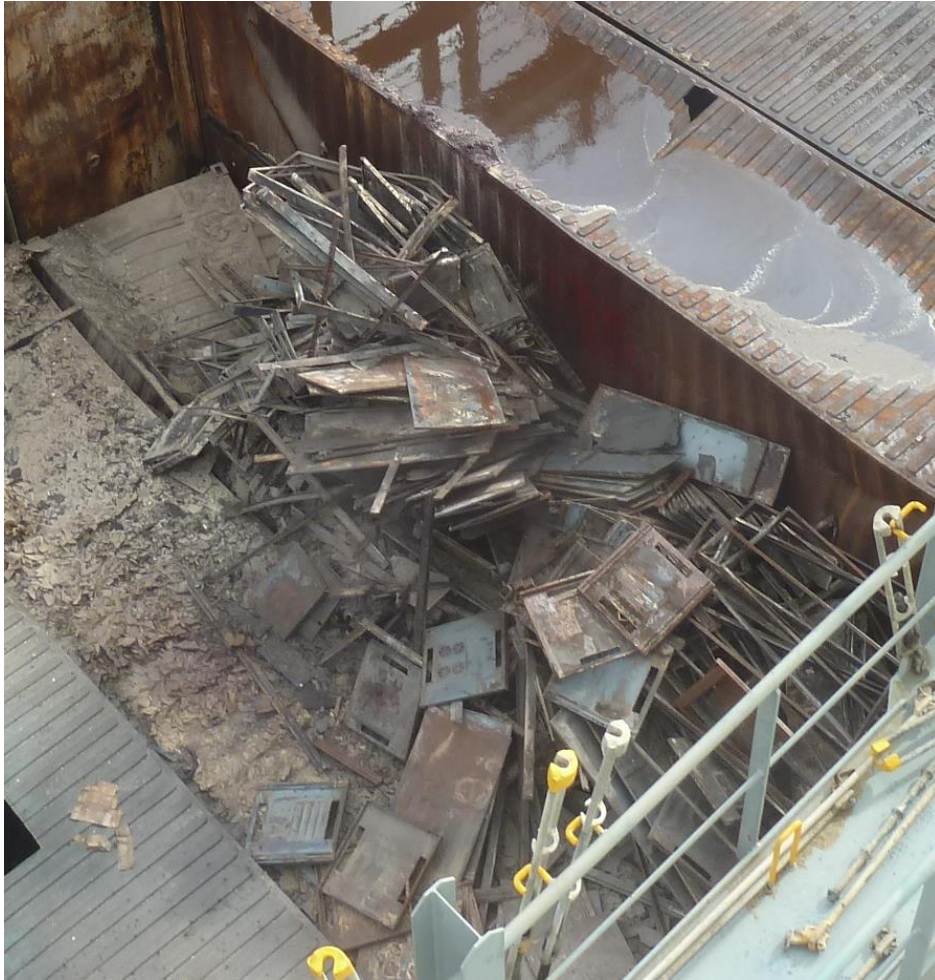
Figure 35

Contents on top of 700220

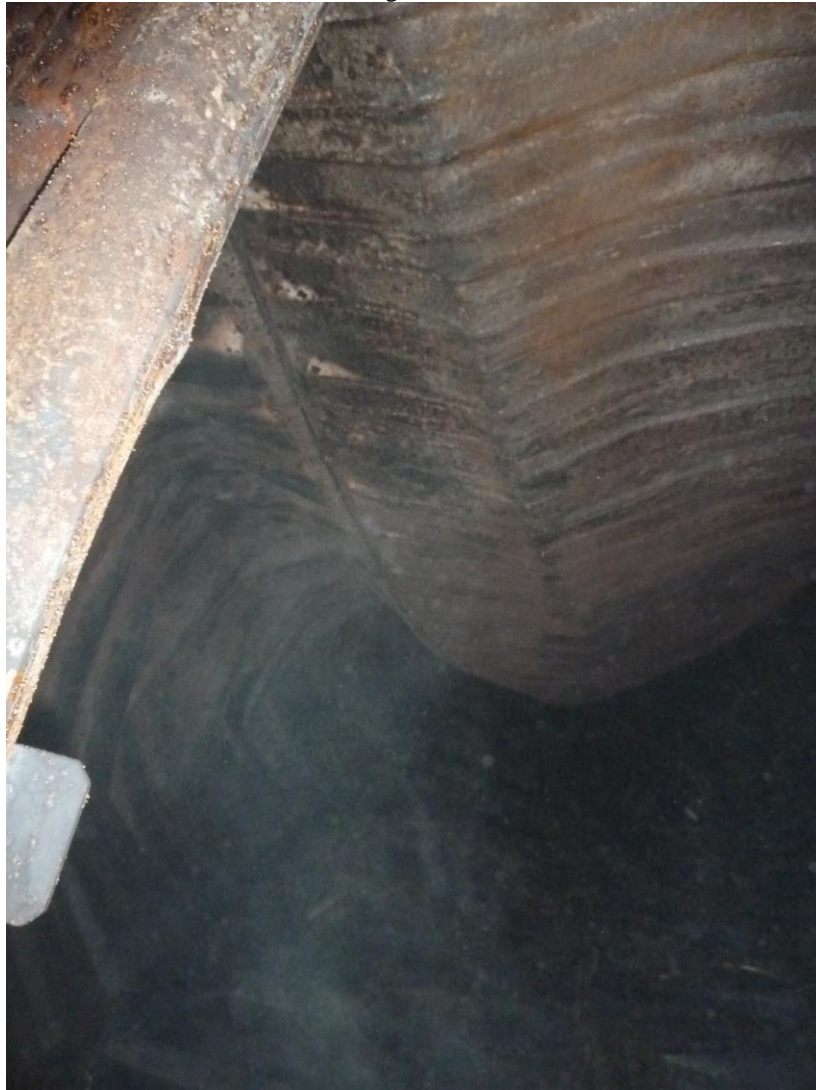
Figure 36

It could be seen from what was left of the container in position 700220 (the container sat directly above the ECR void space) that there had been a large explosion or series of explosions, The sides of the container were convex having been blown outwards and as a result the roof was deformed and had collapsed inwards. The doors (at the fwd end of the container) were completely deformed with the stbd side door blown open. The floor of the container was destroyed with only a skeleton of cross members remaining.

Container 700220 viewed whilst still in the hold, showing ceiling collapsed and sides blow out

It can be concluded that the fire originated in CH 9 from the container in position 700220 i.e. the second container down from the hatch cover and just to the left of the centre line.

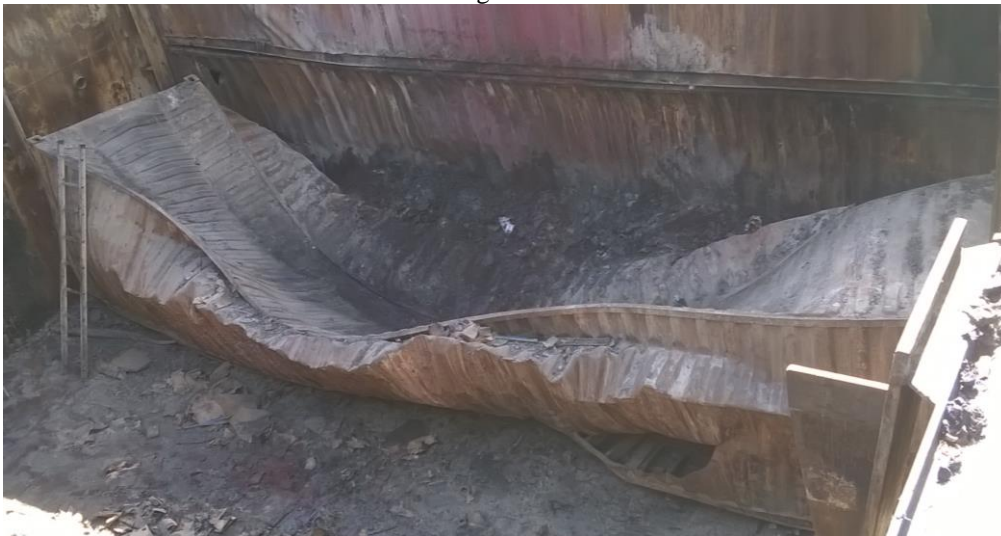
Figure 37

Container 700220 with debris above removed

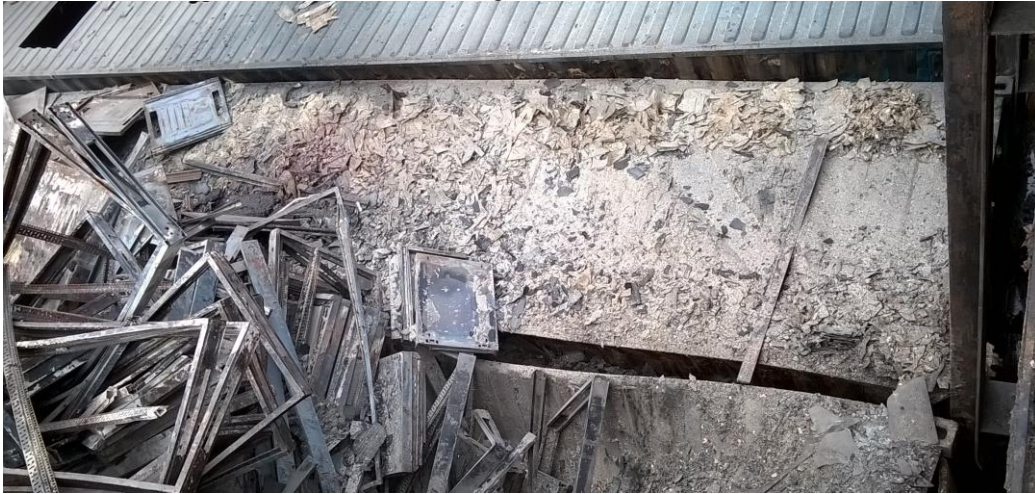
Figure 38

The container in position 700420 directly on the port side of 700220 was found distorted. The side adjacent to 700220 was deformed in a concave direction and its outboard side in a convex direction.

Container 700420 showing deformed side adjacent to 700220

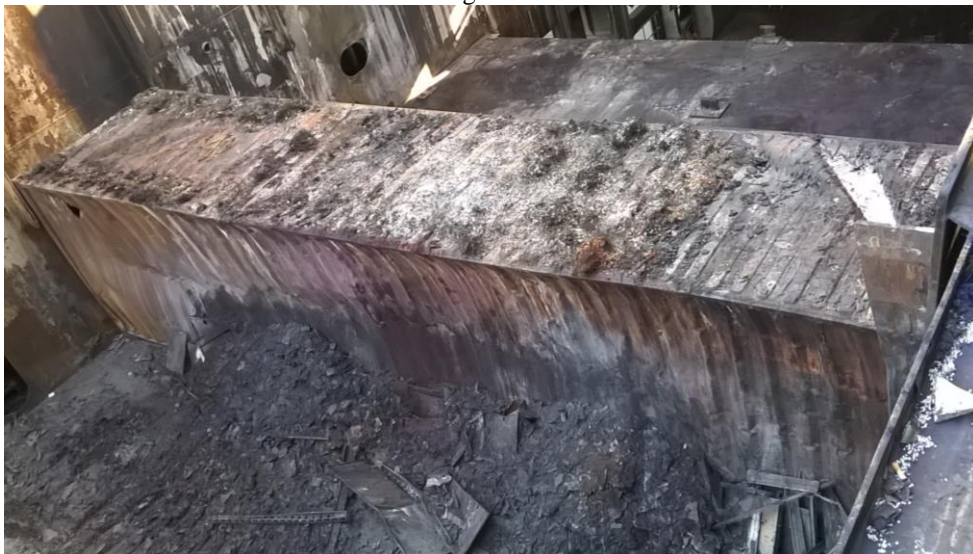
Figure 39

Container in position 700020 directly on the stbd side of 700220 was also deformed. The side adjacent to 700220 was deformed in a convex direction and the outboard side having a concave deformation.

Container 700020 showing deformed side adjacent to 700220

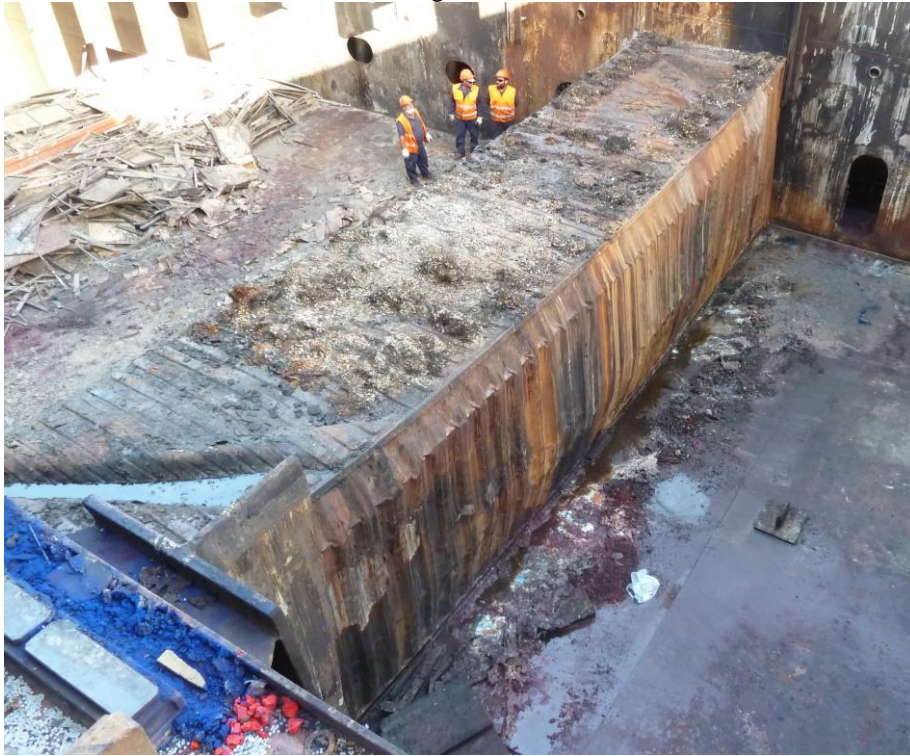
Figure 40

Container 700020 showing deformation on outboard side

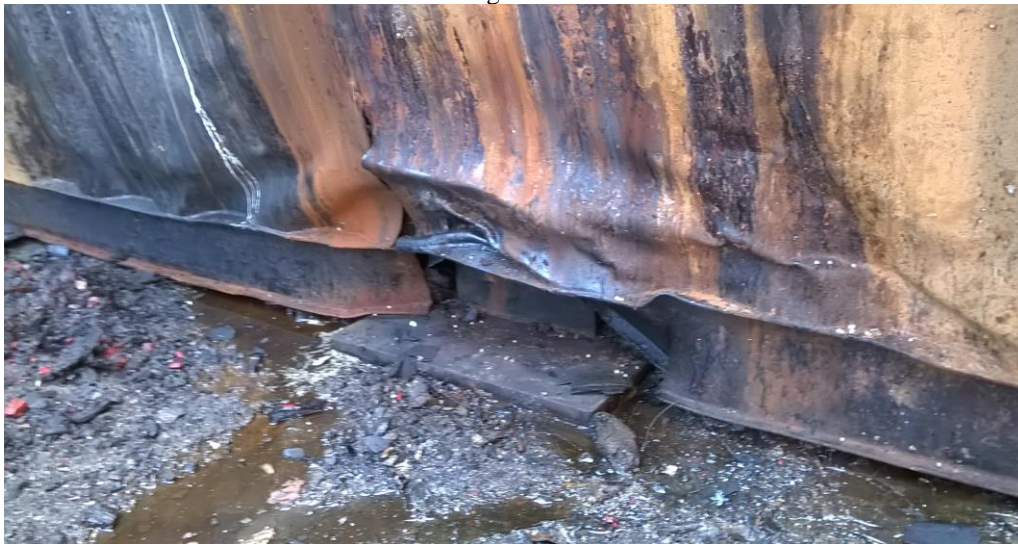
Figure 41

Base of container 70020 is torn on the cell locator as it is blasted outwards

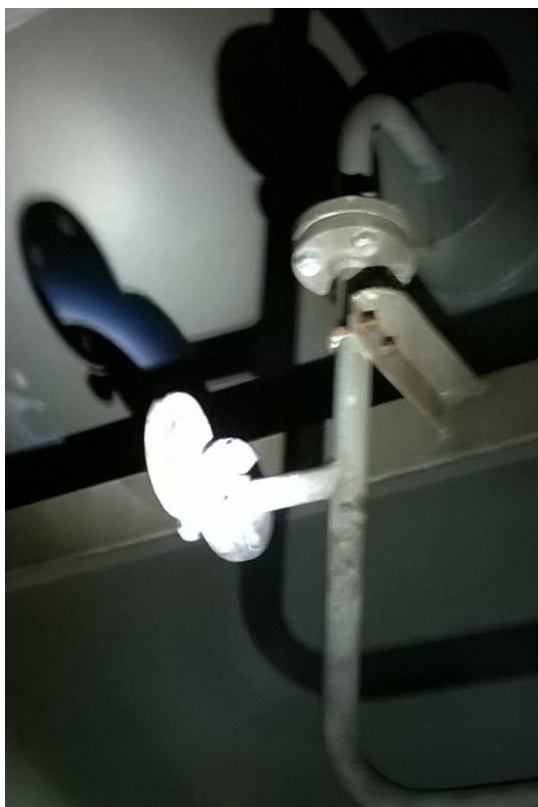
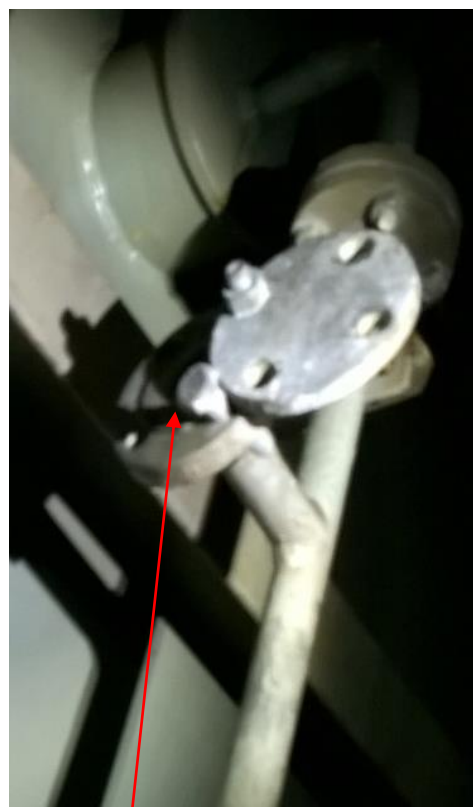
The consequences of this open flange were put to fire experts at Class KR for their expert opinion. It was calculated that about 20% of the CO₂ would have leaked through this open flange rather than being distributed through the CO₂ nozzles. Even though there was a pressure drop in the discharge line it would not have had a great impact on the fire extinguishing performance. Ultimately all of the CO₂ from the initial discharge still ended up in CH9. Also the subsequent release of all other CO₂ bottles would have been more than adequate in provided enough CO₂ for the hold.

Open ended flange

Open ended flange alternate view

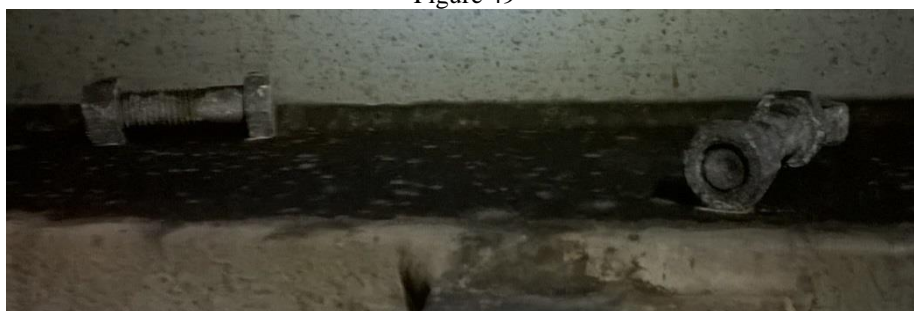
Figure 49

Missing nuts and bolts on framing below

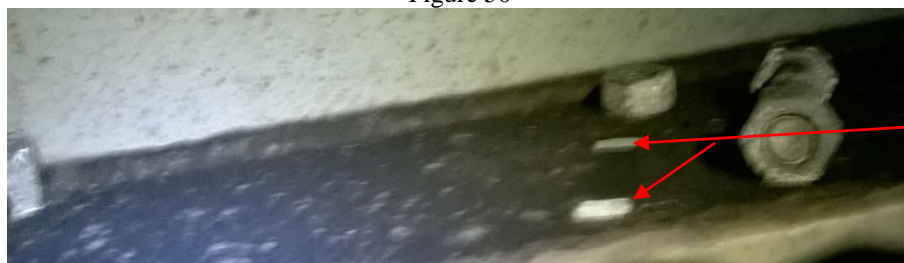
Figure 50

Clean paint

Nut and bolt moved to the right of original position revealing 2 areas of clean paintwork where it contacted the framing.

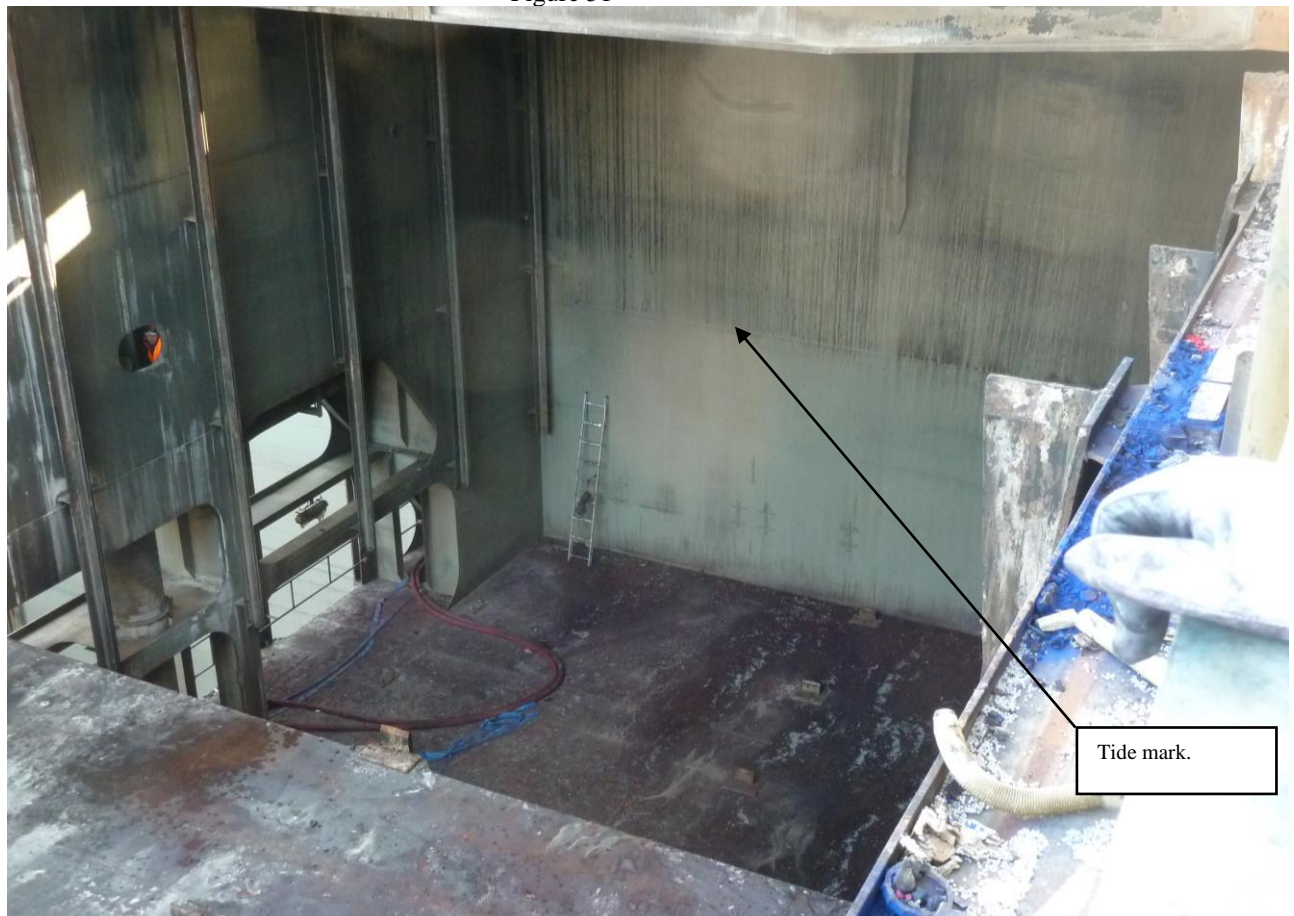
Figure 51

Tide mark clearly seen above ladder on deck 2.

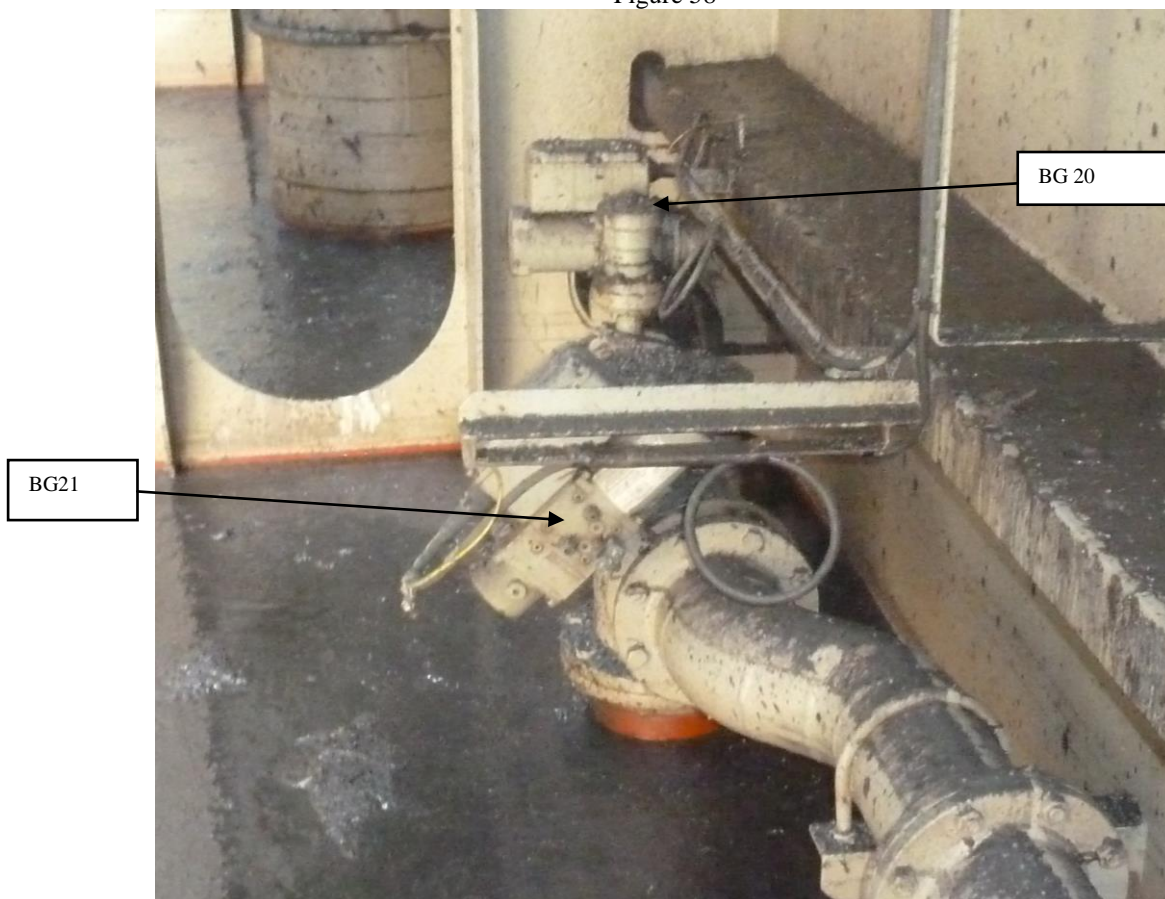
Figure 58

The ships staff attempted to start pumping out CH 9 using the bilge pump, however, found that the valve would not open due to assumed water damage to the actuator.

The ER event log shows numerous attempts to operate the CH 9 bilge suction valves BG020 and BG021 between 17:17hrs and 17:36hrs. The valves were found to be inoperative and thus they were unable to start pumping out the accumulation of the fire water from the hold.

Shows stbd bilge valve and actuator BG21 in the foreground and port bilge valve actuator BG20 can be seen in the background. Both lead into bilge main below via T connection (orange pipe).

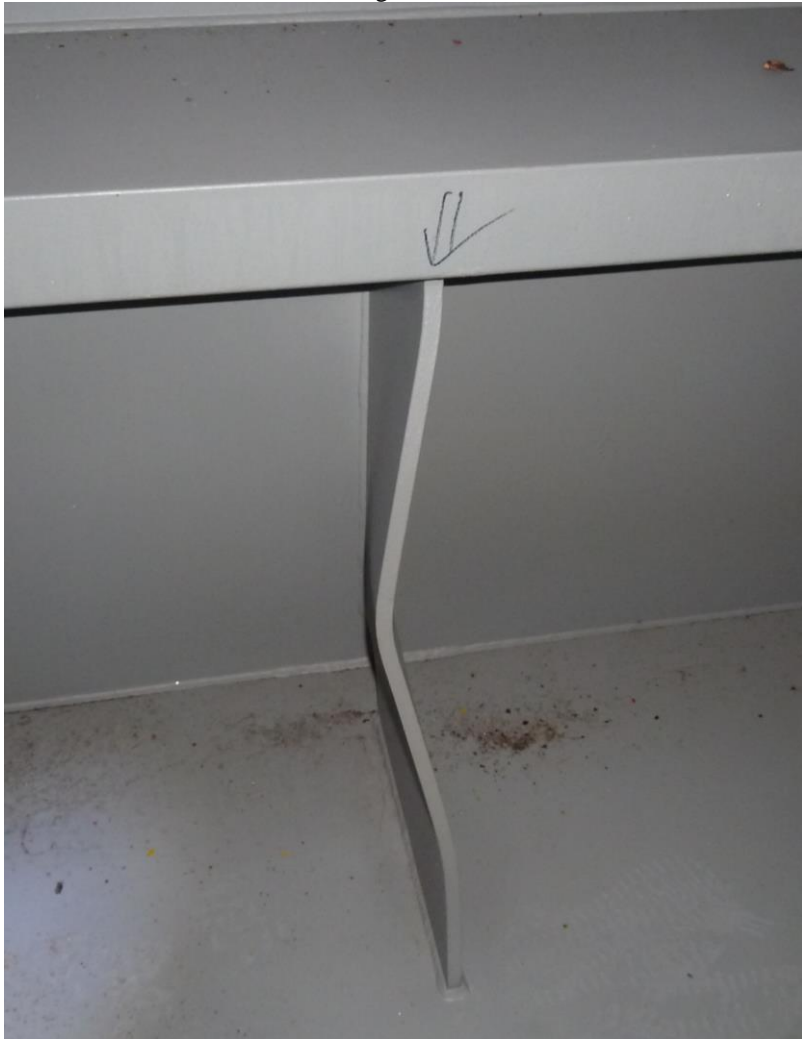
Figure 60

Brackets on stringer deformed

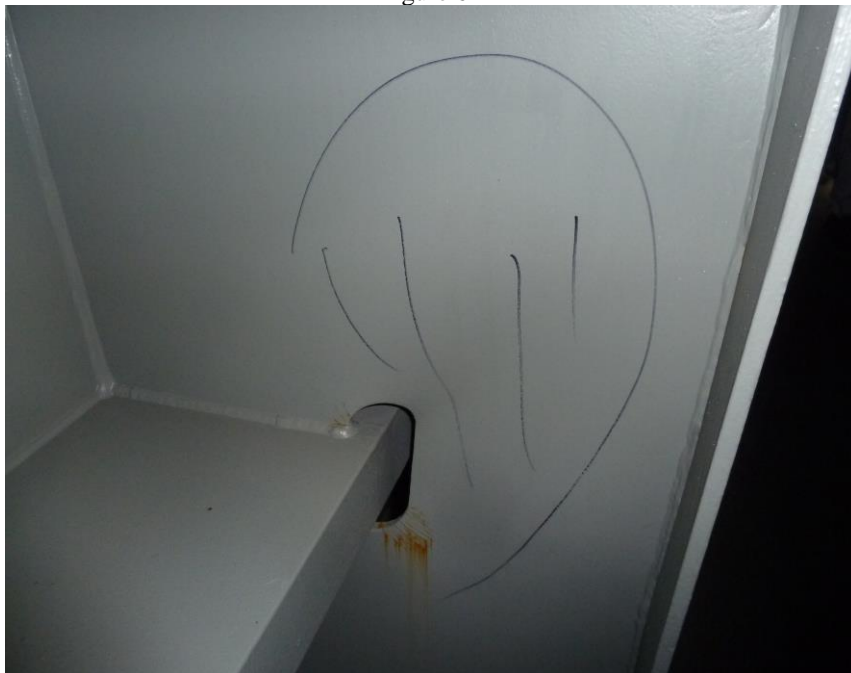
Figure 61

Deformation on vertical girder
