Isle of Man Ship Registry

Casualty Investigation Report No. CA 119

Nordic Visby

Fatality

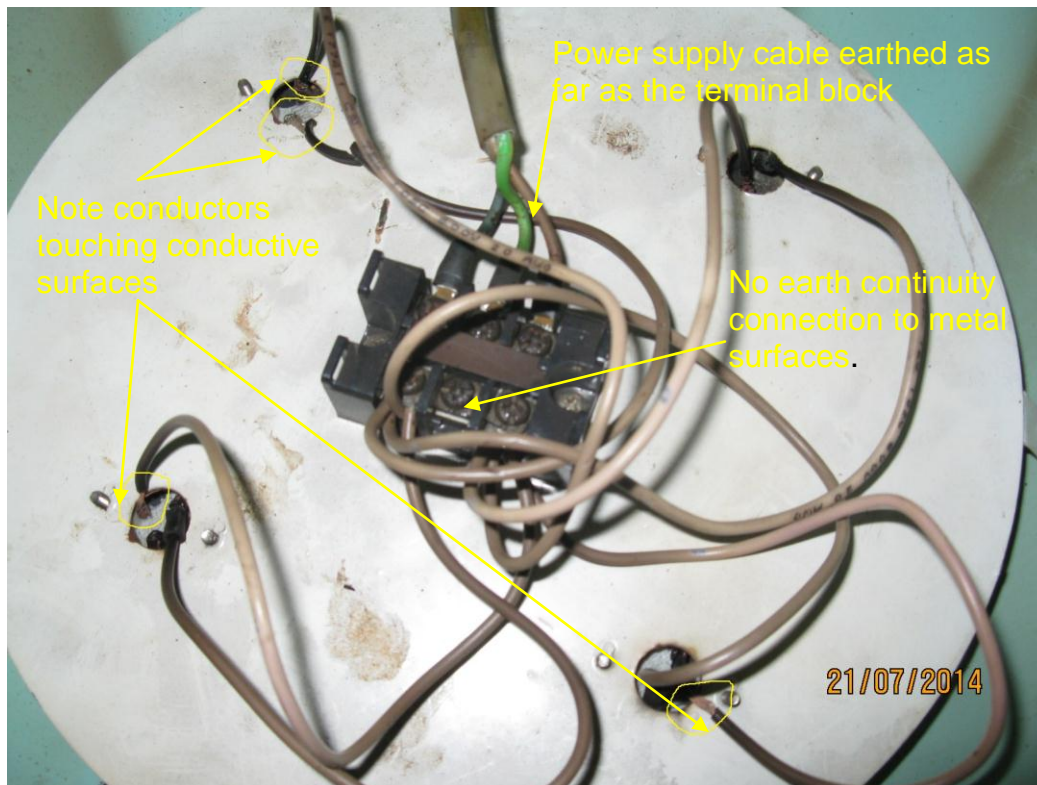
- to be internally wired with the metal parts of the fitting not having continuity wire to earth making earth fault detection impossible;
- to have brittle insulation breakdown on the internal power supply wires to the lamp holders, probably due to high temperatures generated by the unit itself when in use (240~400Watts depending on the bulbs fitted);
- the conductor connections themselves were corroded - possibly due to the high humidity levels normally existing in a ship's engine room and the age of the cluster light; and
- to have been supplied to the vessel some time prior to embarkation of the 3/E who was the longest serving of the engine room staff. Therefore it is not possible to determine if initial safety testing had been carried out. It could have been assumed, on appearance, that the (ship's equipment) supplied portable lights were fit to use.

Although not readily accessible, through insulation breakdown/ internal contact with conductive metal surfaces and because there was no earth continuity wire to alert the monitoring system, the fitting itself became hazardous.

Cluster light in question – note no earth wiring to conductive surfaces (the white plate and fittings secured to it in this picture). Multiple power conductors are highlighted touching metal, but this will undoubtedly be due to disturbance after the accident. Any one of the conductors could have made the fitting “live”.

Through radiated heat in use and general aging, the supply wire insulation condition had deteriorated, exposing the power supply conductors and allowing them to contact the metal (conductive) parts of the fitting, making those "live" as well. Regular inspection may have determined this deterioration allowing rectification or replacement before it became dangerous.

As there was no internal earth connection from the metal parts of the fitting to the terminal block, testing either phase to earth at the power supply plug would not have shown the existence of a fault condition. Also a developing fault on existing equipment would not give an earth fault alarm on the switchboard testing would have to be undertaken between connections at the plug and the metal parts of the fitting itself to show a fault condition.

- further develop the vessel’s PM system to schedule regular inspection and testing of all portable appliances which are subject to wear and tear during normal use, to help ensure they continue to be inherently safe to use.

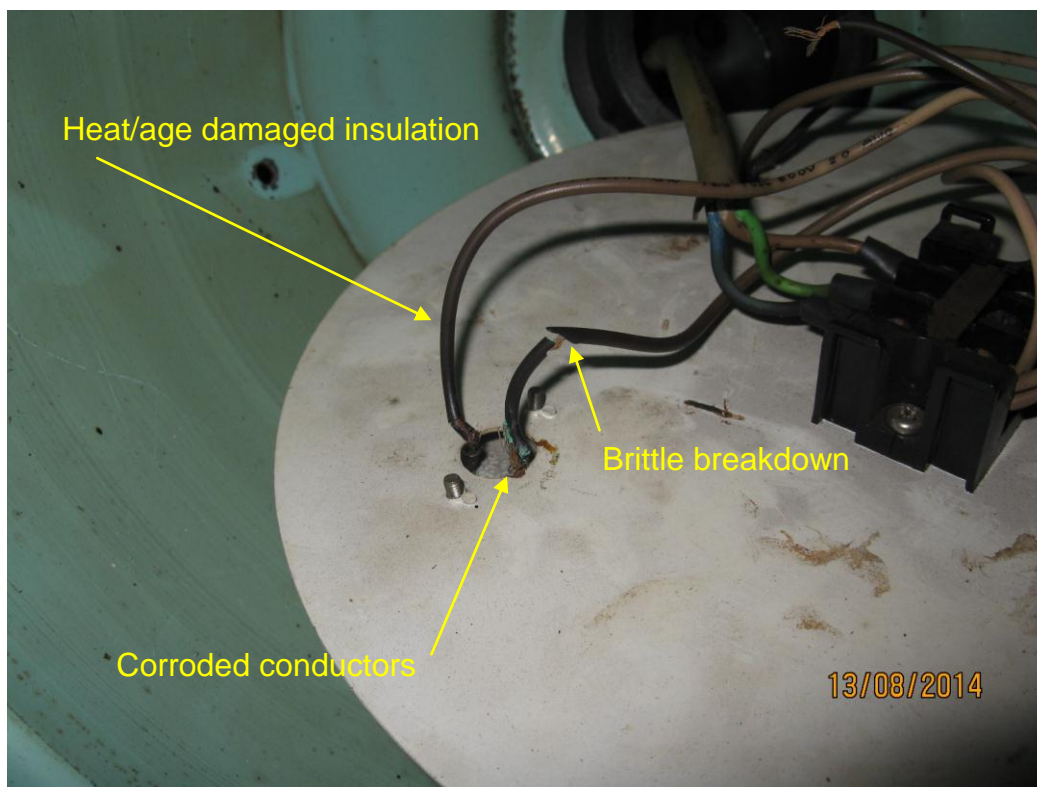
Heat damaged insulation, brittle breakdown, corroded conductors.
