Isle of Man
Marine Administration

Report CA 95

Crane Failure / Fatality

Sallie Knutsen

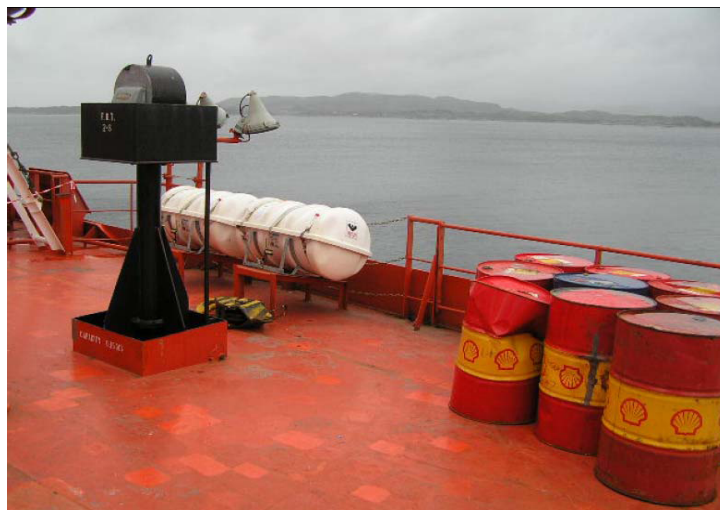
Figure 4

The Chief Engineer fell with the force of the impact, striking the left hand side of his head on the edge of a save-all coaming surrounding a fuel oil vent pipe.

Figure of fuel oil vent pipe save-all

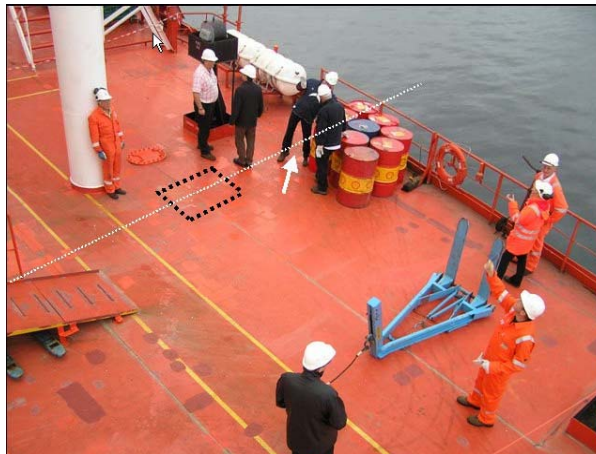
Figure 5

Black dotted box indicates position of chemical pallet
White arrow indicates the position of the Chief Engineer when he was hit
White dotted line indicates transverse movement of the crane

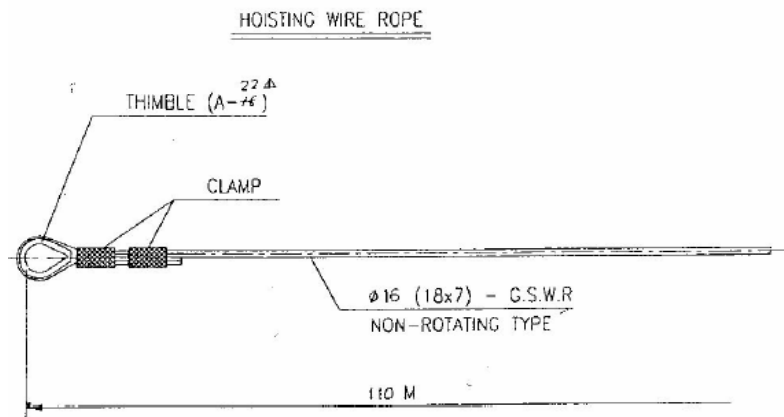
The crane manufacturer's instruction manual shows a wire rope of 16mm, 18x 7 with fibre core (WFC) and shows the correct method for terminating the free end (dead end) of the wire rope using a thimble eye and "Talurite", ferrule clamps as shown in figure 6.

Figure 6 Showing Talurite, ferrule clamps from Manufacturer's Instruction manual

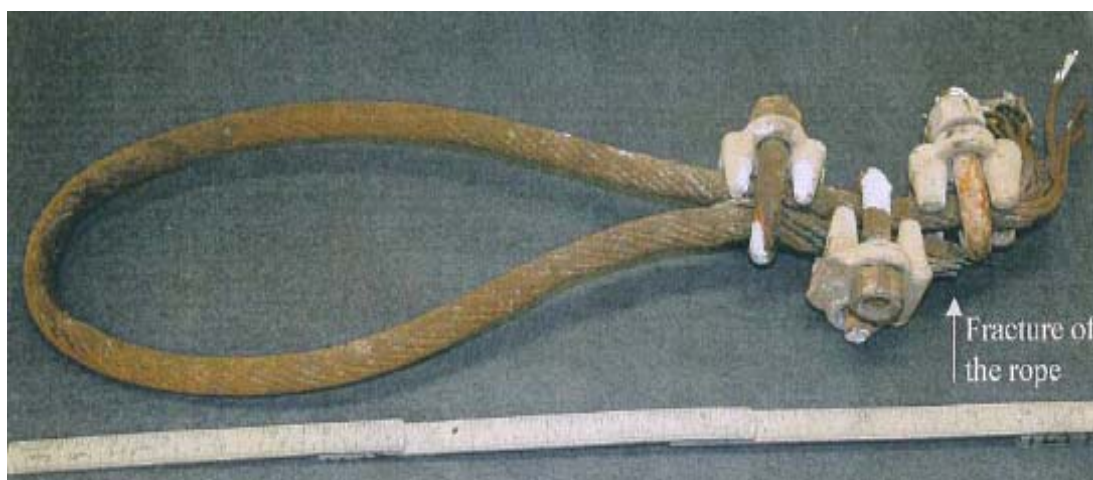
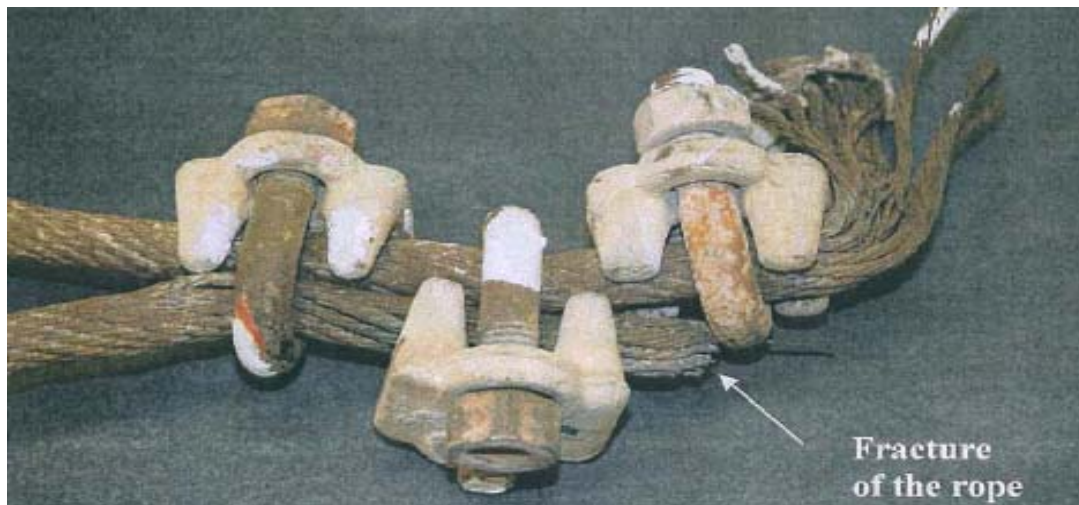
Figure 7

The method used onboard the Sallie Knutsen consisted of three bulldog clamps of the "U" bolt type as shown in Figure 7.

Figures 7 and 8 also show the position where the wire rope parted.

Referring to figures 7 and 8, it can be seen that the first and last bulldog clamps are fitted incorrectly with the saddle attached to the free end (dead end) and the “U” bolt clamping the main wire (live end). The spacing between each clamp is also well below the six times wire rope diameter required.

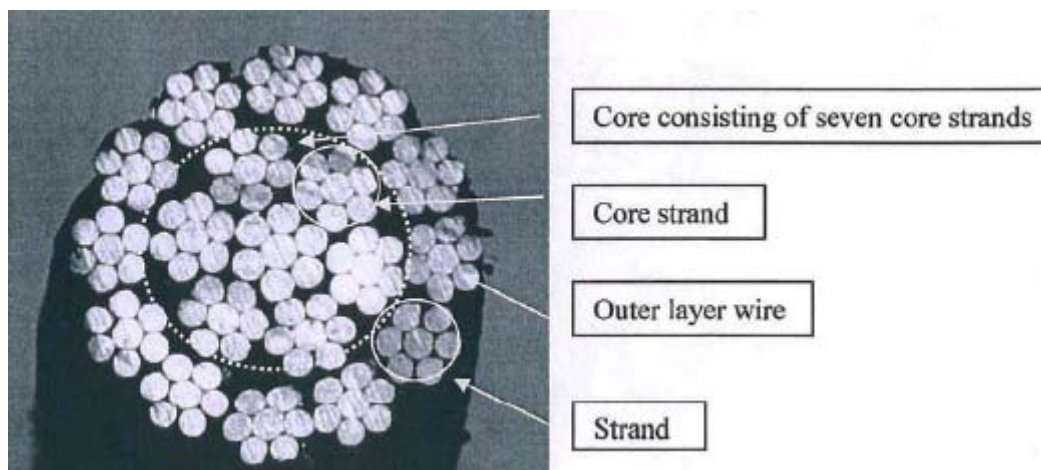
Figure 9

The construction of the steel wire rope was 16mm, 19 x 7 (12/6/1) with steel core (WSC). Figure 9, shows a cross section of it.

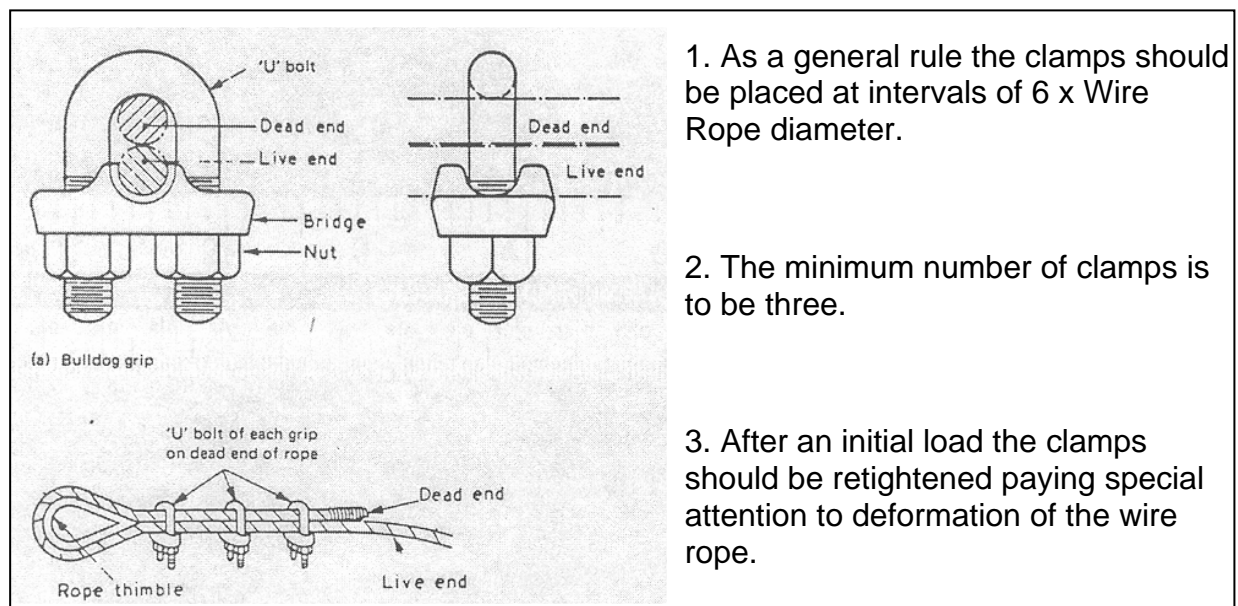
Figure 10

The Isle of Man has issued technical information on the use of bulldog clamps for wire rope terminations (industry circular No.7) the arrangement being shown in Figure 10. This method of termination is only accepted for lifeboat falls and not for crane wires.

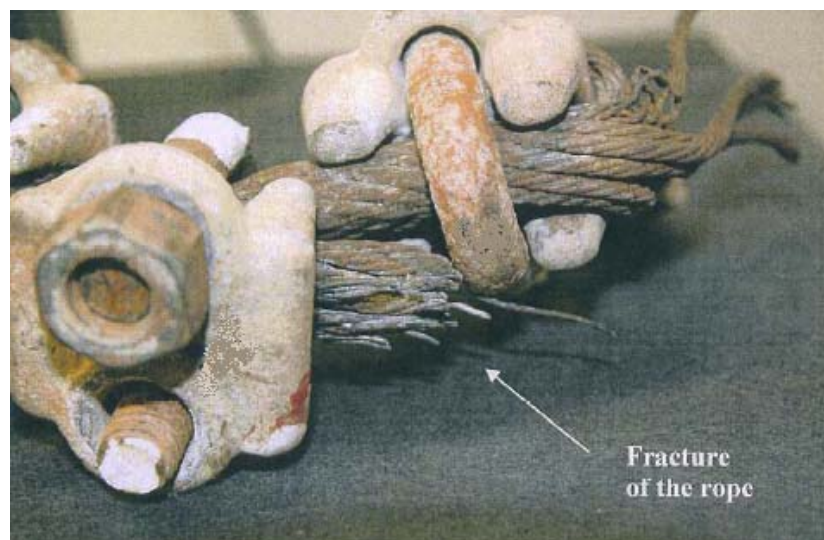
Figure 11

The wire rope has parted / fractured at the contact point of the first “U” bolt from the free rope end (dead end). This is clearly shown in figure 11.

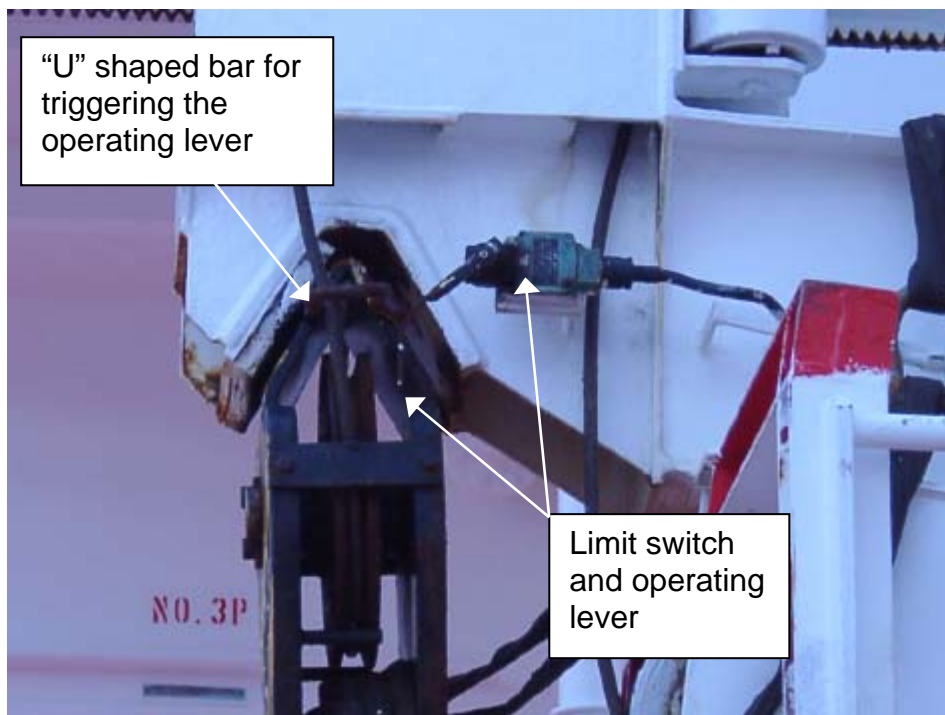
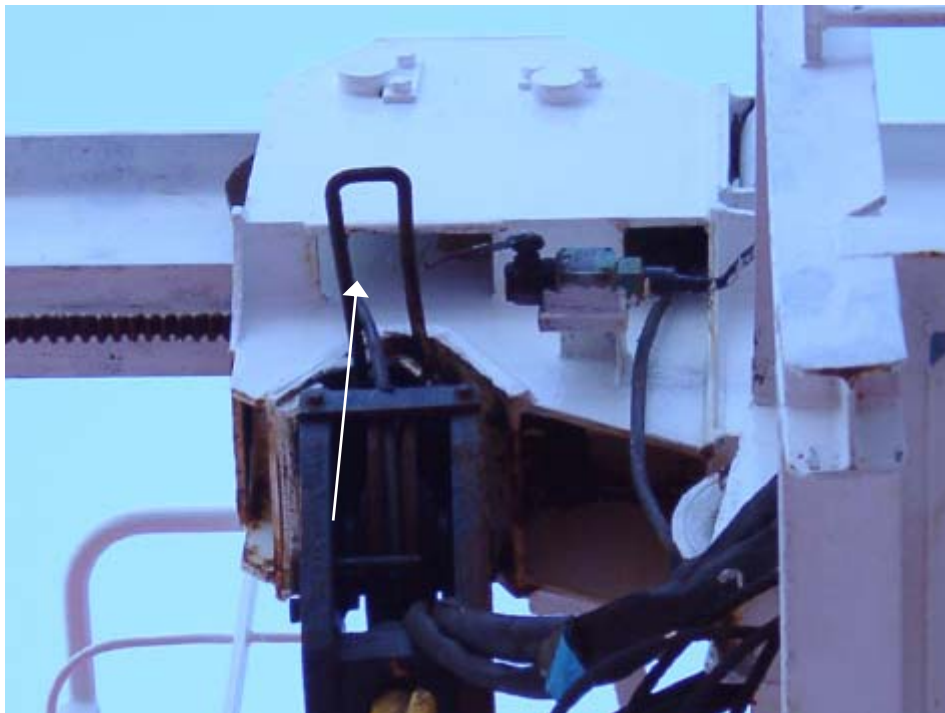
It is likely that the limit switch lever was missing and the hook block was hoisted into its housing, since a force was produced in the wire sufficient in magnitude for it to fail.

As can be seen from figures 12 and 13, both the “U” shaped bar which should trigger the operating lever and the operating lever itself, have been deformed in such a way that the limit switch may not operate when hoisting.

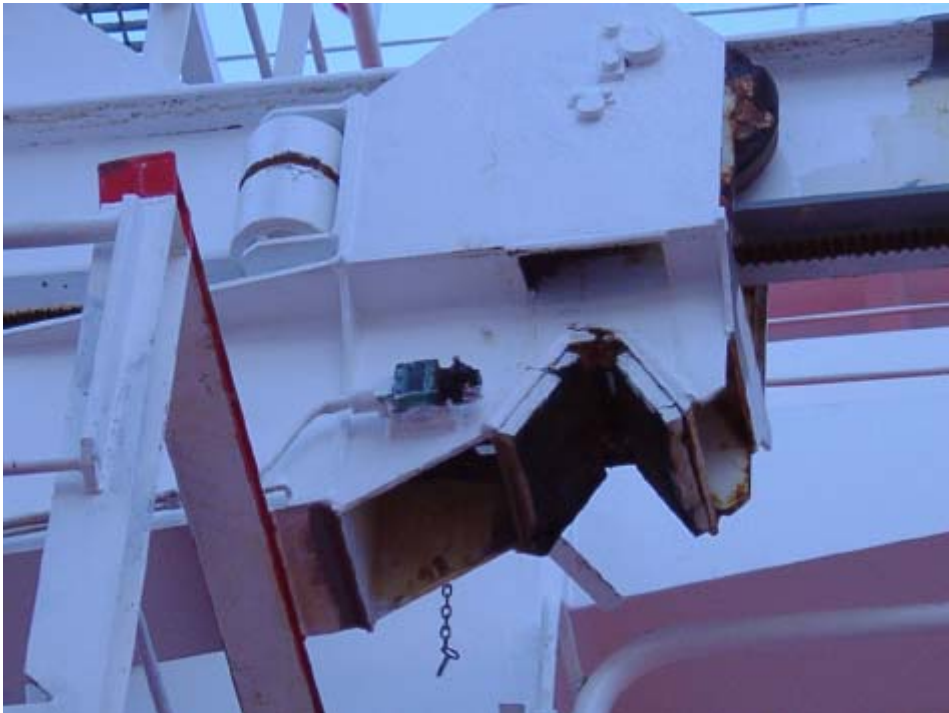
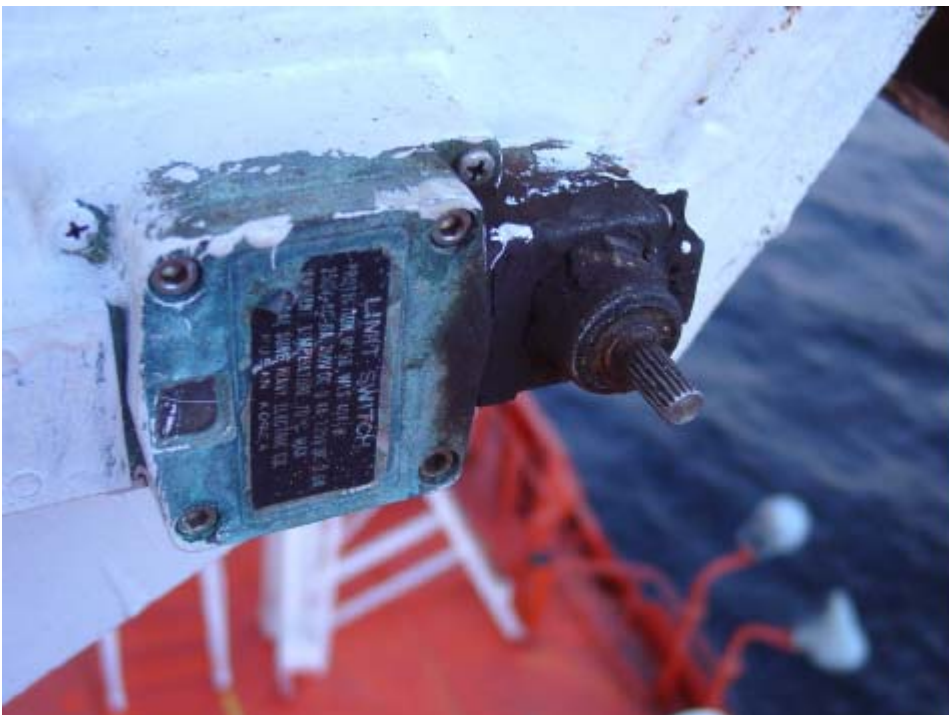
Figures 14 and 15 show the hook block housing and the limit switch on the starboard side of the gantry crane following the accident.

The figures show the operating lever missing from the limit switch.

The crane’s safety devices were inspected after the accident and the starboard hoist limit switch was found to be working electrically, but the operating lever was missing.

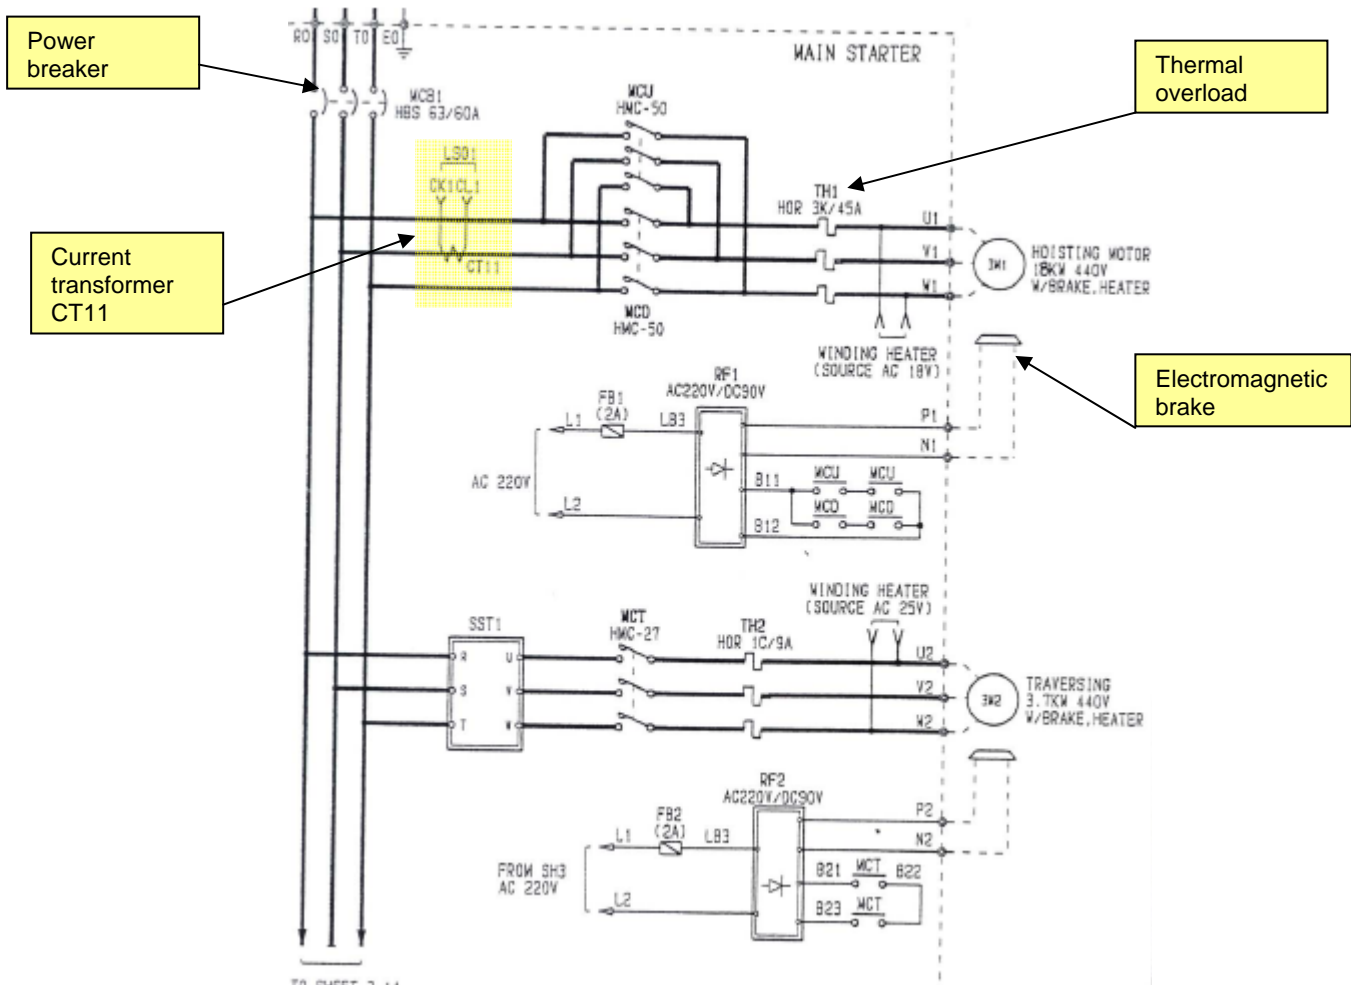
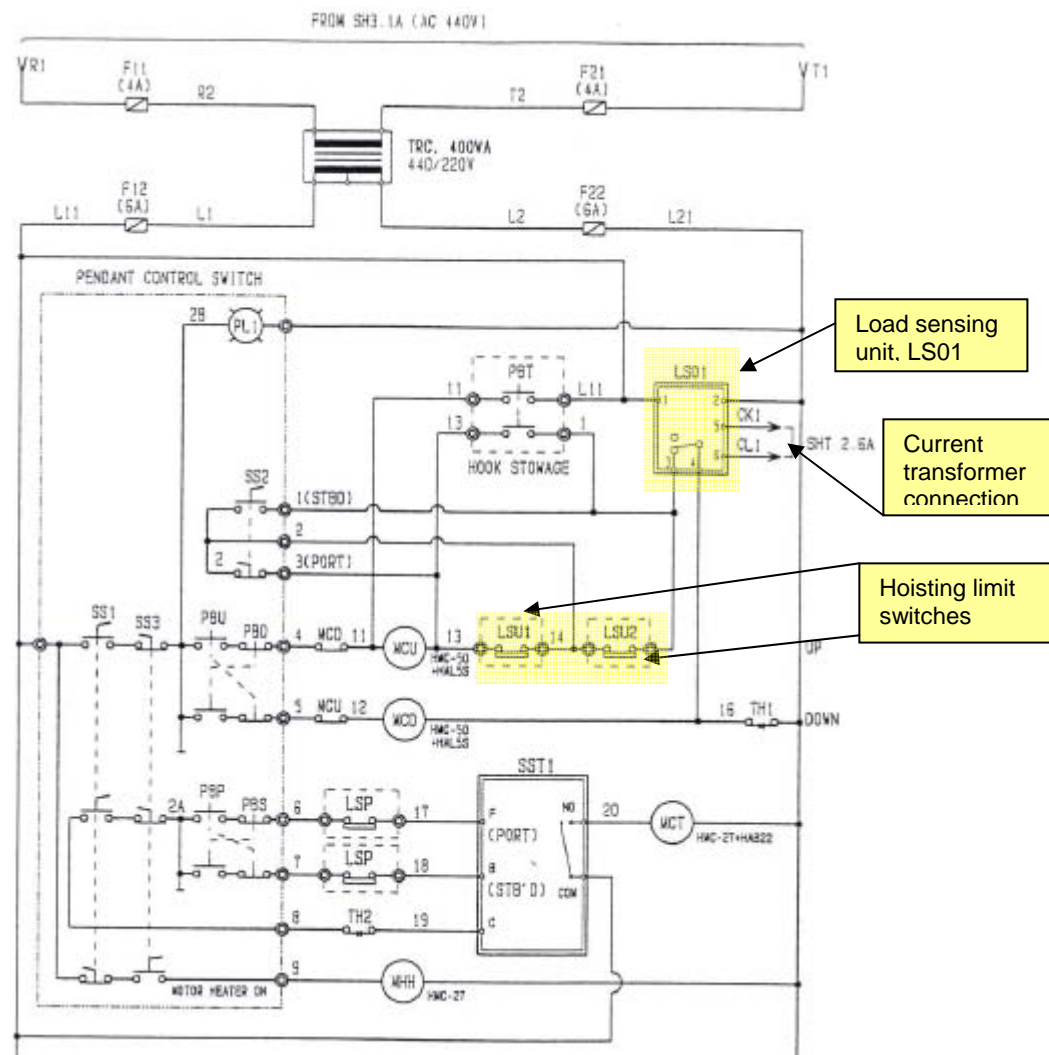
The crane overload protection consists of a current transformer (marked CT11 on figure16), a microprocessor controlled load sensing unit (marked as LSO1 on figure17) and an electromagnetic brake which forms part of the winch drum and which is applied when the power source is removed.

Once the unit has locked out, it needs to be manually reset. Following the incident, no manual reset was required to operate the crane. It was later found that the current transformer had failed and was not actually providing an input signal to the load sensing unit, when it actually failed could not be determined.

- ensure that any safety devices fitted to their equipment should fail safe. The failure of any safety device should shut down equipment safely until the cause has been found and rectified.

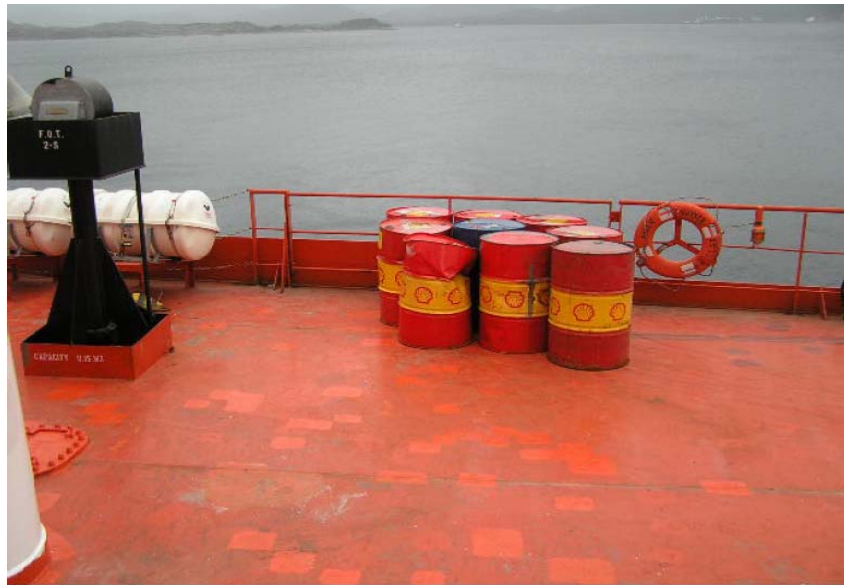
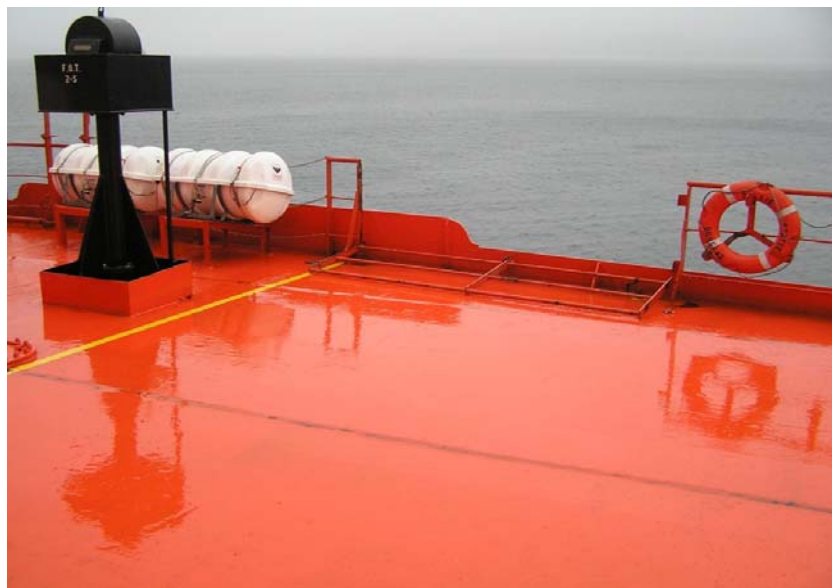
With the barrels in this position, the ship's side rail could not be folded down and hence the height of the side rails determined the height at which the stores and provisions needed to be raised to enable stores and provisions to be lifted on board.

Figure 19 clearly shows the position the side rails should be lowered to, when lifting stores and provisions onboard with the crane.

To increase safety during hoisting operations, the ship's side rail underneath the gantry crane is designed to be lowered in order to maximise the amount of available headroom. Unfortunately in this incident, oil drums were stowed against this section of railing for back loading to the tug (for disposal) and prevented it from being lowered (see figures 18 and 19).

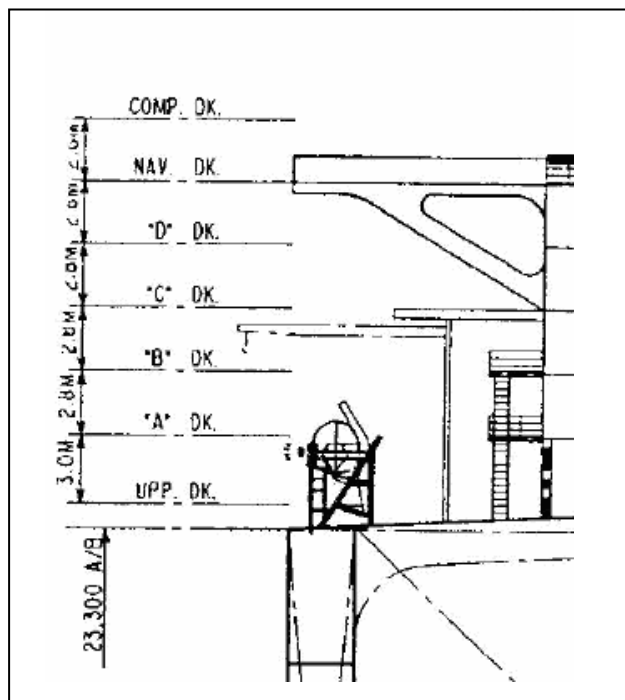
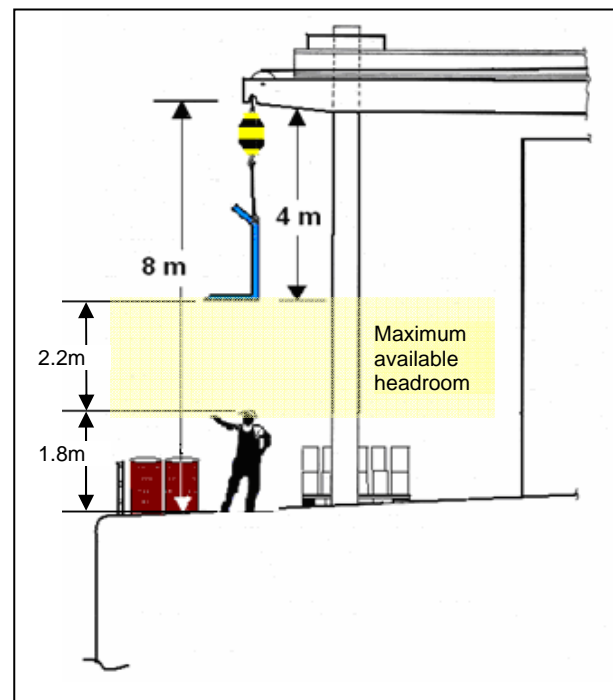
The maximum headroom between the crane gantry and the main-deck without anything suspended is 8m (see figures 20 and 21). When any load is suspended, this headroom is reduced, limiting the remaining amount of vertical travel available.

During this operation, the pallet fork, which was used in conjunction with a “wire stop” and the hook block to lift the pallets, was measured to be 4m in total. This had the effect of reducing the available headroom from 8m to 4m.
