Isle of Man
Ship Registry

Casualty Investigation Report No. CA99

**Isle of Man Registered "SCOTTISH BARD" and Panamanian
Registered "O PRINCESS"**

Collision

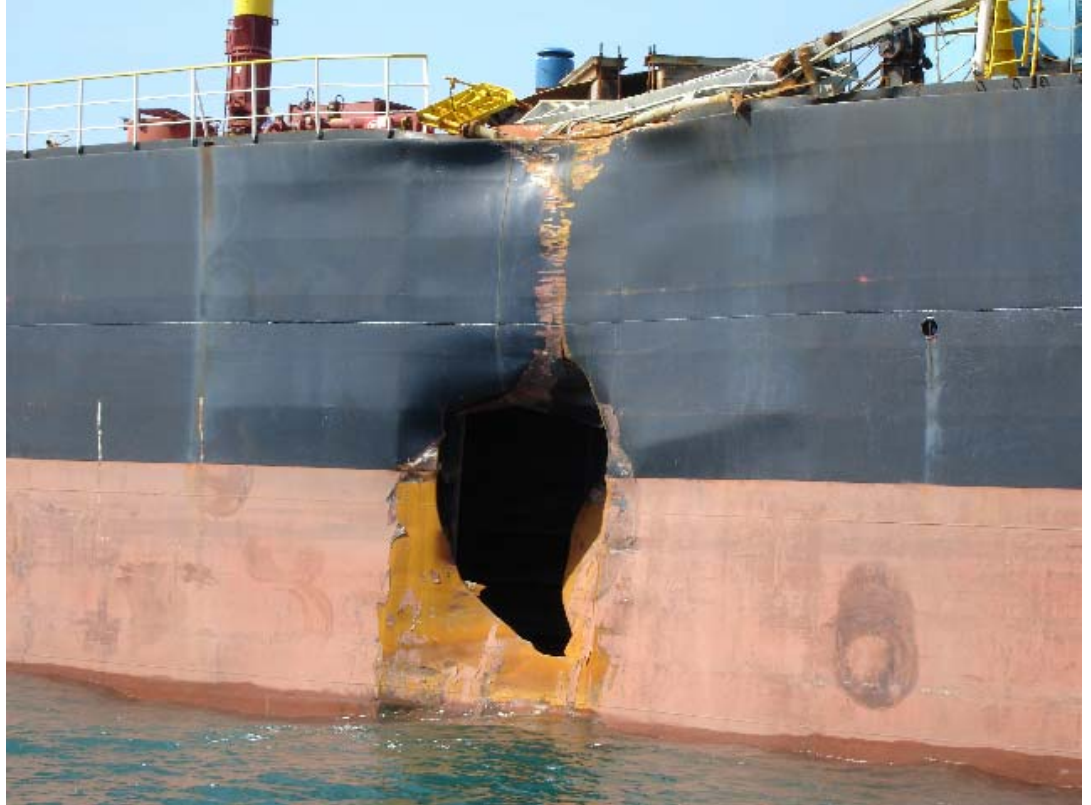
First Contact

Location: #4 Port Wing Water Ballast Tank is holed above the waterline. Area height 3m, area width 3.5m, area thickness 15mm.

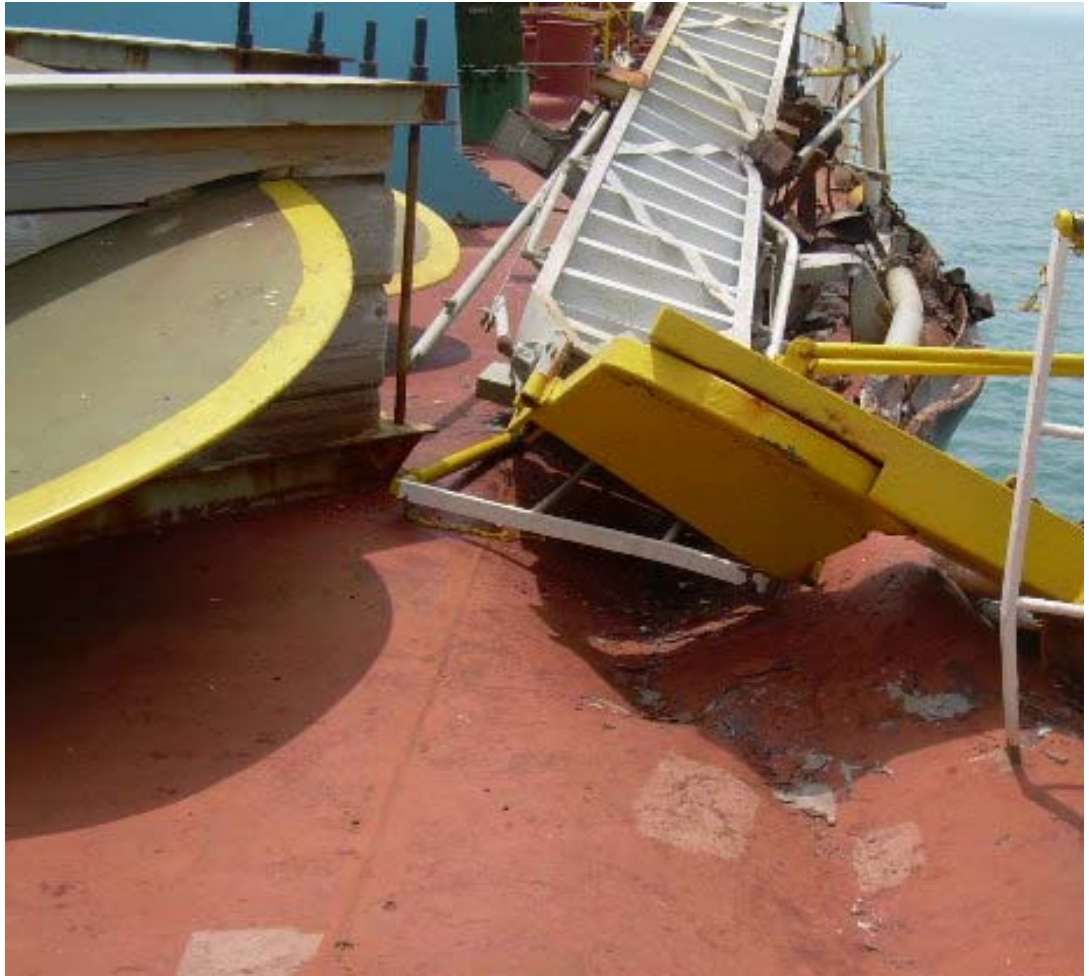
Port Side Looking Aft - In this area it can also be seen that the accommodation ladder, side railings and various deck piping systems have also been significantly damaged.

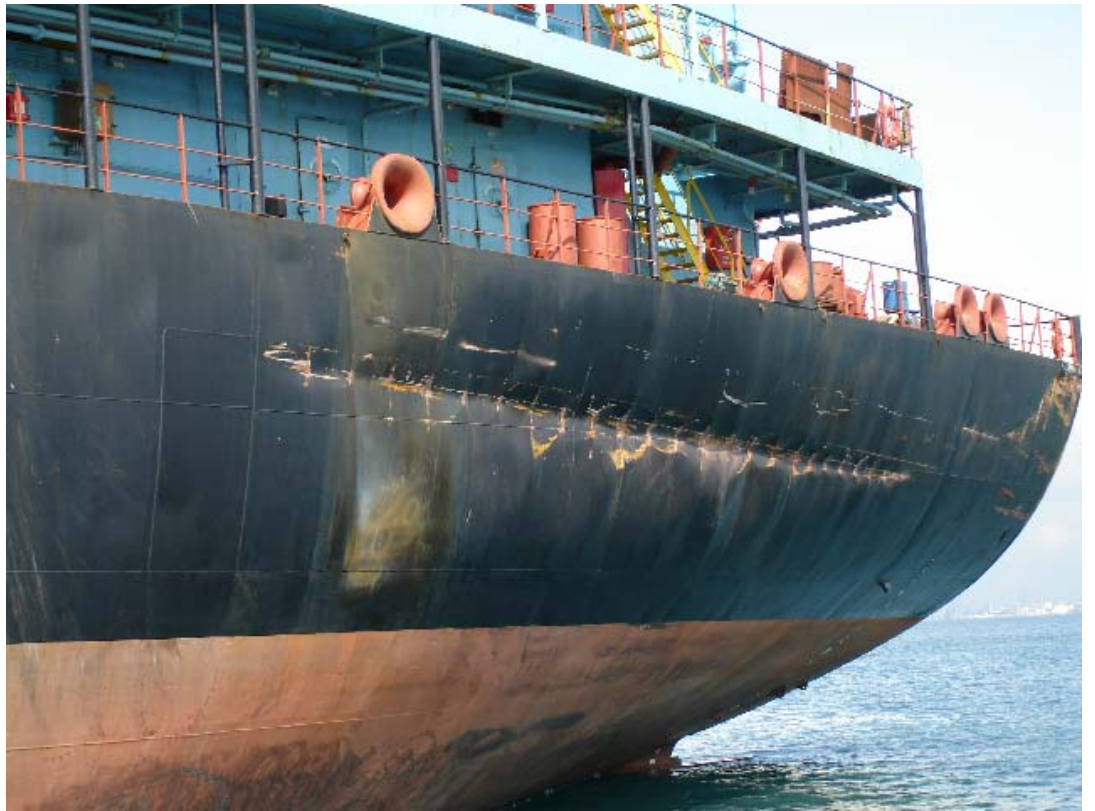
Second Contact

Side shell plating and associated internals at the aft port side shell were buckled 2m from the upper deck.

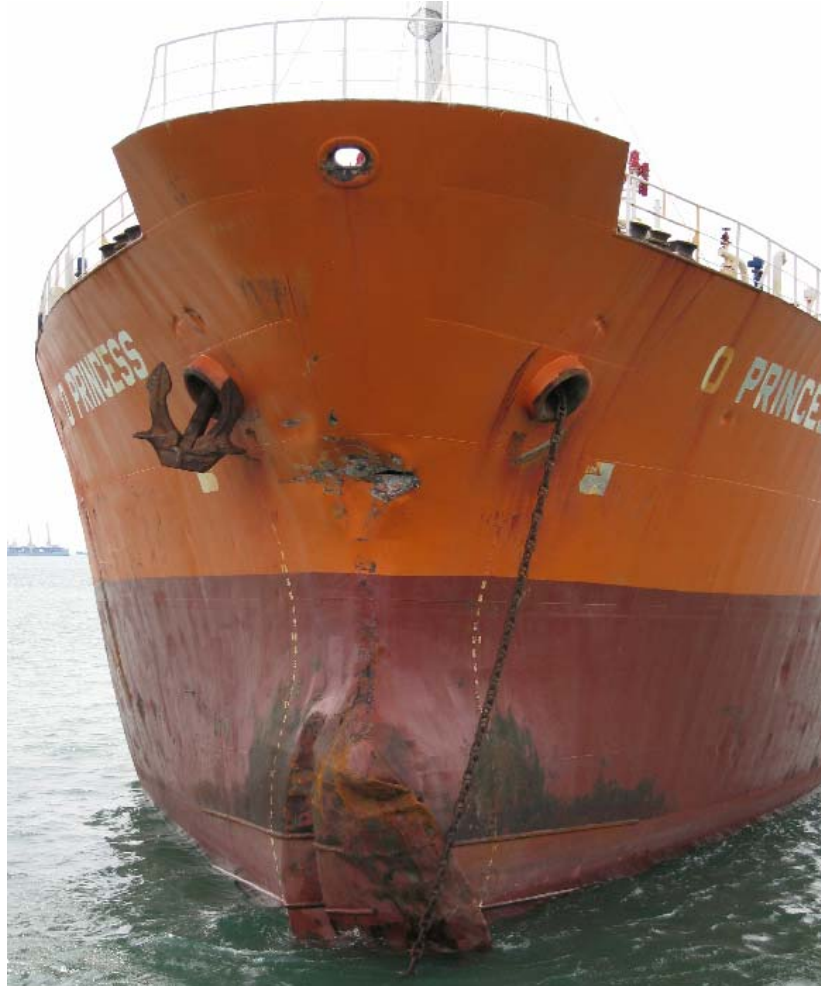
First Contact

“The forward Side Shell plating at the stem was found dented and holed at the centre of dented area. Forepeak tank top was also found buckled. Bulbous Bow Area plating was found heavily damaged and plating was found holed. Starboard Side Anchor was found bent.”

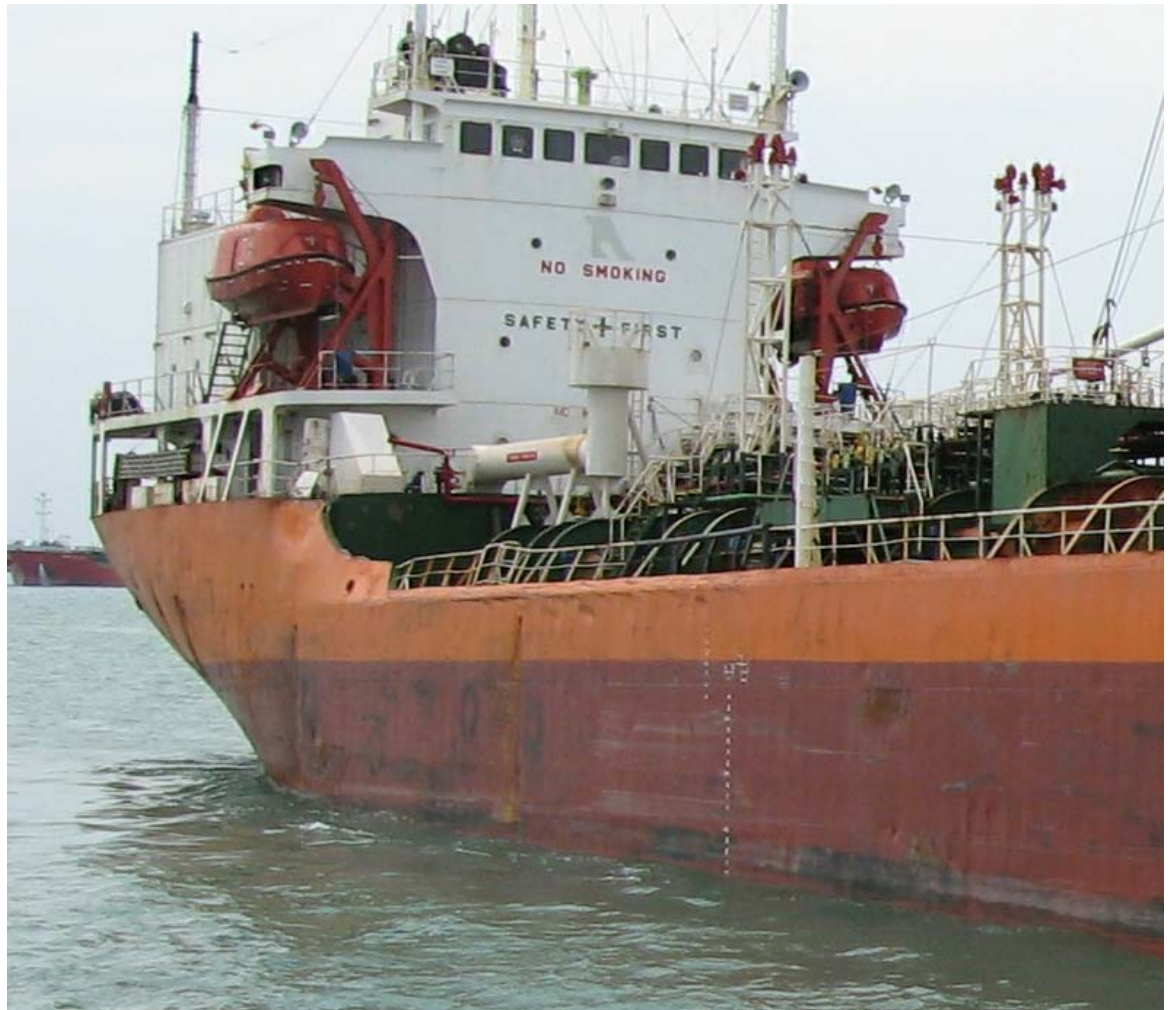
Second Contact

“Poop deck plating including internals found buckled in way of Bosun’s Store (S) to side shell. Poop deck plating was also found torn and holed. Side shell found badly dented between Upper deck to Poop deck. Bulkhead plating including internals found buckled. No. 3 Fuel Oil Tank (S) air vent pipe including saveall coaming and Bosun’s Store (S) mushroom ventilation was also found damaged.

Bulwark plating including stays found set in and stays were detached from deck. Hand railing and side shell coaming (fish plate) was also found to be bent. Upper deck plating was found to be buckled.”

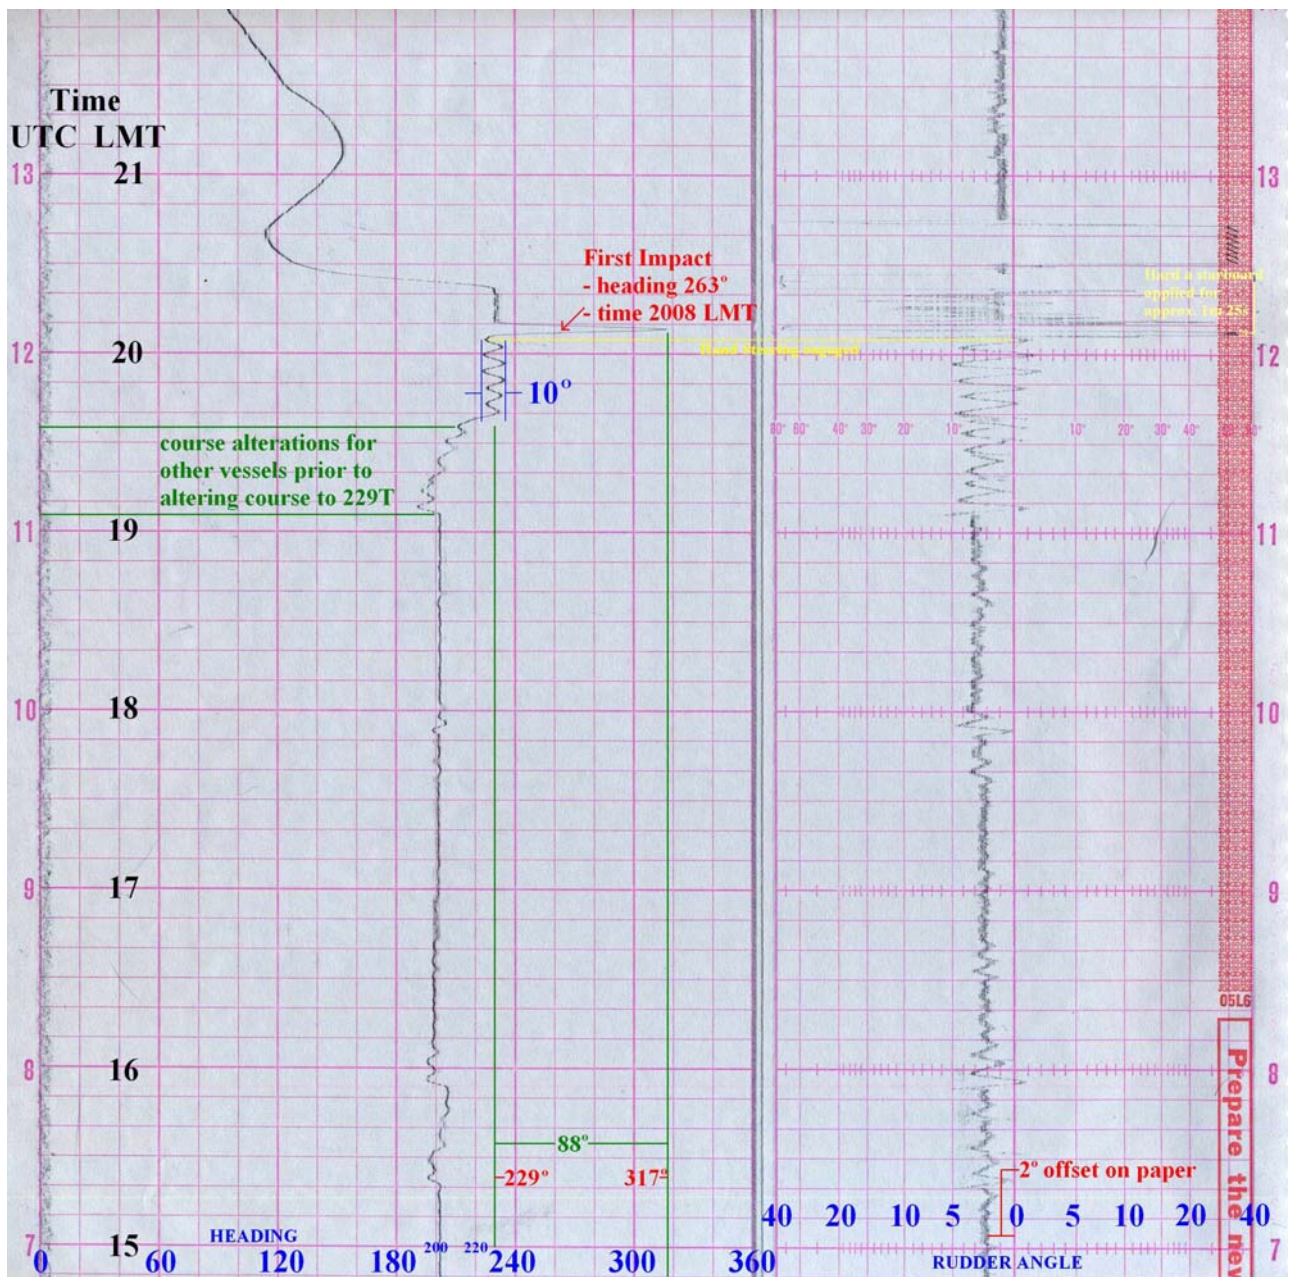
1.9 Scottish Bard's Course Recorder

The above annotated trace recording from the Scottish Bard shows the heading and rudder angle before, during and after the collision.

The Scottish Bard's Course recorder shows the heading meandering 5° either side of the intended track from approximately 1940 until the collision occurred. The Scottish Bard altered course at 1940 to 229°T using the autopilot. The OOW stated that the meandering was caused by the ship settling down on the new heading on one steering motor whilst being affected by the oncoming tidal stream.

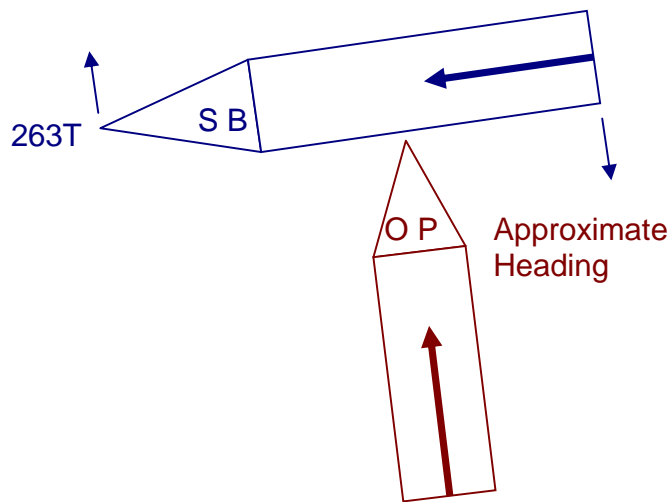
The heading of the O Princess (OP) at the first contact cannot be accurately determined. Witness reports from the Scottish Bard stated the O Princess was roughly perpendicular to the Scottish Bard. The bow of the O Princess rises up on the main deck of the Scottish Bard causing damage to the deck whilst the bulbous bow penetrates the hull of the Scottish Bard and becomes momentarily embedded.

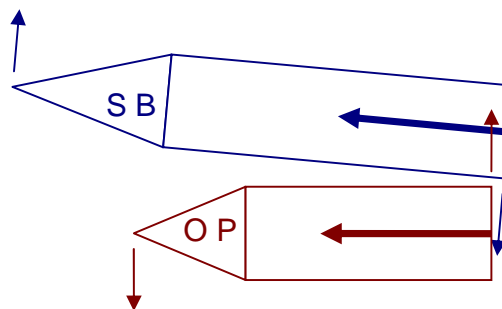
With the Scottish Bard still turning to starboard the resultant forces cause the bow of the O Princess to port thus forcing the stern to starboard and eventually dislodging the bulbous bow from the Scottish Bard. The port quarter of the Scottish Bard and the starboard quarter of the O Princess make contact causing indentations to the shell plating of both vessels.

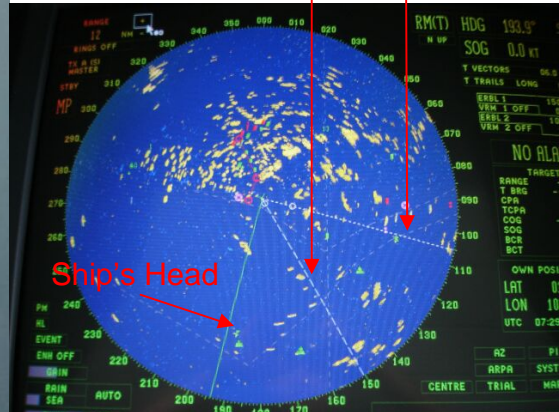
12nm Range - Shadow sectors between 270° and 315° from ships head. (Nb picture taken after collision for illustration only.)

The shadow sector between 270° and 315° shows targets are being displayed. It was stated by witnesses that the O Princess was continuously tracked until the collision occurred. Therefore the 270°-315° Shadow sector of the S Band Radar did not affect the tracking of the O Princess significantly.

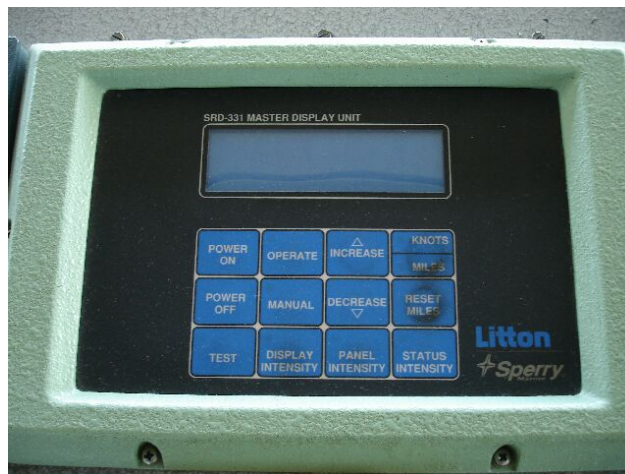
The speed log display unit installed on console B.

Under SOLAS 74/78 Ch. V Reg 12 (o) a defective speed log does not make the vessel unseaworthy but requires that the defective equipment is repaired as soon as possible in a port with suitable facilities. The speed log is recorded in the Safety Management defect reporting system as a repair item to be addressed. On two occasions technicians have visited the vessel to repair the speed log but without success.

The use of the GPS in lieu of the defective speed log on the Scottish Bard is likely to have affected the ARPA calculations and information displayed to the OOW. However the difference to the CPA calculations as a result of using Speed Over Ground data as opposed to using Speed Through Water data would not significantly affect the CPA data bearing in mind the ARPA calculations are required to be accurate to 0.5nm.

Ensure that defective bridge equipment is repaired as quickly as possible.

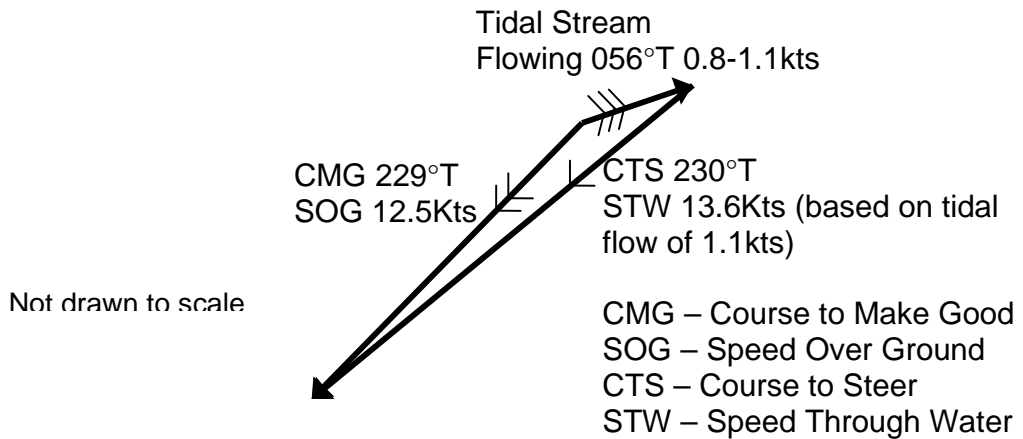
The diagram shows that the speed through the water is 13.6kts based on a tidal flow of 1.1kts. Since the speed input to the radars was speed over ground derived from the GPS a speed error of approximately 1 knot was incorporated into the ARPA radars whilst calculating the CPA and TCPA of targets. A manual speed input into the radars was not used.

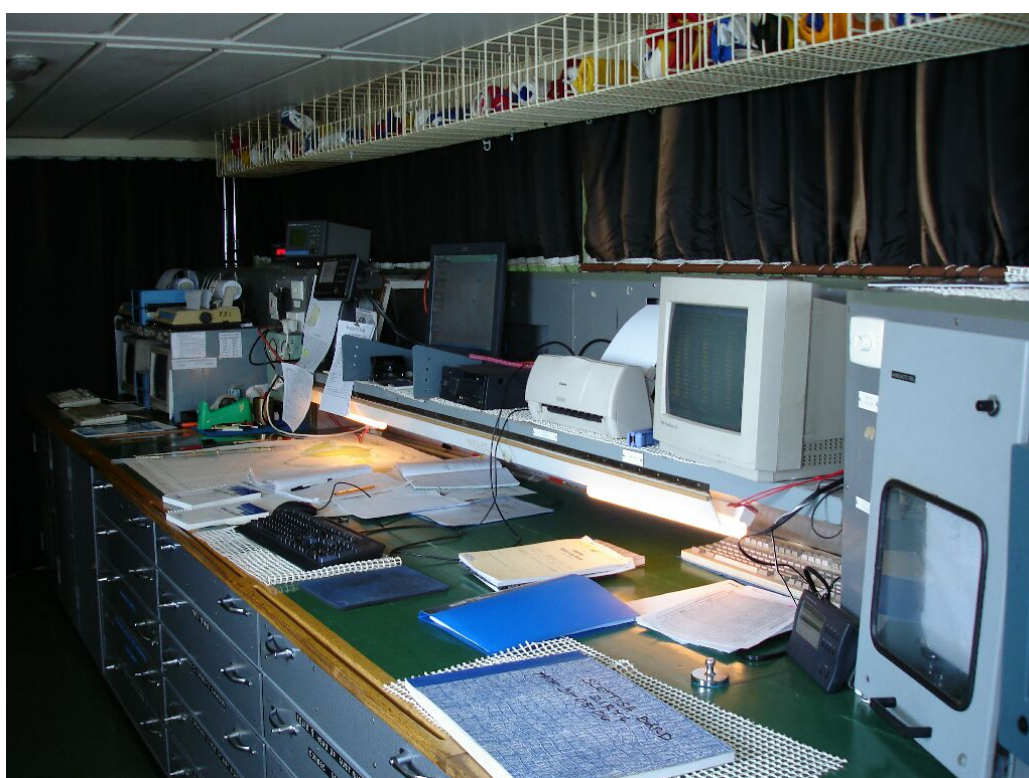
Scottish Bard - Curtained off Chartroom

At 2001 the OOW goes to the Chartroom to write the Log Book. Between 2001 and 2006 the OOW does not monitor the traffic conditions either visually or by Radar. The Chartroom has been curtained off to block light entering the remainder of the bridge area. From the curtained-off chartroom it is not possible to maintain a look out and remain fully apprised of the prevailing circumstances and conditions.

The Scottish Bard’s OOW was distracted by the need to complete the Deck Log Book. This distraction took his attention away briefly from keeping lookout and monitoring the prevailing circumstances and conditions. The OOW assumed that all vessels on the Port Bow would pass clear down port side. In this case it would have been prudent to write the deck log book after the watch handover.
