Isle of Man Ship Registry

Casualty Investigation
Report No. CA118

**Isle of Man Registered “Sharp Lady”
Enclosed Space Fatality and Near Fatality**

23rd August 2013

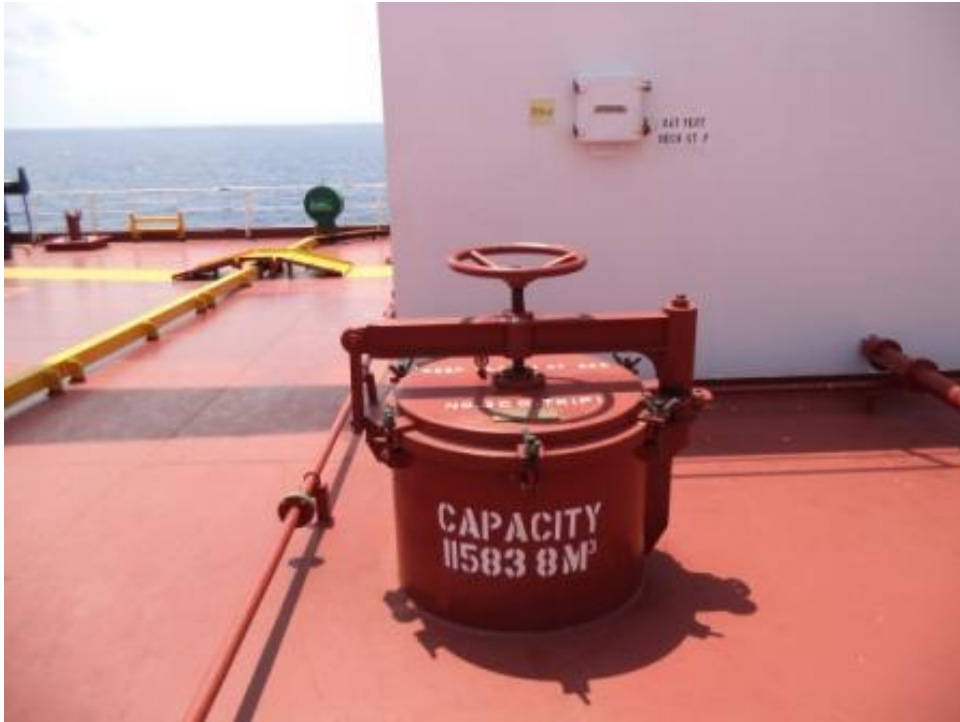
Sharp Lady – 3P Cargo Oil Tank – tank access hatch

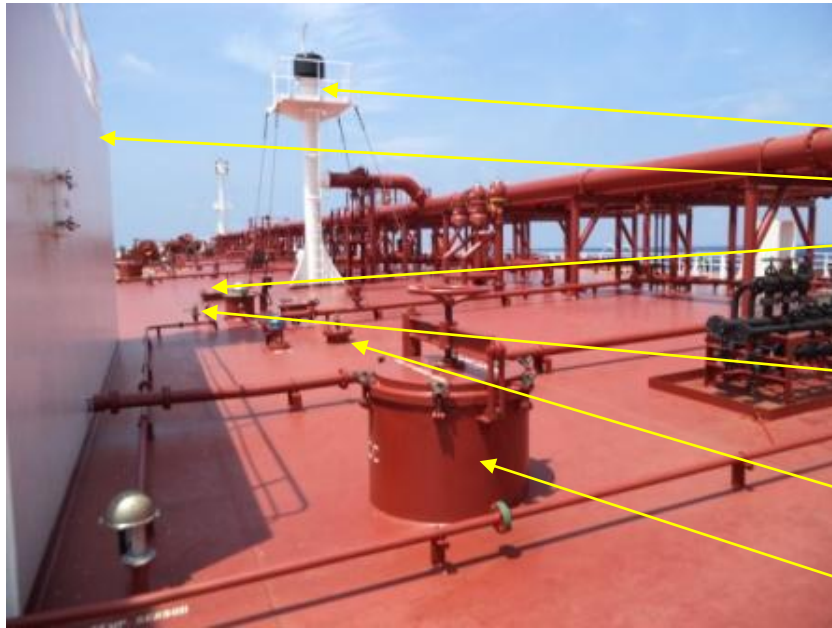
3 Port Cargo Oil Tank main deck area

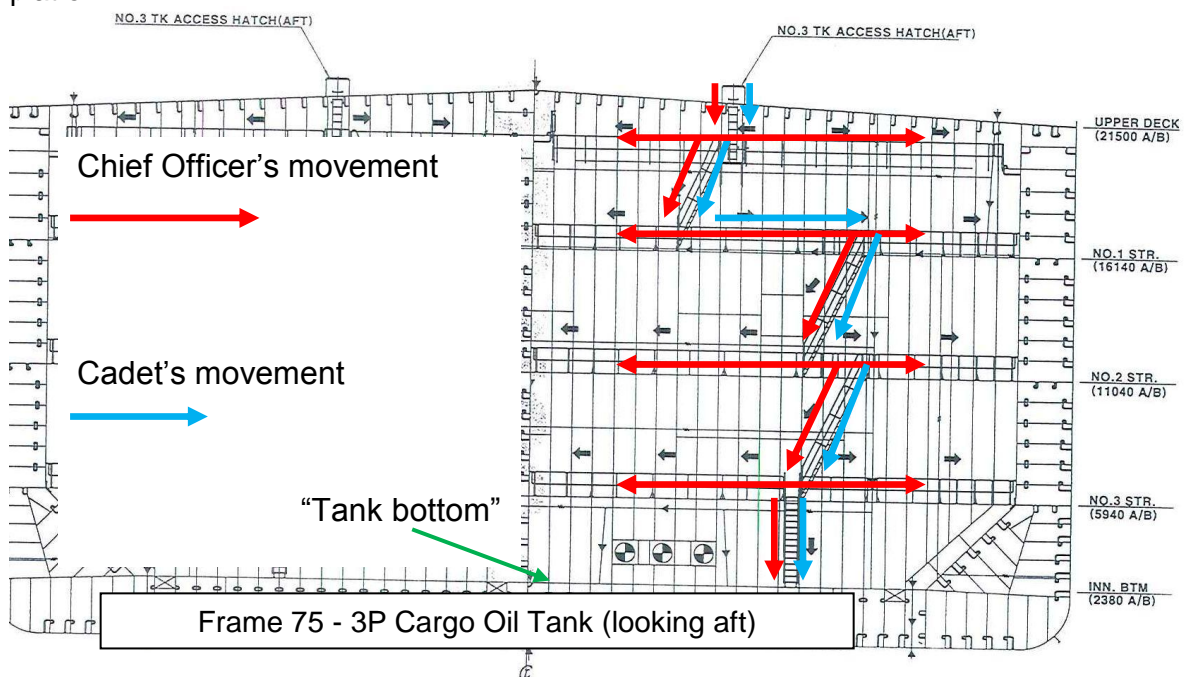
The diagram below depicts the movement of the Chief Officer and Cadet in 3P Cargo Oil Tank. The Chief Officer proceeds first, he climbs down onto the first platform and checks the atmosphere across the platform with the personal gas meter. The Cadet then proceeds down the stairs to meet him. This is repeated for the remaining platforms until No 3 Str platform.

1039 Chief Officer and Cadet reach the tank bottom. Chief Mate feels dizzy and hears his personal gas meter alarming. The Cadet reaches the tank bottom and instantly feels the effects of the gas inhalation. The Cadet hears his personal gas meter alarming. The Chief Officer shouts and gestures to the Cadet to wear his EEBD and leave the tank. The Chief Officer feels dizzy and shocked by the events and immediately proceeds to exit the tank.

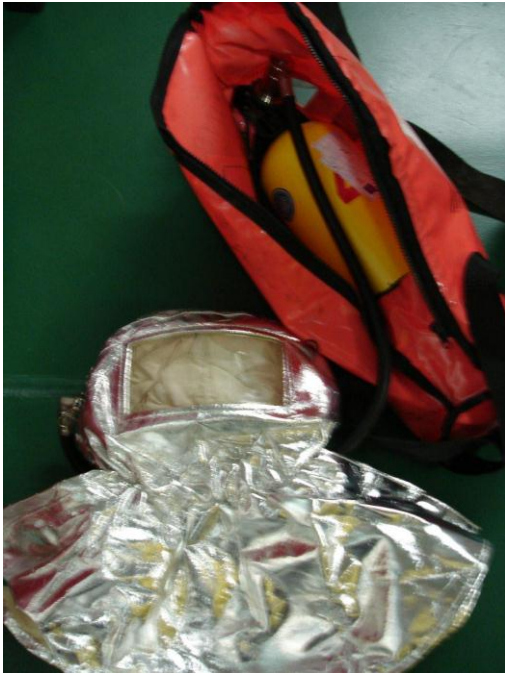
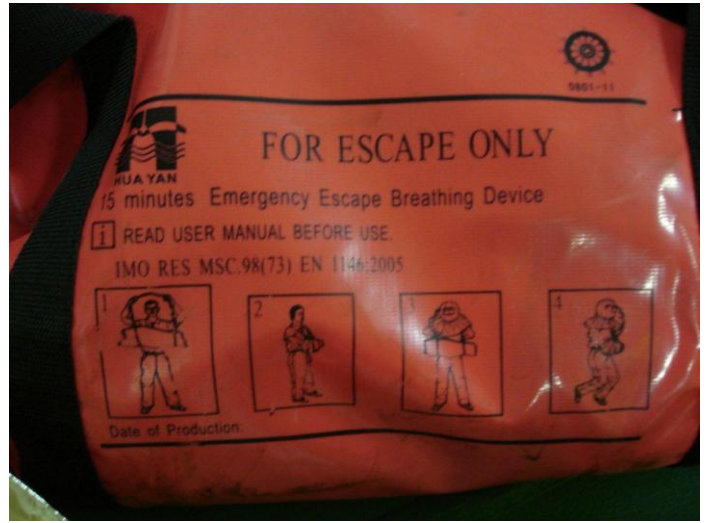
The Sharp Lady is provided with 15 Jiangsu Huayan Marine Equipment EEBDs each capable of approximately 15 minutes duration of average usage. The EEBD is approved to IMO Res MSC.98(73). The EEBD is a self-contained, open circuit, compressed air, constant flow EEBD. It comprises a compressed air cylinder with a combined reducer/cylinder valve, attached to a close fitting escape hood by a breathing hose. The whole unit is contained within a stowage bag ready for immediate use. The high-visibility bag is clearly marked FOR *ESCAPE ONLY*. See the following pictures;

The manufacturer's instructions state EEBDs are intended for use in atmospheres polluted by smoke, toxic gas, hot vapour or low oxygen levels while escaping to a place of safety. The 15 minute duration of the EEBD is achieved by means of a reducer/cylinder valve which restricts the flow of air from the cylinder to the mask, so that once activated a steady flow of air is provided to the wearer. It is not a demand valve system. It is likely that as the Cadet lay unconscious on the tank bottom the constant flow of air from the EEBD reduced the damaging effects from the toxic gas.

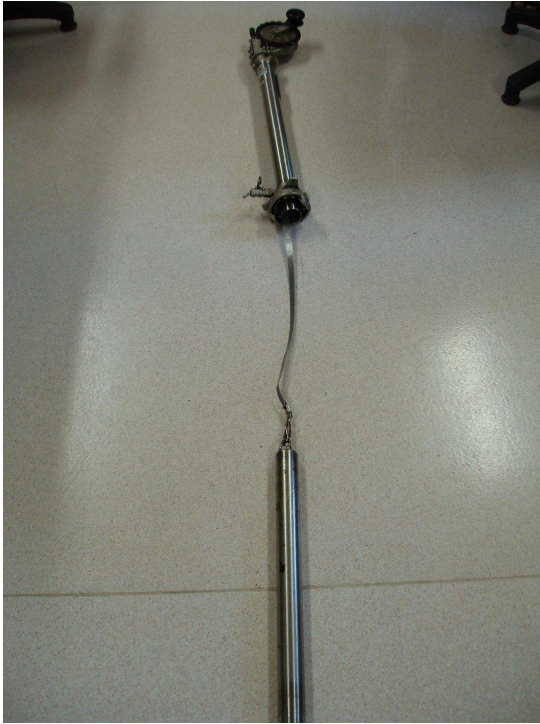
The complete oil sampler device

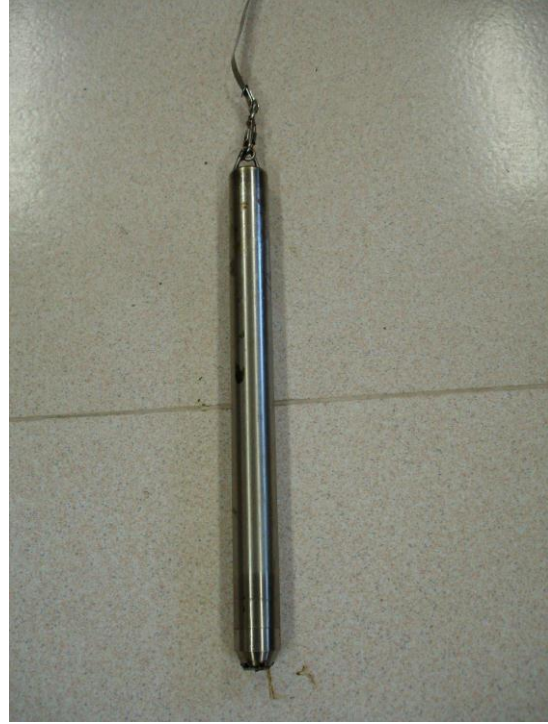
The oil sampler bucket

Note – this is not the oil sampler that broke in Geelong on the 09th August 2013.
