Report on the investigation of
explosion and fire
on
Border Heather
in Grangemouth
Firth of Forth, Scotland
31 October 2004

**Report No 5/2006
February 2006**

At about 1823 UTC on 31 October 2004, the 2159gt Isle of Man registered tanker *Border Heather* suffered an explosion and fire in her forecastle while in Grangemouth. Significant damage was caused to the vessel's structure and systems but no-one was injured and there was no pollution.

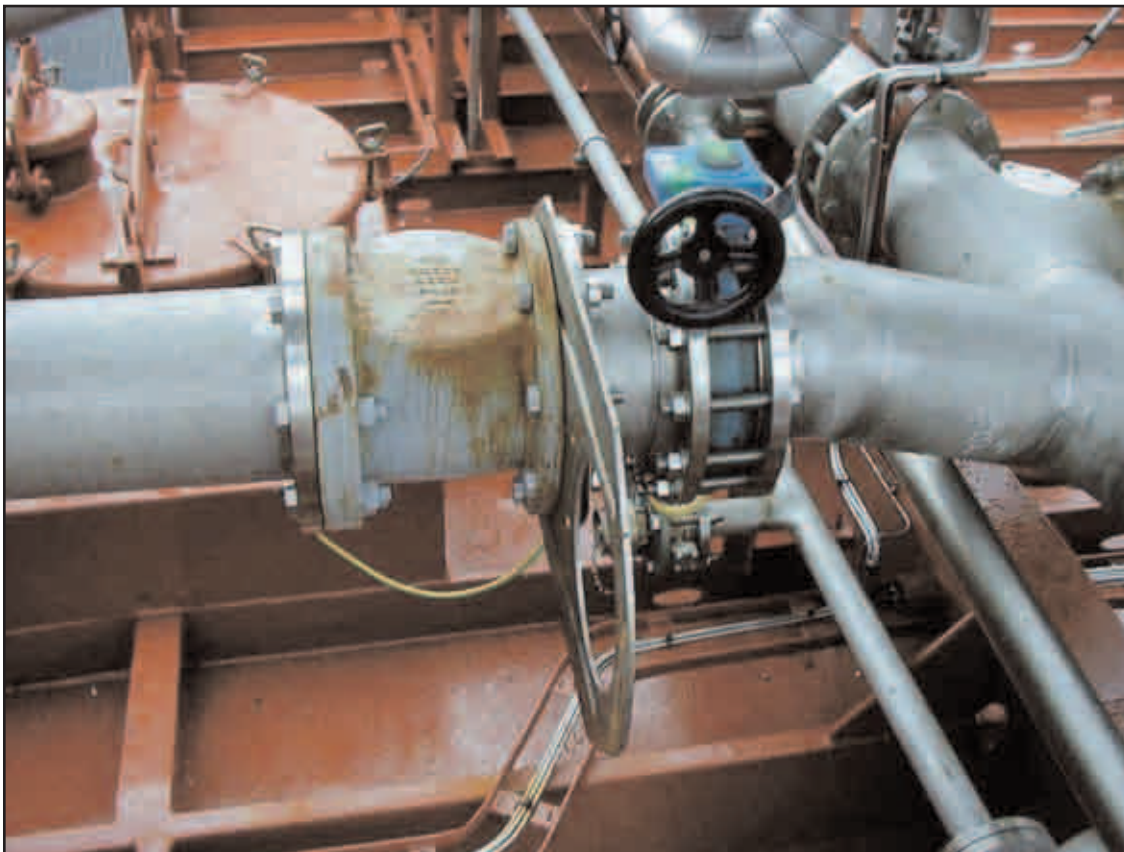
Spectacle plate in 'blacked' position

However, the spectacle plate could make no contribution to safety unless it was used. Although ISGOTT contains clear advice that connections between permanently installed gas freeing fans and cargo systems should be blanked when not gas freeing, and in spite of the Grangemouth terminal's requirement that ISGOTT should be fully complied with, the ISGOTT recommendation could not be satisfied by the 'as built' arrangement of the gas freeing system on *Border Heather* without the spectacle plate being put in the blanked position after the gas freeing fans were last used.

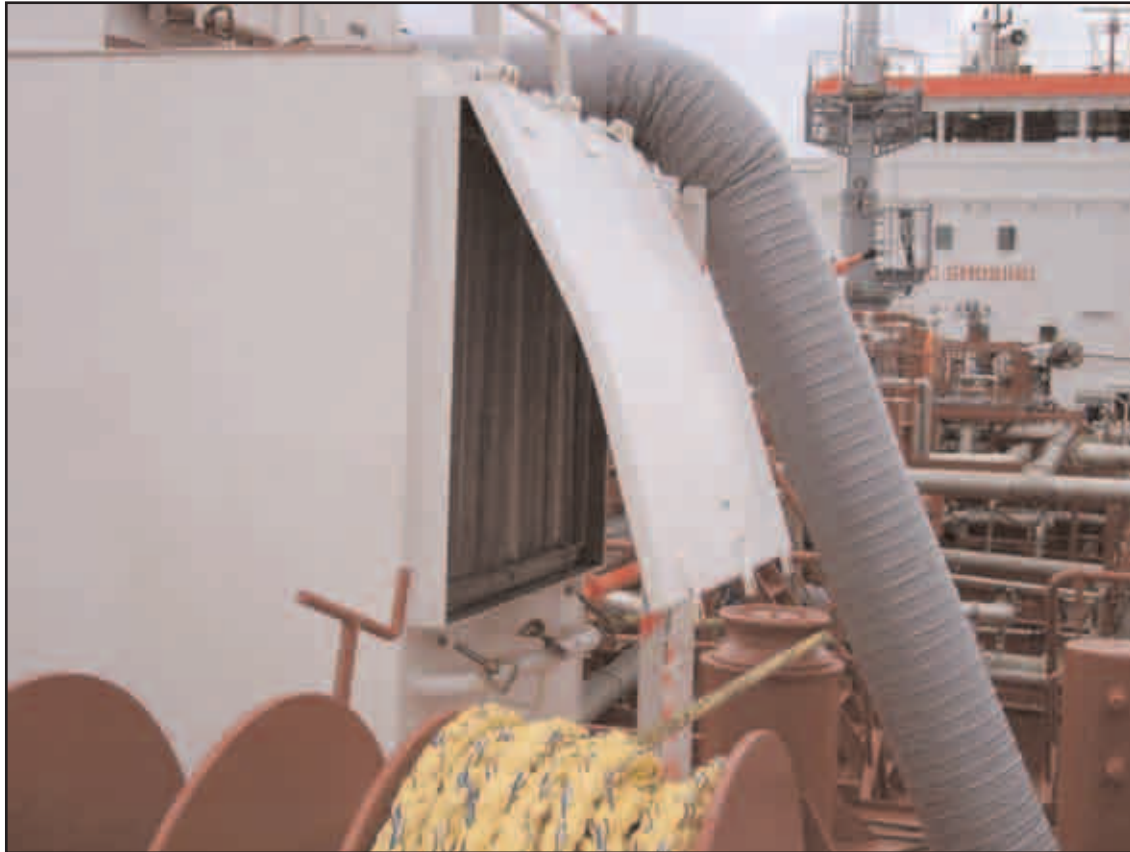
Figure 7

Vent flap

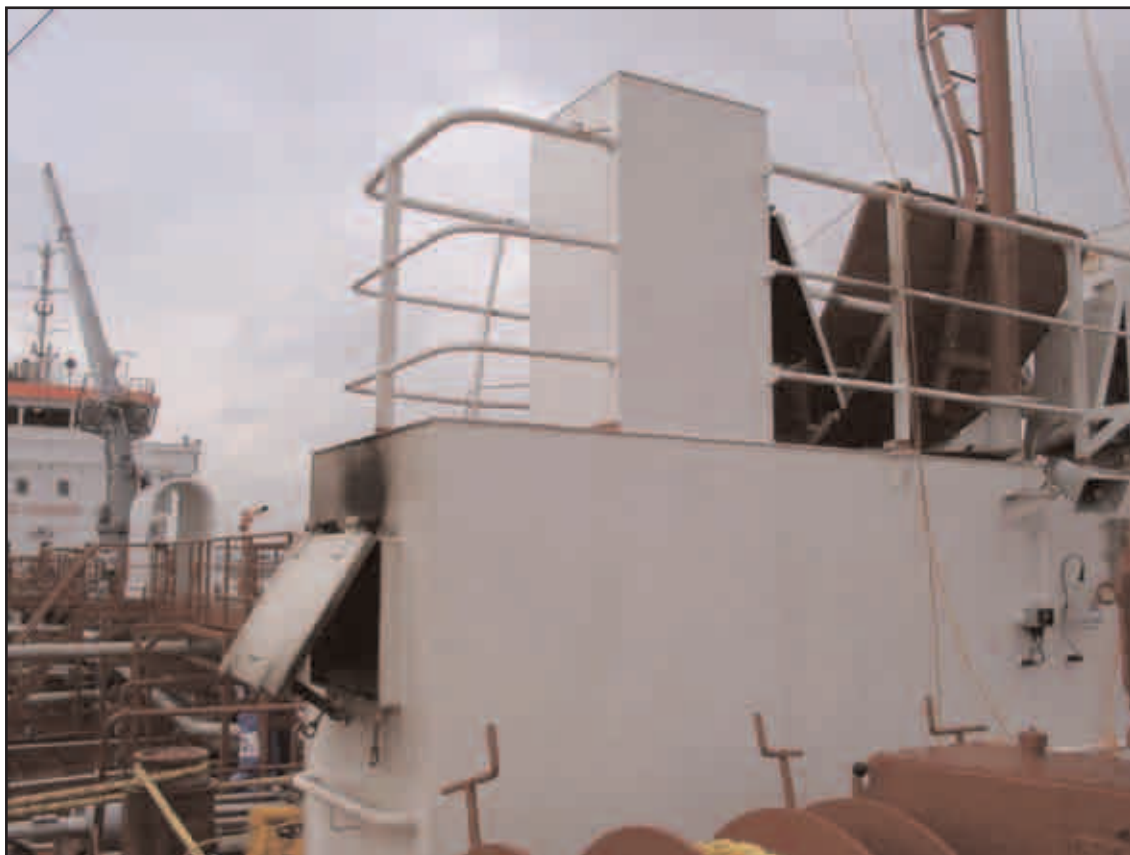
Figure 8

Hatch and fore mast ladder

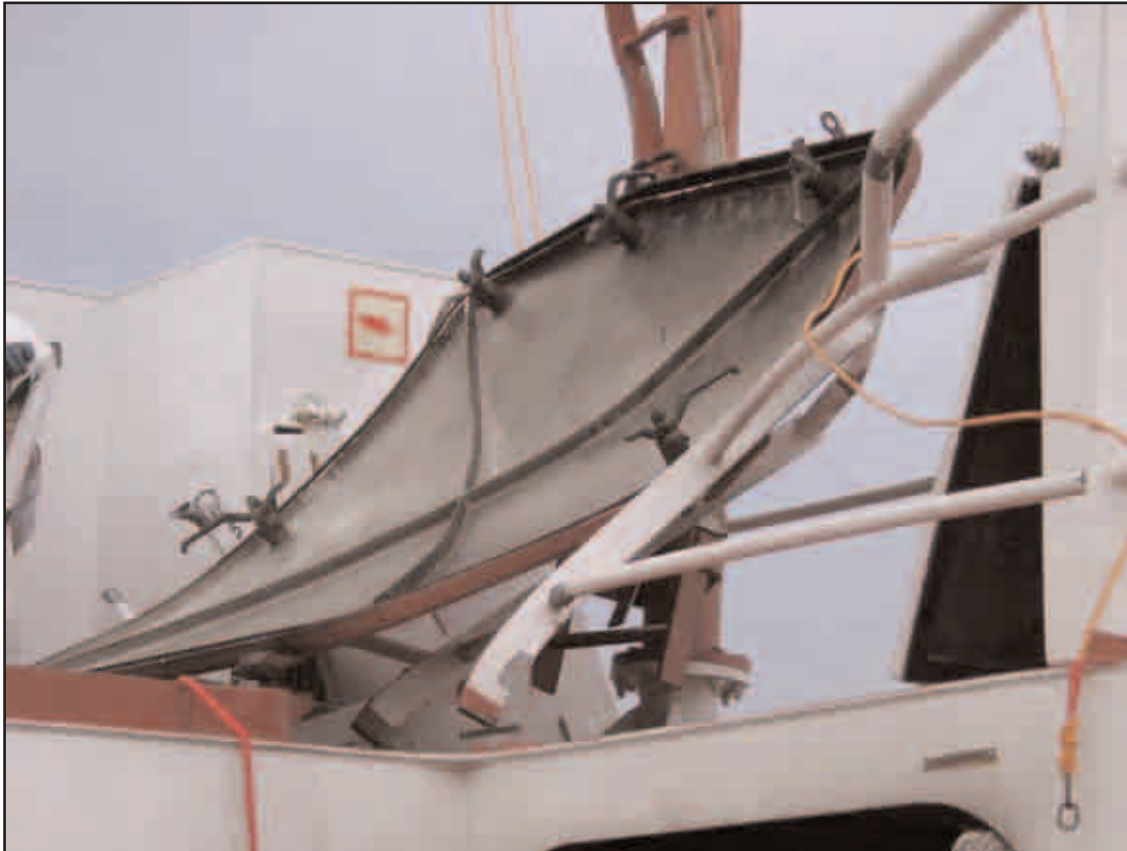
Figure 9

Hatch in deckhouse and guard rails

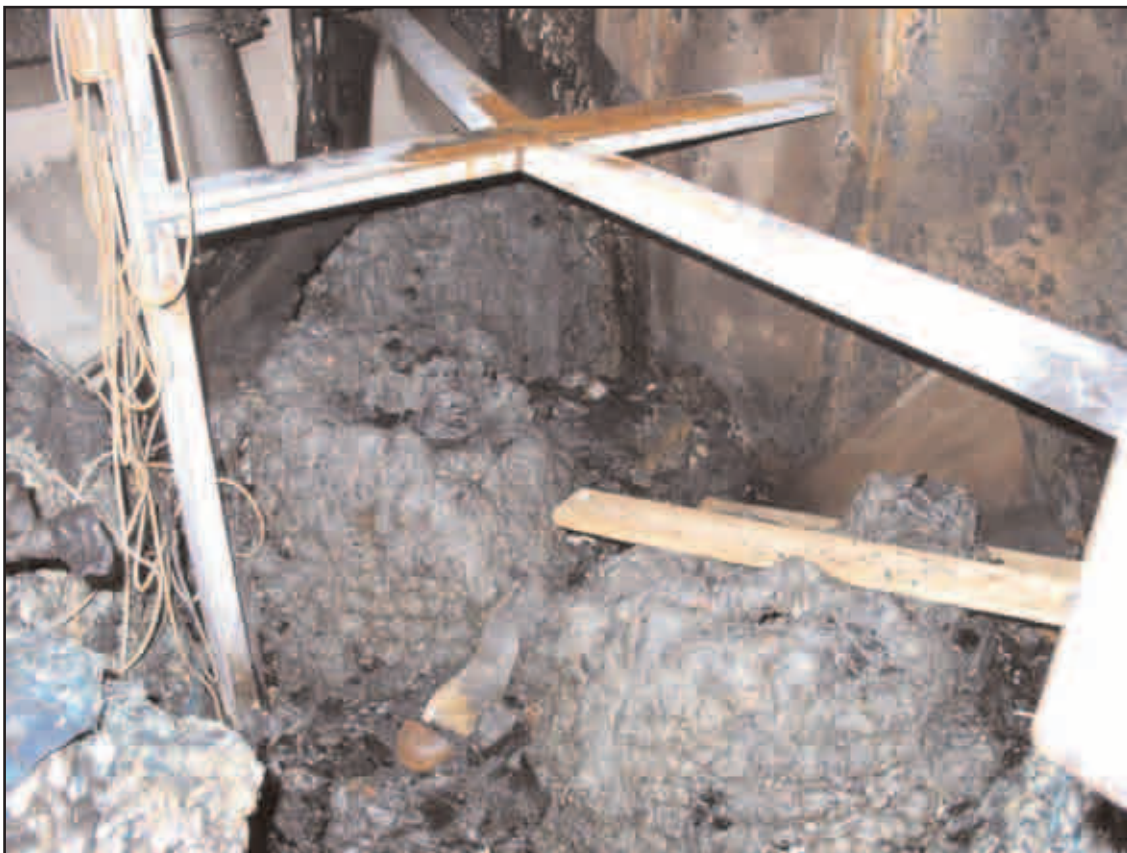
Figure 10

- heat damage to access door and seal
- heat damage to aft bulkhead and electrical fittings and wiring
- heat damage to rope coils stowed beneath forward gas freeing fan (**Figure 10**)

Rope coils

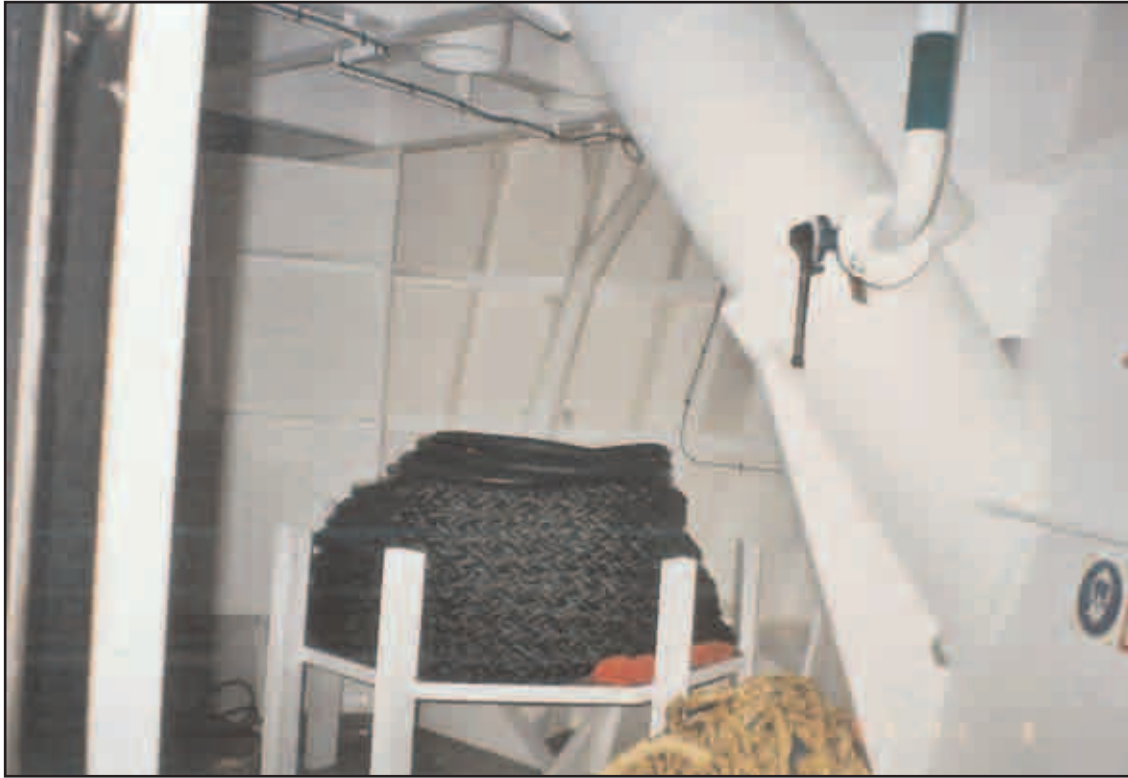
- no damage internally (**Figure 11**)

Forward store showing no internal damage

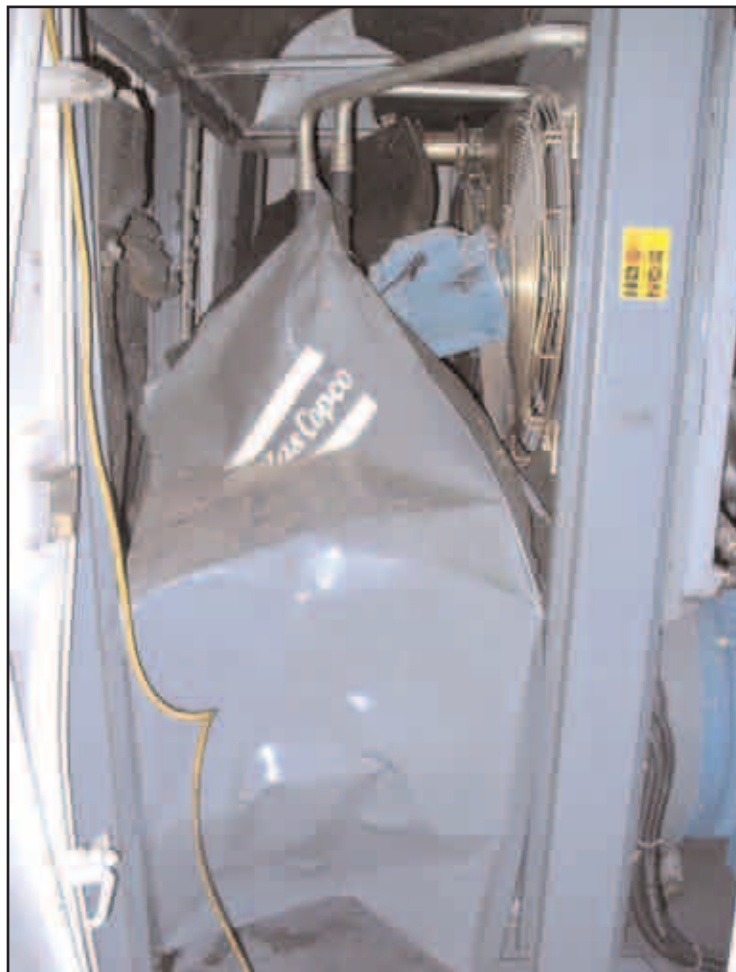
Figure 12

- access door set in
- pressure damage to compressor enclosure, fan motor mountings and air trunking (**Figure 12**)

Pressure damage to compressor enclosure

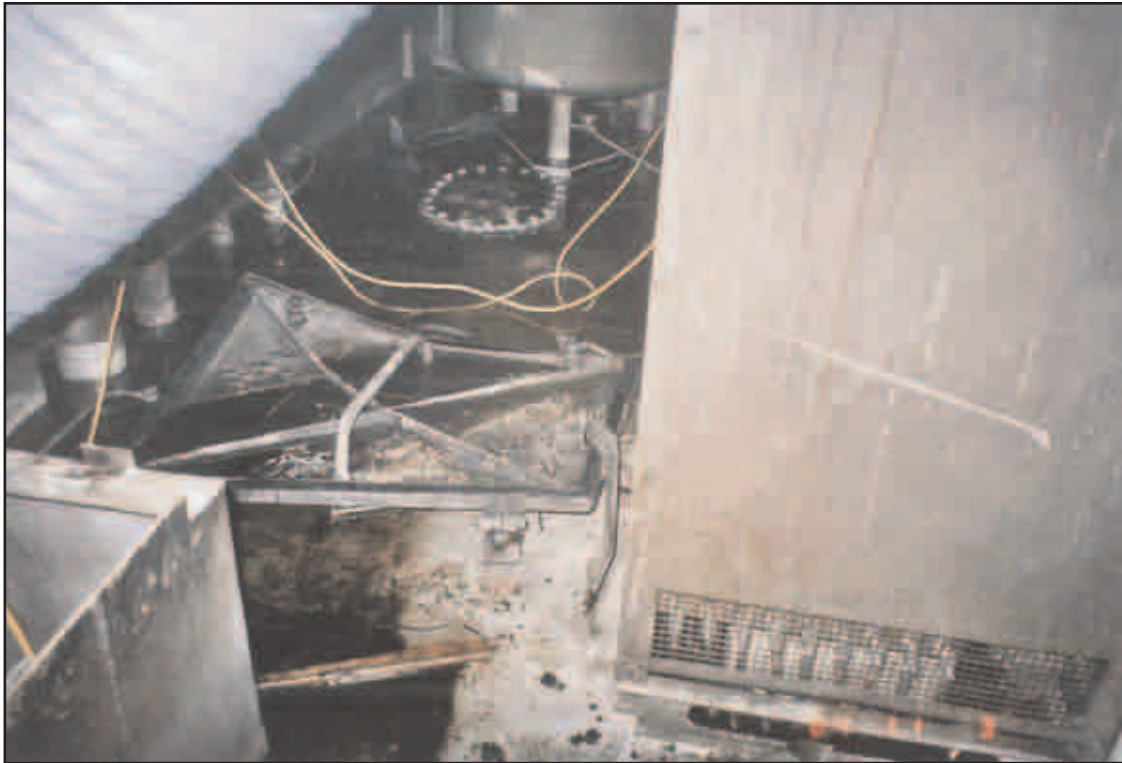
Figure 13

- smoke and pressure damage to electrical cabinets throughout
- hatch down to bow thruster room set up and broken from hinges (**Figure 13**)
- deck set up
- paint store door set in. No damage to paint store internally (**Figure 14**)

Damage to hatch

The pattern of damage in the forward spaces points to high pressure being generated in the bow thrust compartment, setting up the deckhead and blowing off the hatchcover in this deck.

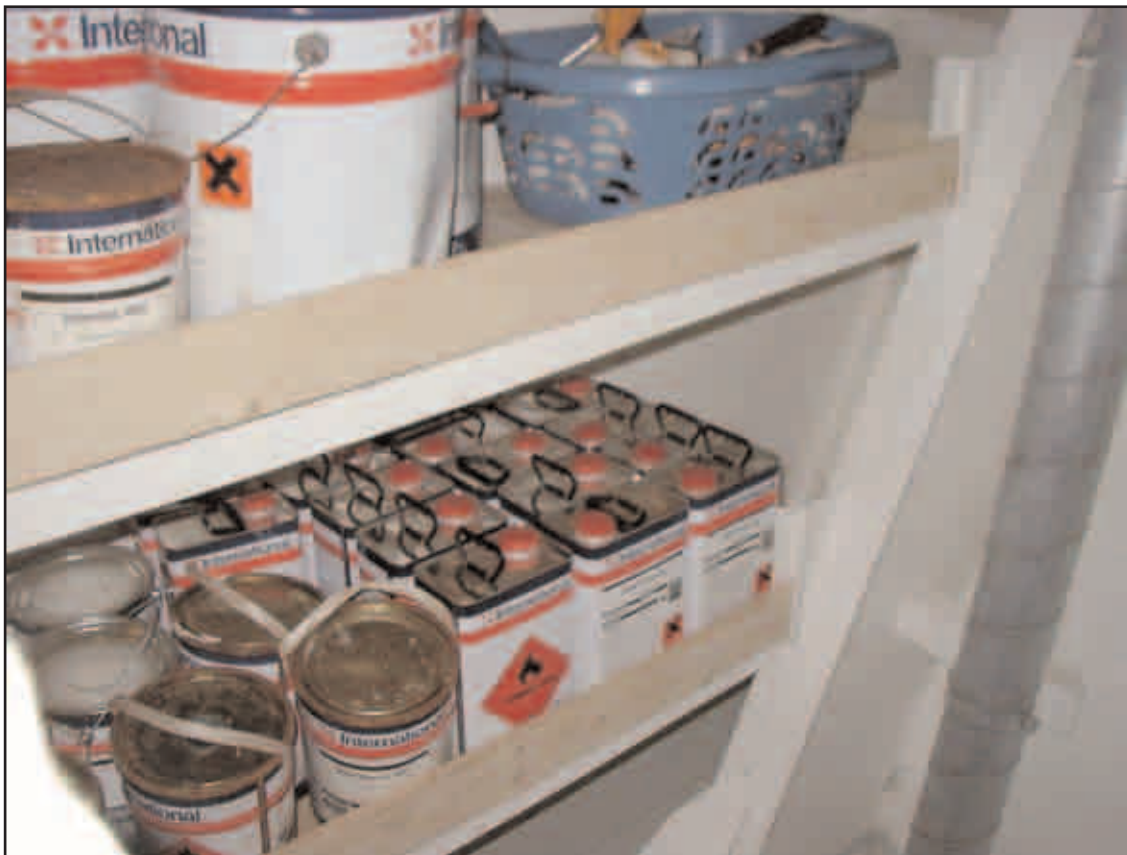
Figure 14

No damage internally to paint store

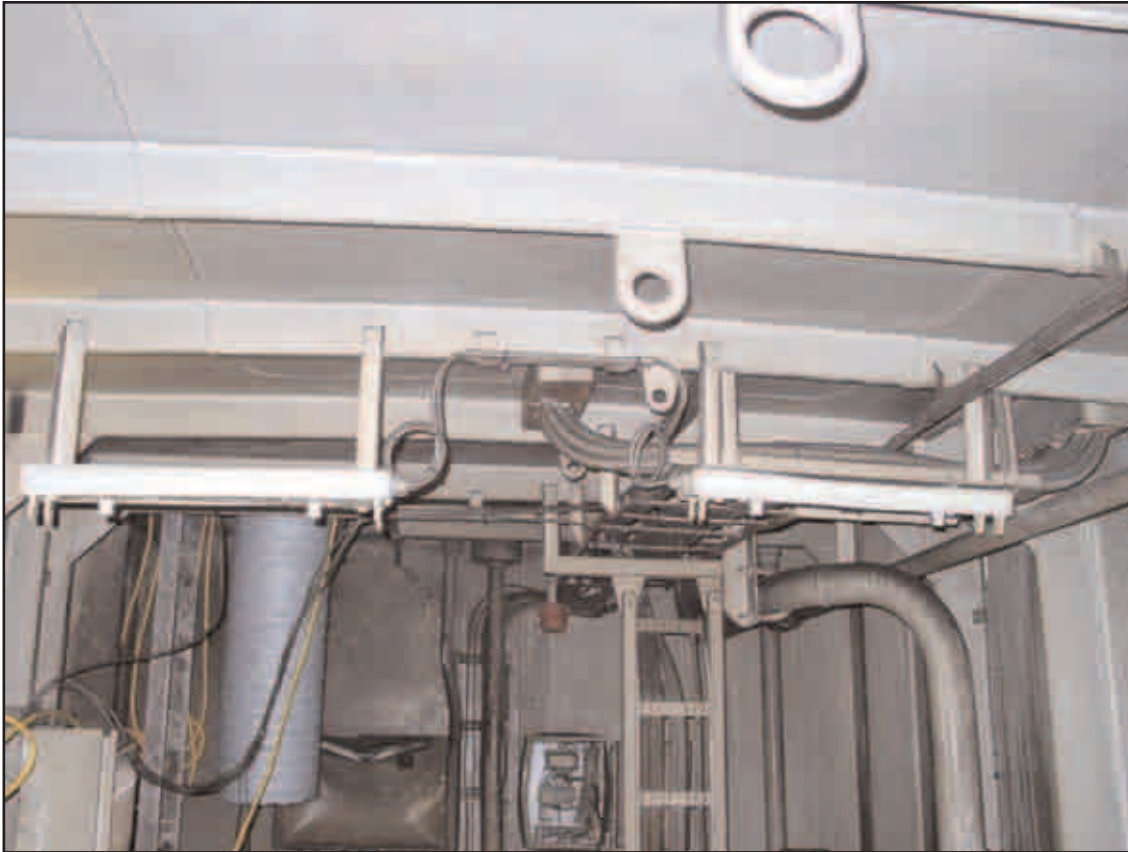
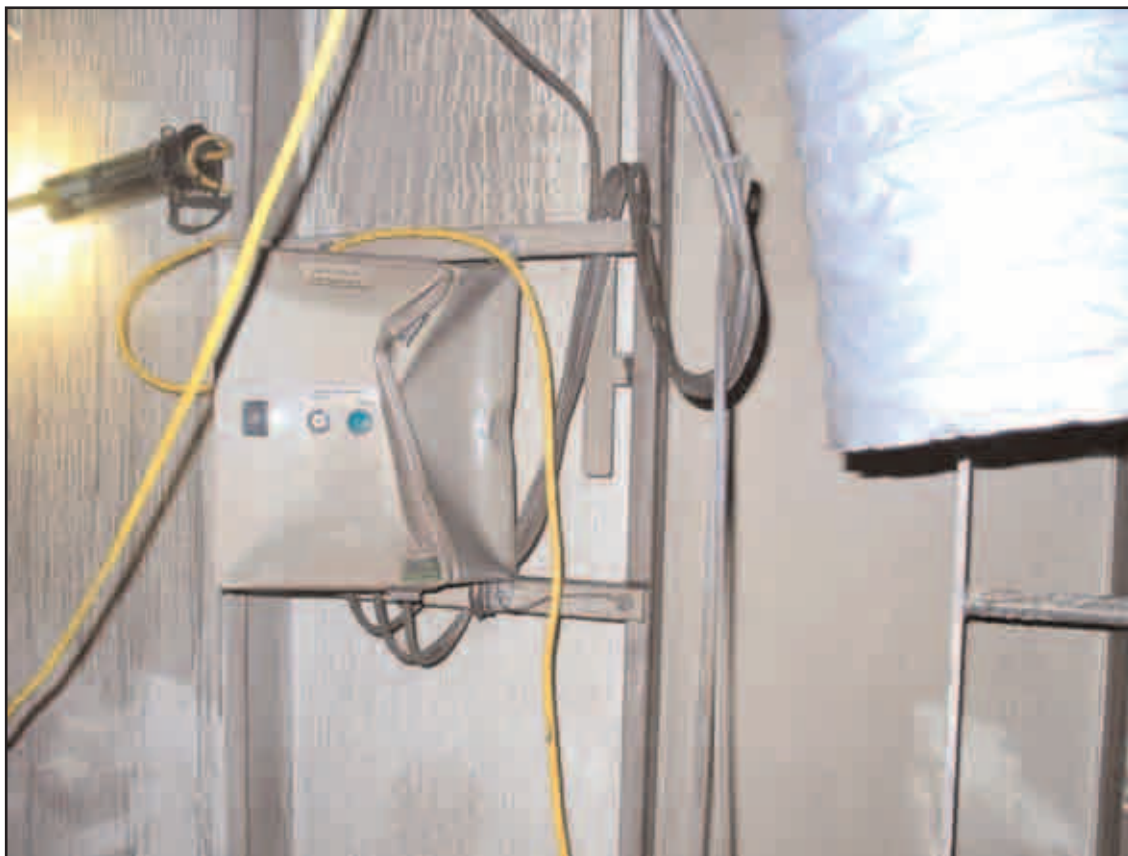
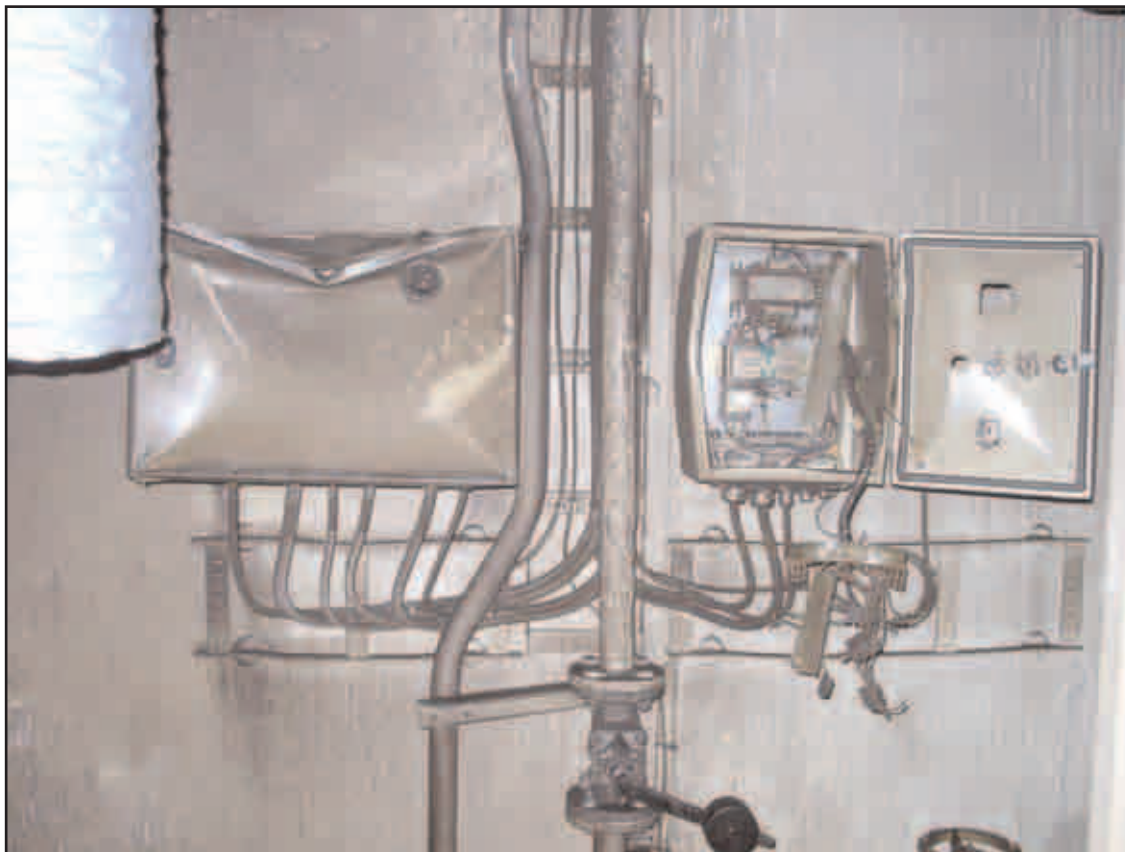
- deckhead set up
- pressure damage to three electrical cabinets
- light smoke damage throughout (**Figures 15,16 & 17**)

Damage in bow thruster room

This is clear indication that ignition occurred in the bow thrust compartment. Once this hatchcover was blown open, vapour in the upper spaces was then exposed to the still burning gas passing through the hatch. Thus, combustion spread throughout the stairwell and, through its open door, into the gas freeing room. The increase of pressure generated by the hot gasses blew open the door to the purge air compressor room and the hatch in the top of the deckhouse, and caused other damage to doors and vent flaps.
