**Marine Administration**  
***Oaseirys Lhuingys***

**Casualty Investigation Report CA 68**

**EMILIA THERESA**

**Cargo Tank Explosion**

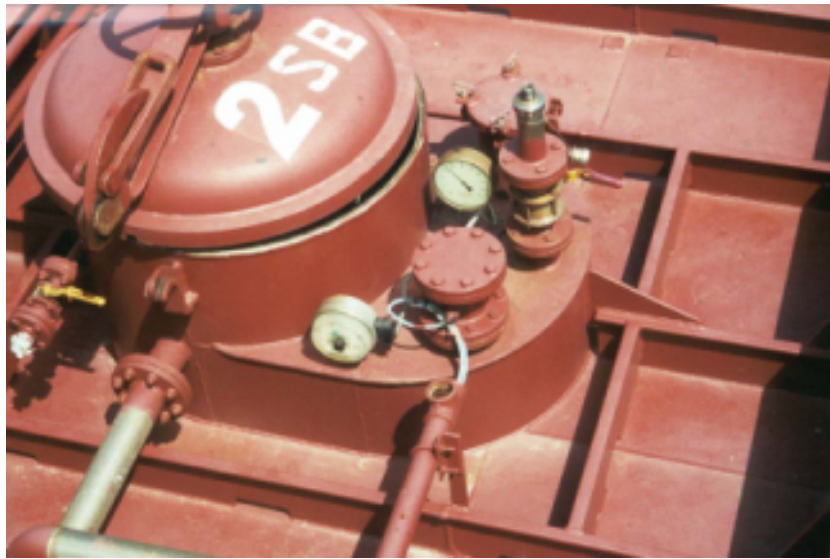
Fig 1. Example of Sampling and Ullage arrangements for each tank. (Behind is the open ullage port with the easy open handles in front is the restricted ullage / sampling port)

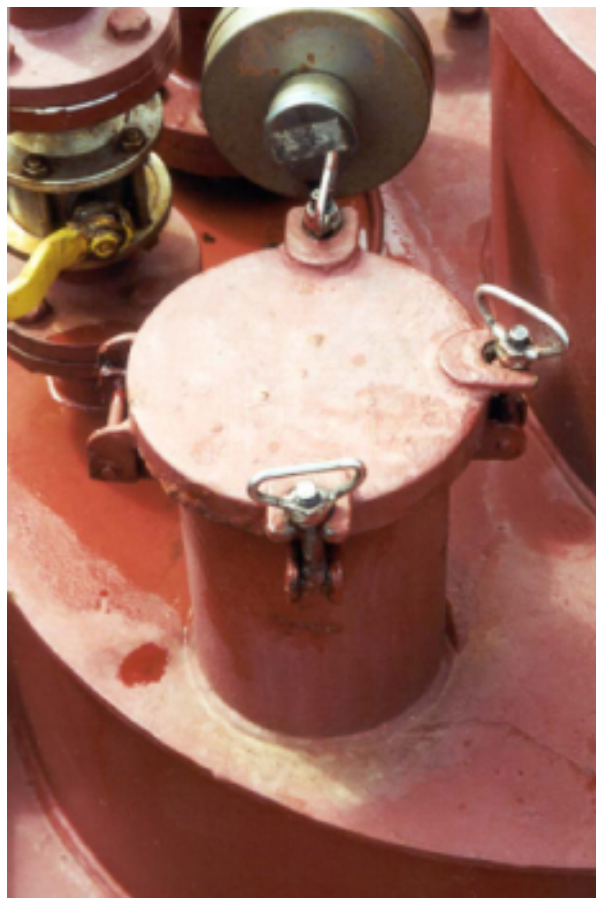
- 4.4 The “open ullage” ports are secured with threaded handles (Appendix 1, Fig 2).  
This allows them to be opened without the use of any special tools or keys.  
This arrangement clearly allowed the sampling to take place independent from the ship’s staff.

Fig 2. Close up of an open ullage port.

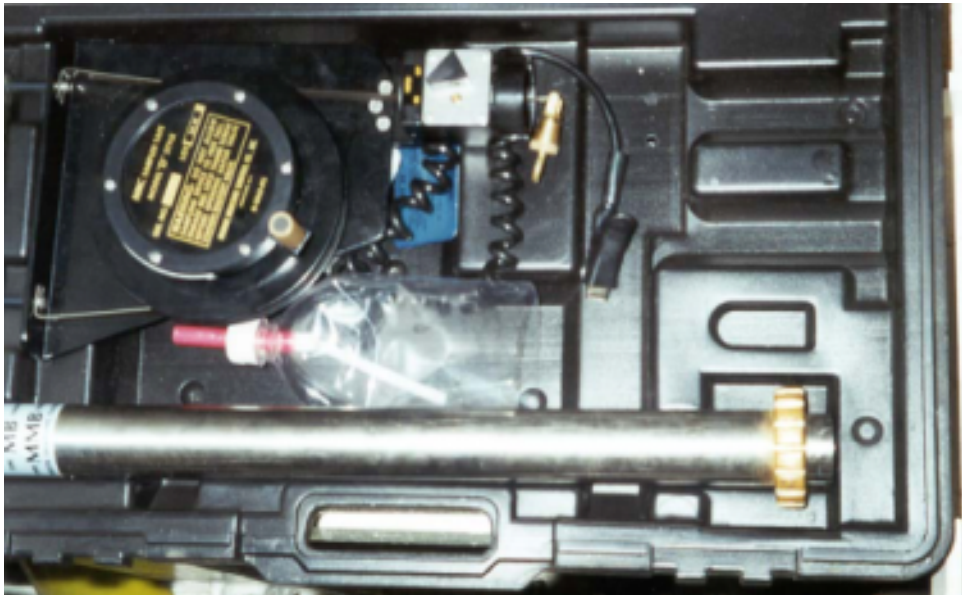
- 4.5 The ISGOTT guide is very clear that the sampling equipment undoubtedly used by the cargo surveyor is not allowed at any time and the Unifleet safety manual only allows it to be used 30 minutes after loading has been completed.  
The correct and safe Closed sampling equipment (Appendix 1, Fig 3) was available on board.  
This was stored in the aft pump room.  
The deck officers were fully aware of this and proficient in its operation.

Fig 3. Sampling Equipment available on board.

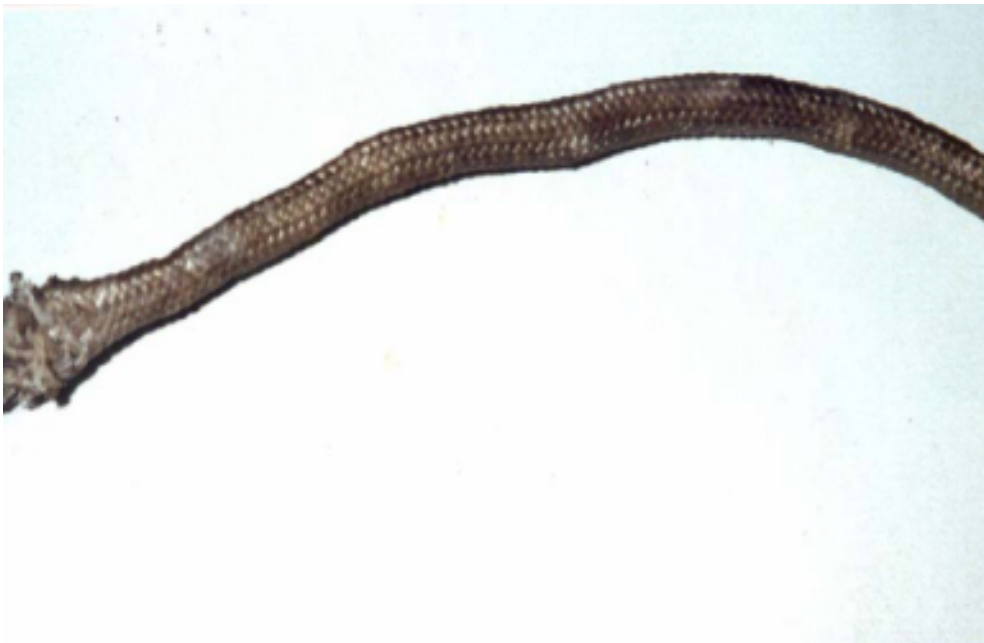
- The sample can and rope were taken into custody by the Master but later removed by another ITS cargo surveyor. The Master did not obtain a receipt for it. There was on board a length of the rope which the master had cut off from the rope attached to the sample can (See Appendix 1 Fig 4) This was clearly a man made fibre which was charred and blackened.

Fig 4. Sample of the rope found attached to the sampling can after the explosion

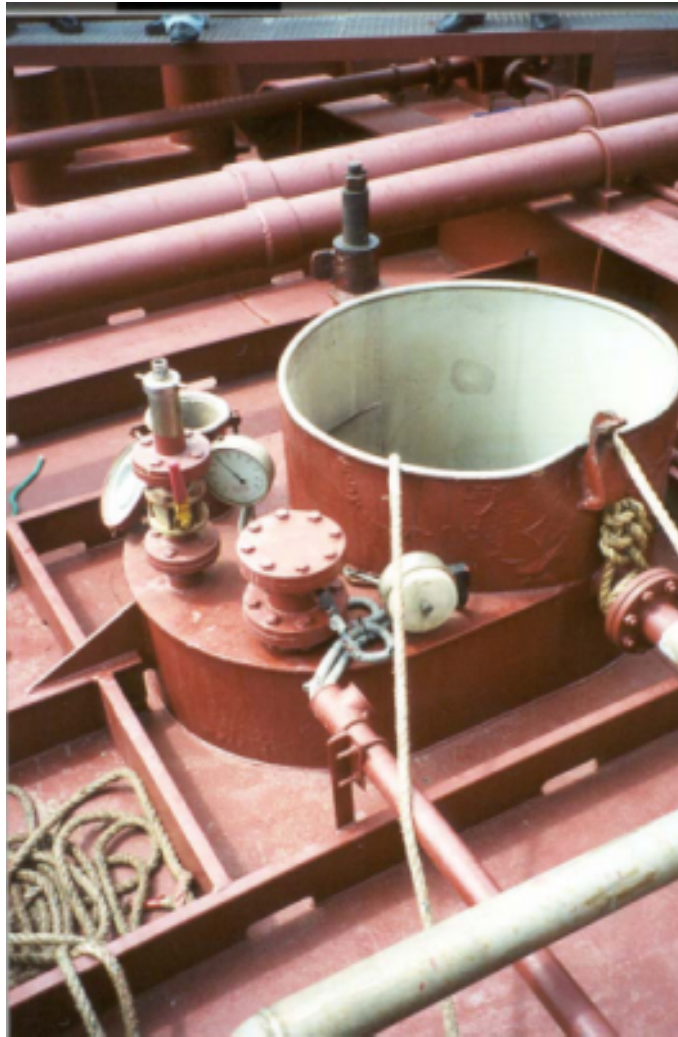
The lid from No1 port Cargo tank lid was blown off by the explosion which caused superficial damage to the structures and pipework on deck.

There was some structural deformation of the tank structure but no breach.

Fig 5. Damage to the tank entrance to No 1 Port Cargo tank

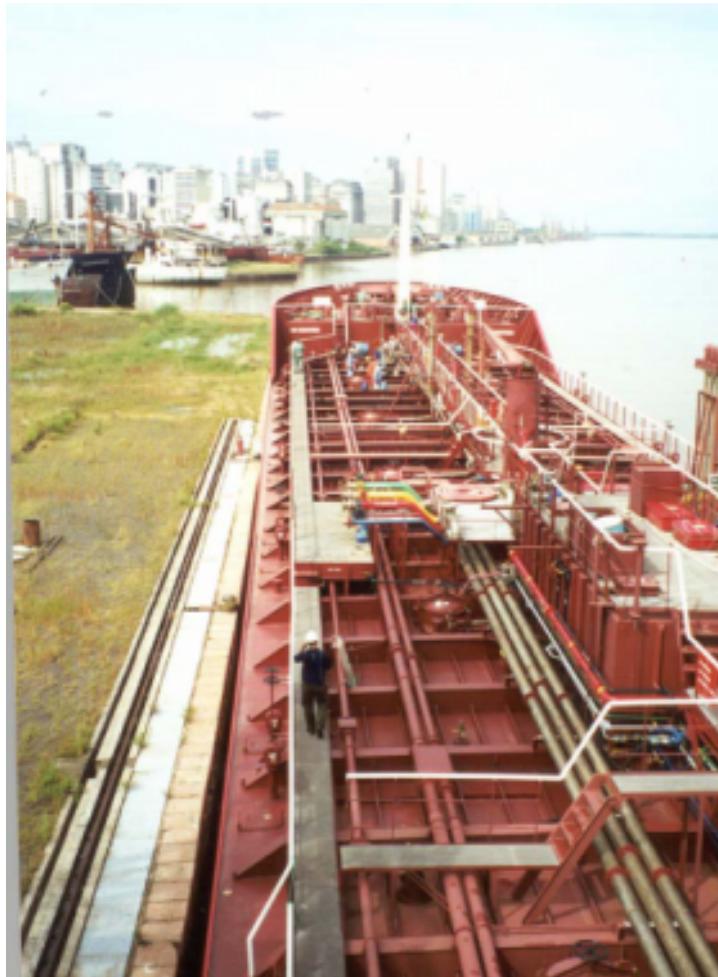
Fig 6. View from the cargo control room of the cargo area.

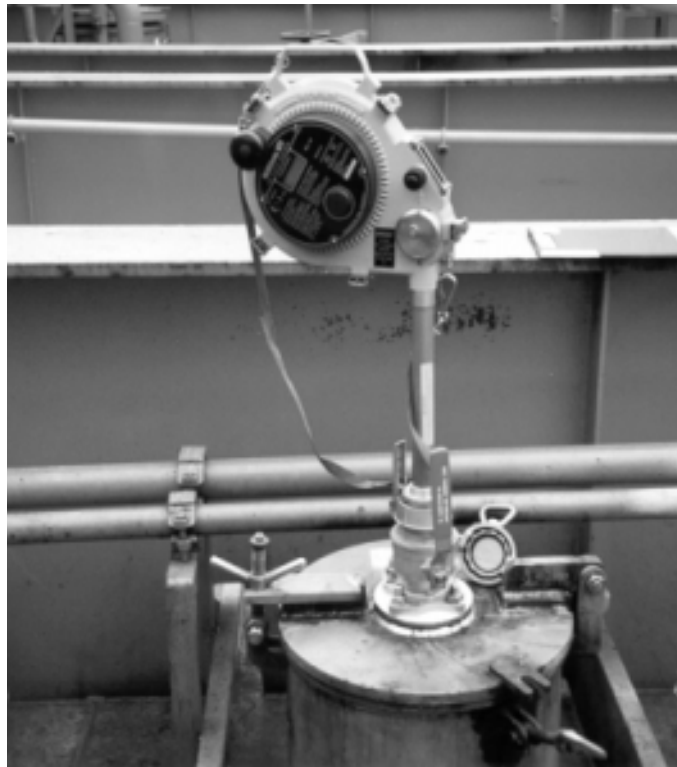
Fig 7. A example of a MMC gauge in use

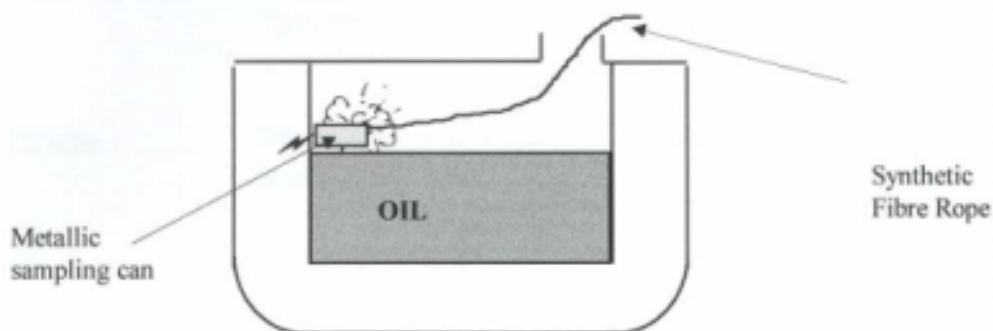
Since there were no other possible sources of ignition in way of cargo tank No1 port. The explosion of the vapour in the ullage space of the tank was undoubtedly caused by the spark produced by the electrostatic dissipation of the accumulated charge when the cargo surveyor introduced the metallic sample can into the tank. (The process of static electricity generation and the mechanisms for spark generation are given in Appendix 3.)

Fig 3 a. The metal can floats on the surface of the liquid, and quickly attains the potential of the liquid. Upon contact with the tank structure there will be an electrostatic discharge.

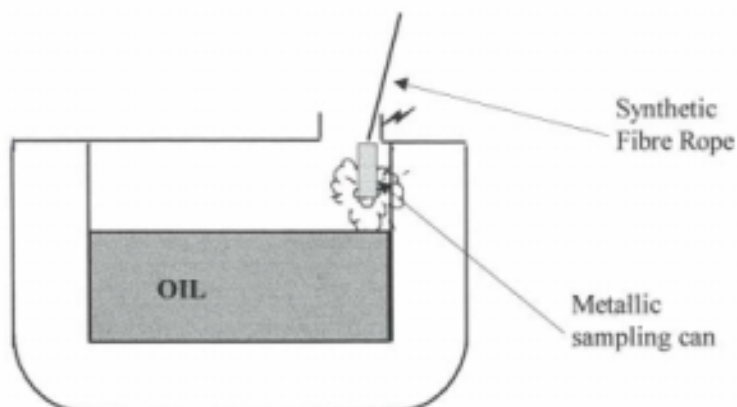
Fig 3 a. The metal has been immersed in the liquid and has attained the potential of the liquid. During the extraction from the tank the can makes contact with the tank structure and electrostatic discharge occurs.
