Isle of Man Ship Registry Technical Isle of Man **Advisory Notice**

COSMO MED and Type Approved Fire Doors – Faulty A60,	Ref. 007-17
A0 and B15 Fire doors	Issued 30/08/2017

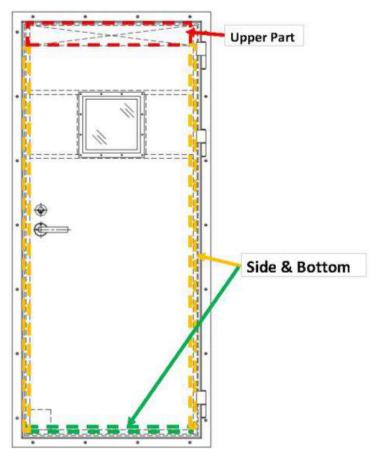
Figure 1: Affected areas of COSMO fire doors

It has come to light that the insulation in these doors is missing from the upper part, sides and bottom of the doors, the areas in which the insulation is missing is shown in Figure 1. This is likely to have occurred during a change of work process when new equipment was introduced in November 2013.

The fire doors affected have been found to fail on the insulation performance criteria requirement of the IMO FTP Code Part 3.

Owners and operators of affected Isle of Man registered vessels should take temporary mitigating measures in the form of regular fire watch/fire patrols, added precautions in case of hot work, pay attention to good housekeeping and to arrange fire hoses so that they are readily available near the affected doors in the interim period, considering the small increase in risk to the safety of the vessel.

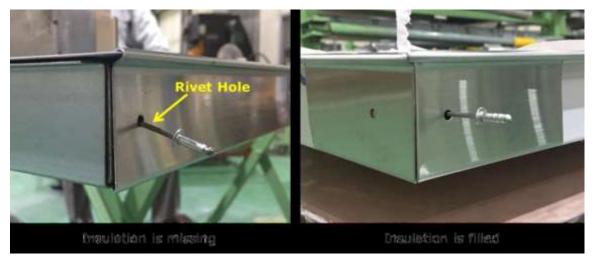
Figure 2: How to check COSMO fire doors to identify if insulation is missing (left) or if insulation present (right)

- 1. Remove a rivet or hinge bolt from the side of the door.
- 2. Insert a metal pin through this rivet/bolt hole, and check for missing insulation.

3. If a door is found to be missing insulation, please inform COSMO at: COSMO CO., LTD. 20, Myeongnyesandan 2-ro, Jangan-eup, Gijang-gun, Busan, Korea Tel: +82 51 519 9900, Fax: +82 51 519 9900 www.bn-cosmo.com
