**Port State Control Inspections - Deficiencies from 2017**

The purpose of this notice is to advise shipowners, operators, managers and Masters of Isle of Man registered ships of information in respect of Port State Control activities

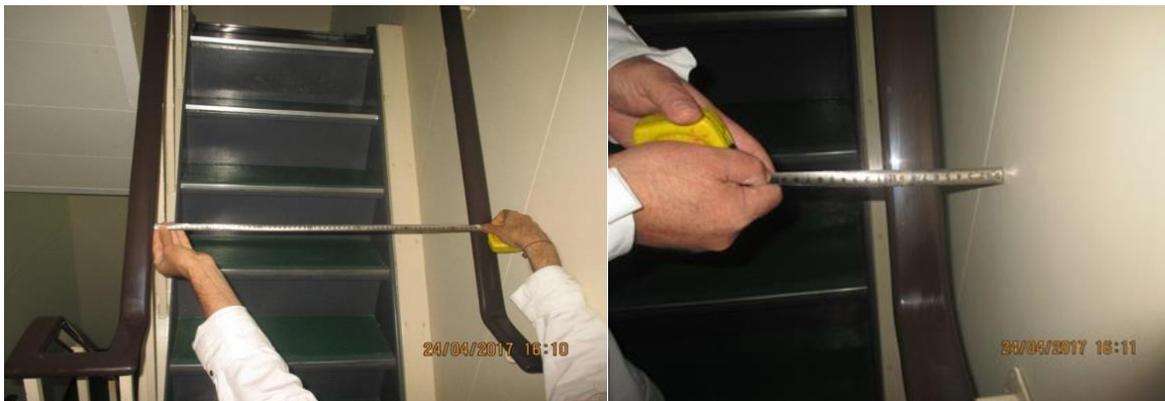
Deficiency No.1 - Code 07120 - means of escape, clear width of all stairways in accommodation less than 700mm. The gap between the handrails was actually recorded as 650mm.

Stairways and corridors used as means of escape shall be not less than 700 mm in clear width and shall have a handrail on one side. Stairways and corridors with a clear width of 1,800 mm and over shall have handrails on both sides. "Clear width" is considered the distance between the handrail and the bulkhead on the other side or between the handrails.

The original design of the ship from new had included two handrails on the respective accommodation stairway. The ship had undergone 9 previous PSC inspections including two inspections in the coastal state which raised this deficiency, with 7 previous inspections recording zero deficiencies. The subject of the "clear width" of the stairway handrails and never been raised before this inspection.

The outcome was to remove the bulkhead handrail and increase the "clear width" beyond the minimum 700mm to 750mm.

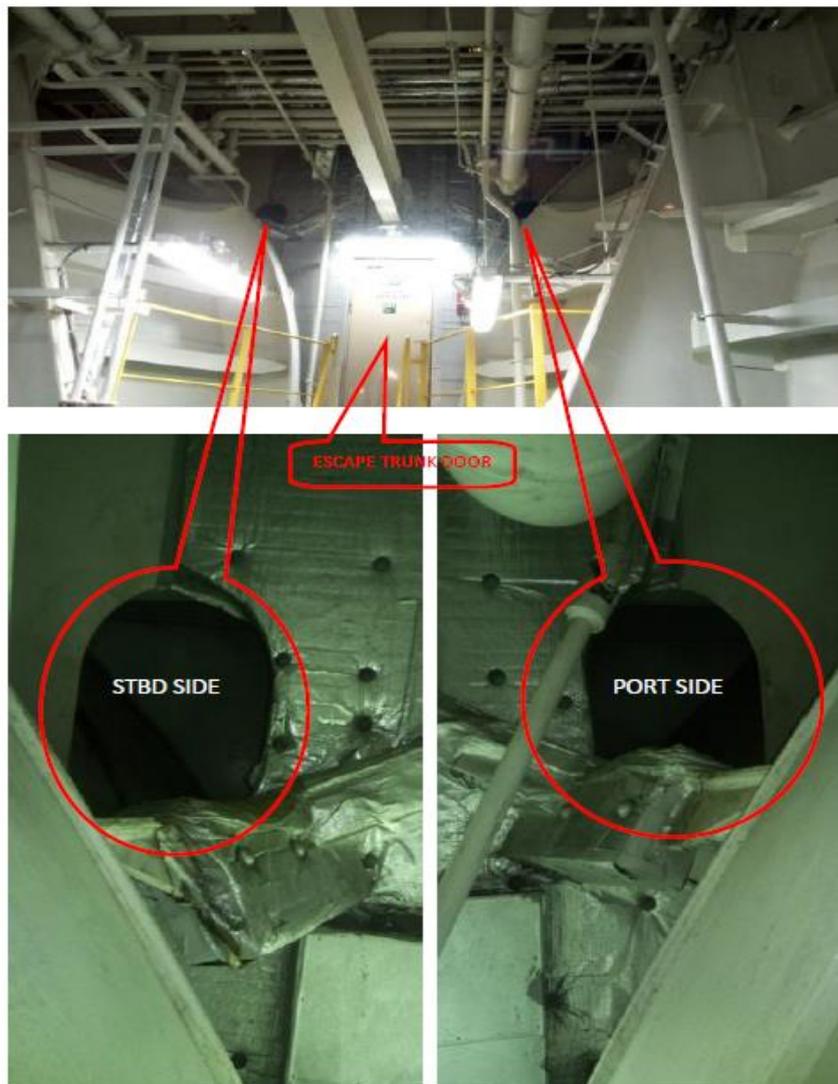
Deficiency No.2 - Code 07120 - means of escape, the insulation of escape trunk incomplete on both side in engine room

The deficiency centred on the port and starboard void spaces surrounding the escape trunking in the aft part of the machinery space. The void spaces are accessible through a lightening hole either side of the trunking. The area could only be checked by accessing the lightening holes via the stringers between the E/R Floor and E/R 3<sup>rd</sup> Deck. Once inside the void space a close up inspection of the trunk sides inside was able to determine the extent of the deficiency. The trunking bulkhead had a substantial section of missing fire insulation in each respective void space. That the PSCO went directly to this area during the inspection indicated a known fault in this class of ship.

However, for all such built escape trunks in the aft part of the machinery spaces, it would be prudent of ship operators, managers and Masters to investigate their respective ships accordingly to ensure there is no missing "A60" fire insulation
