## **Isle of Man Ship Registry**

Casualty Investigation Report No. CA127

**Collision between the BW MAPLE and DAWN KANCHIPURAM**

on the 28<sup>th</sup> January 2017

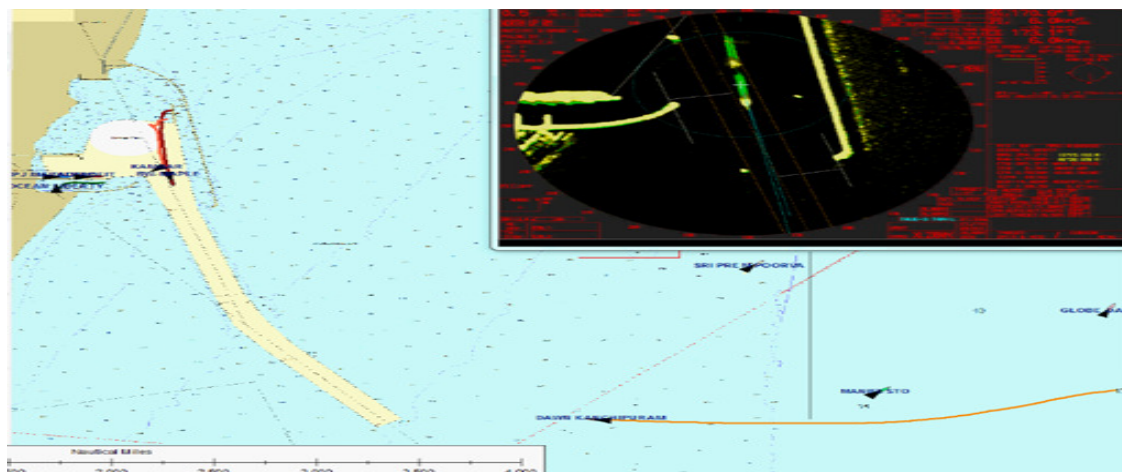
**Local Traffic In The Vicinity**

- 3.41 At the time of the incident the local conditions were as follows;
- 3.42 Visibility - Good  
Wind - North Easterly Beaufort Force 3  
Swell – 2 to 3m  
Air Pressure – 1010hPa  
Temperature – 24°C  
Tide- On 28th January 2017, the low tide was at 02:12hrs and high tide was at 07:57 hrs. The tidal range was about 0.9m and the collision occurred when the tide was in flood (low to high) phase.  
Currents were predominantly towards south with a range of 0.1 to 0.2 Kts along the coastal stretch of Chennai.
- 3.43 Traffic conditions in the area as the BW Maple approached the breakwater as far as can be ascertained are illustrated below. The buoyed channel was clear and the nearest vessel in open waters to the east is at a distance of approximately 2.75nm. Local fishing vessels may also have been in the area.

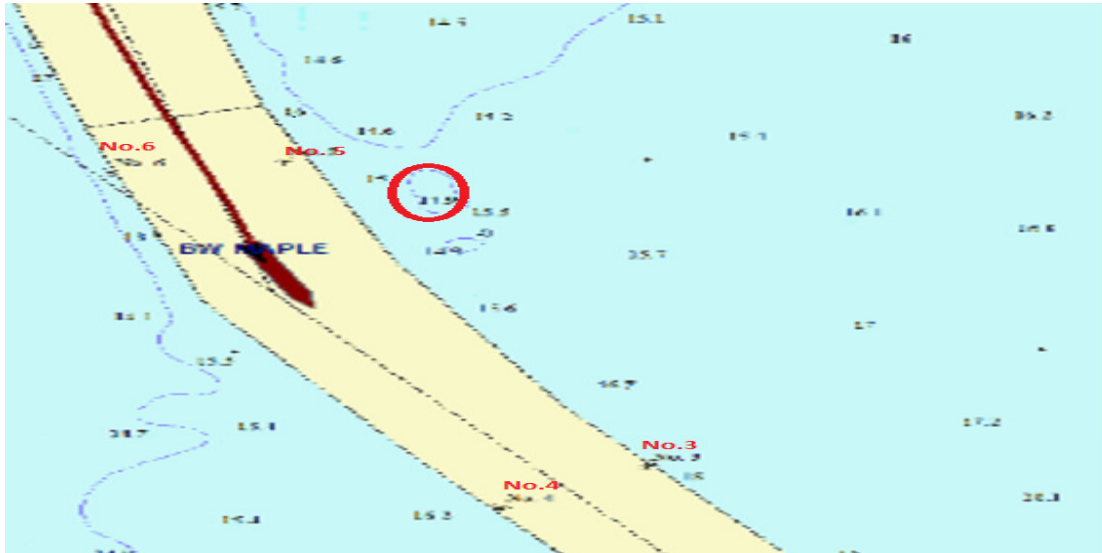
**Shallow Patch to the East of No. 5 Buoy**

- 3.45 To the south east of No. 5 buoy is a shallow patch showing a charted depth of 11.9m. To the west of the buoyed channel buoys there is reduced water. The BW Maple had a maximum draught of 10.4m on departure

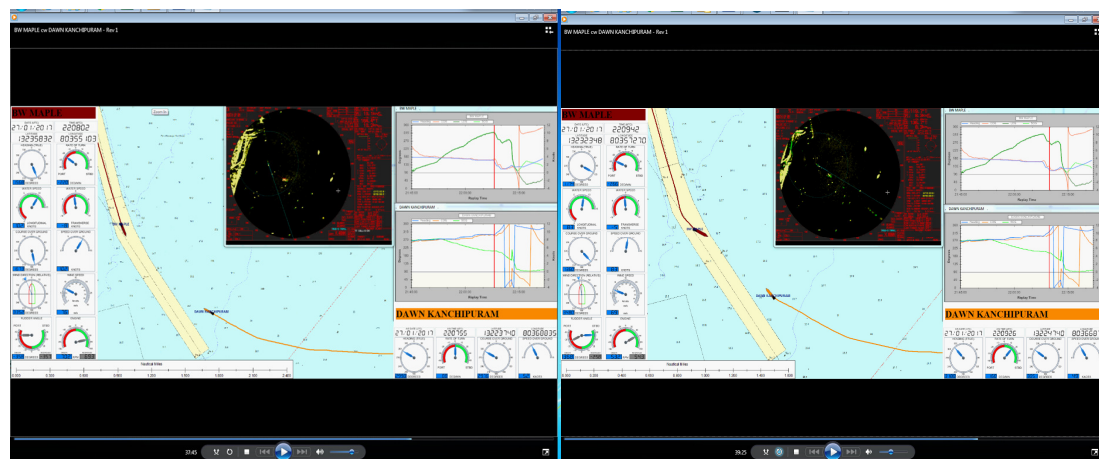
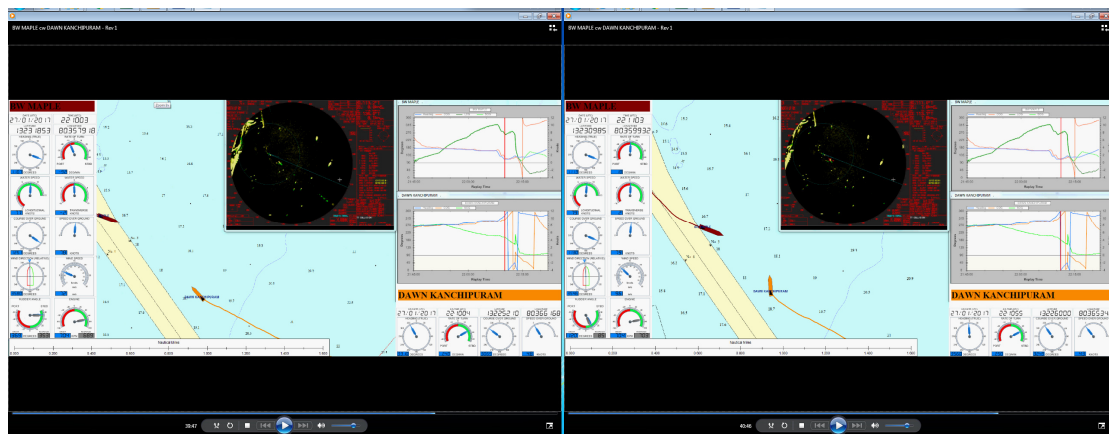
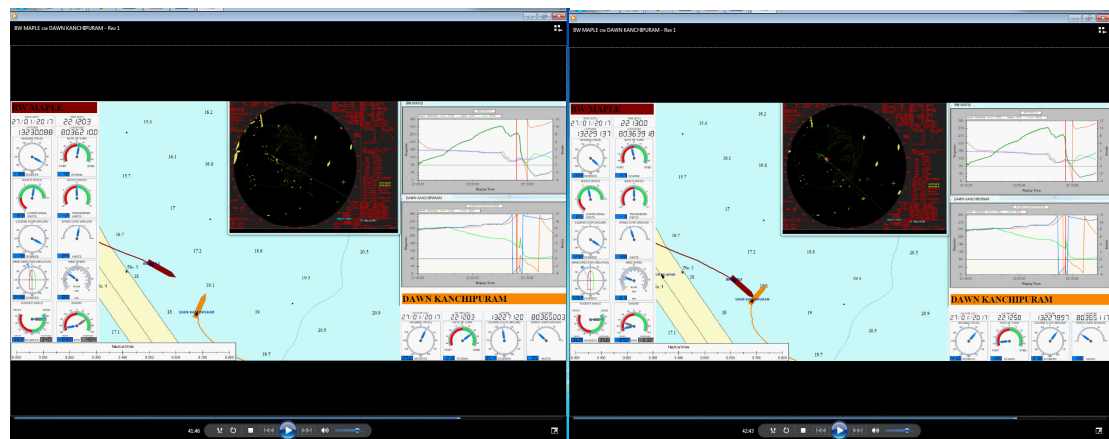
3.89 As can be seen from the below illustrations, the impact occurs when the BW Maple’s heading is approximately 131° at a speed of about 7.4 knots.

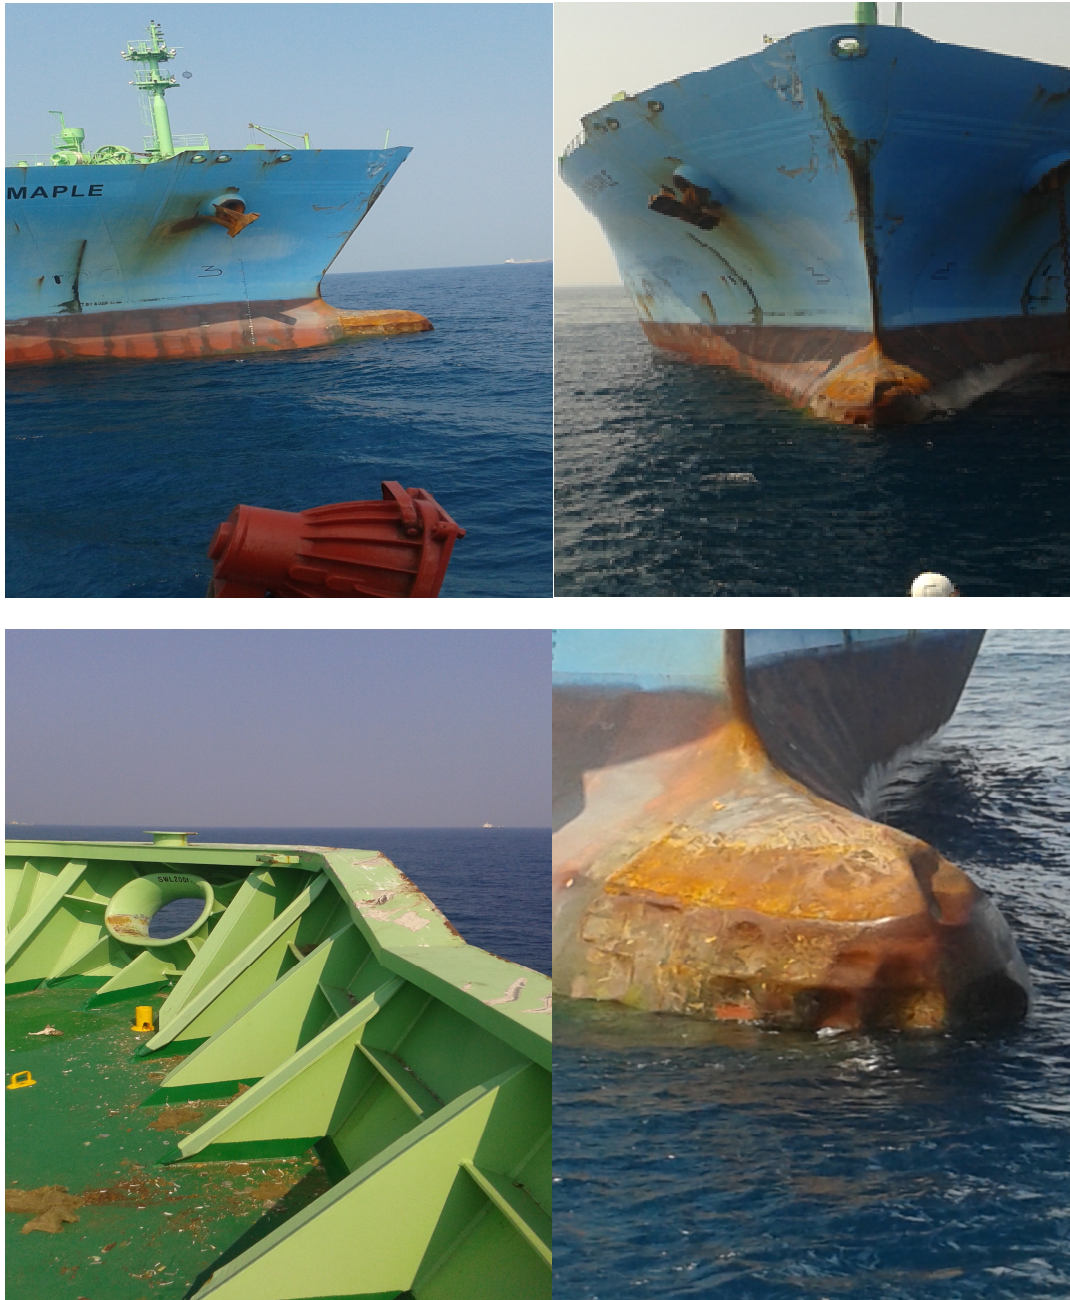
### 3.94 BW Maple Images

### 3.92 Damage to the BW Maple

3.93 A hull damage occasional survey was completed by the attending Classification Society on 31/01/17. Damage occurred to the bulbous bow, forepeak ballast tank, bulwark plating, bulwark railing, and shell plating. The structural capacity and the watertight integrity of the cargo area including the collision bulkhead are not impaired by the damages in present condition.
