Isle of Man Ship Registry

Casualty Investigation Report No. CA 128

M/V Cheshire

Ammonium nitrate fertiliser cargo decomposition

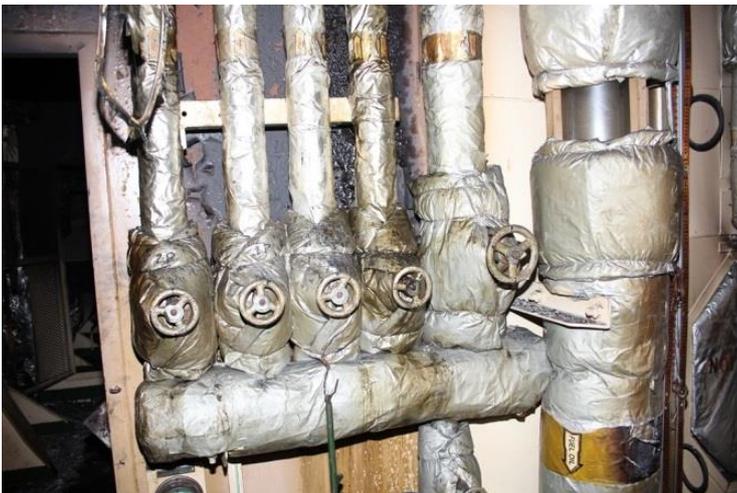
HFO heating coil steam valves (confirmed as being closed in the managers initial access to the vessel) ^[2]

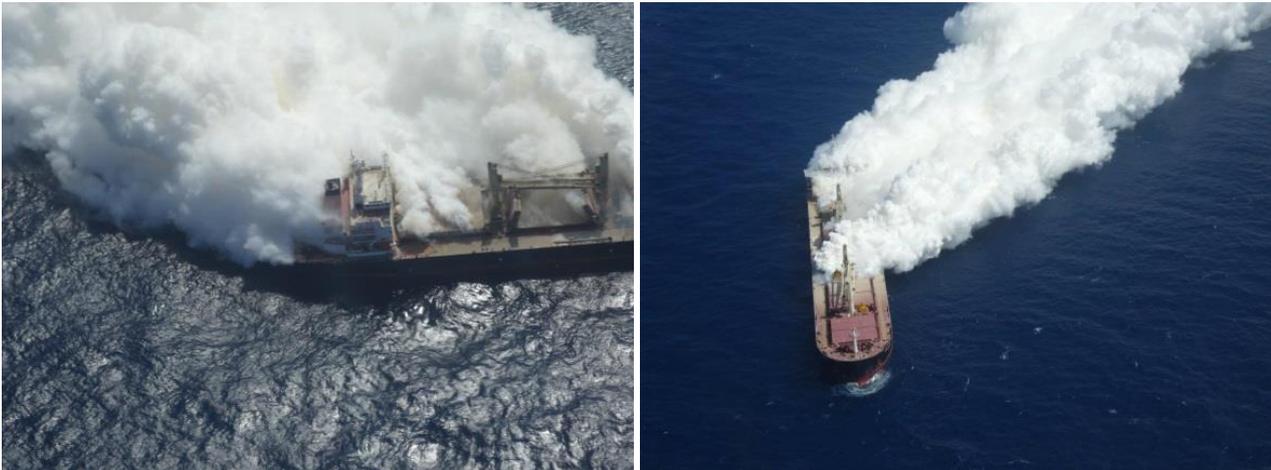
Examples of the conditions described by the crew on the 13/14th August (toxic gas enveloping the accommodation and being drawn into the engine-room ventilation system) these pictures taken after the vessel was evacuated with CH#3, # 4 & #5 decomposing and toxic gas plume visible from 14nm away. ^[1]

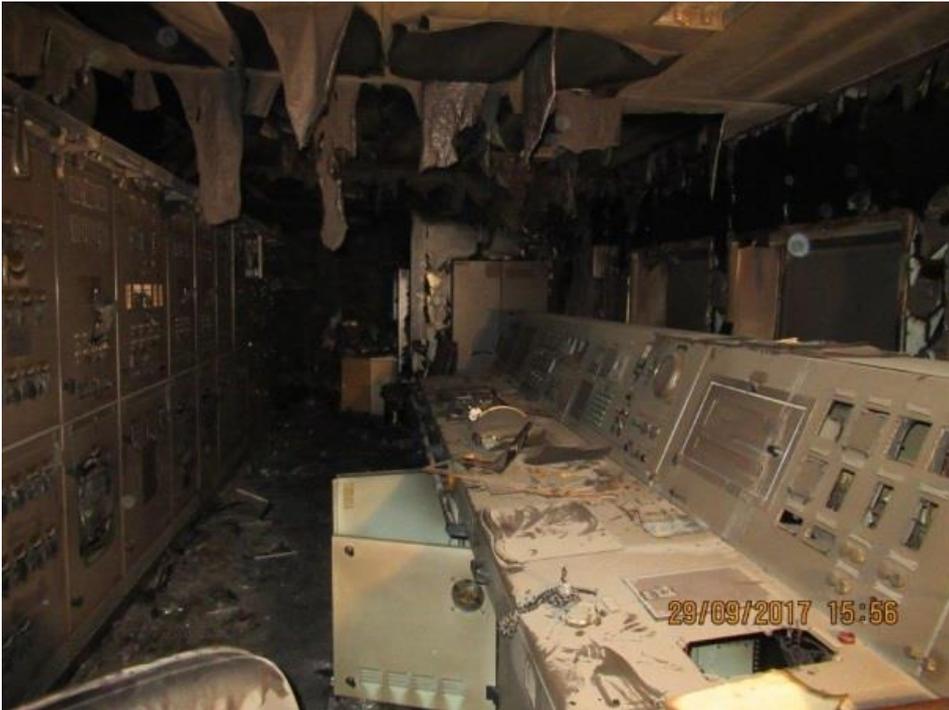
Post salvage photograph of the engine control room giving some indication of cargo decomposition particulates that were drawn into the engine-room by the ventilation and blocking the turbocharger filters (approx. ½ ton of dust was removed from the ER) – note that structural fire insulation is designed to offer protection for hours, not days and why fire damage was also evident in the engine-room. ^[3]

The blocking filters and high deviation temperatures caused by the particulates, prevented the vessel from going fast enough astern to gain sufficient steerage to clear the gas cloud, this meant that the situation was going to continue until the wind outside the vessel picked up enough for the vessel to finally clear the significantly sized cloud evolving from CH#4 and completely surrounding the vessel, since there was little or no wind to disperse it.

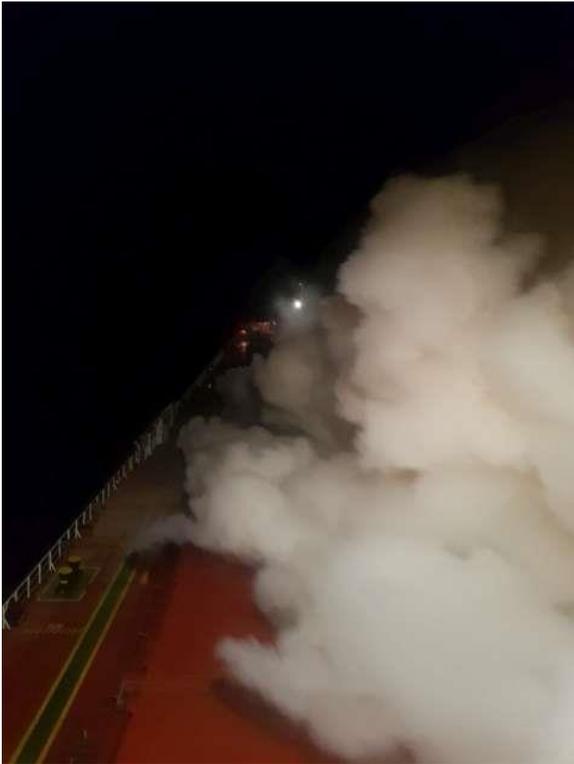
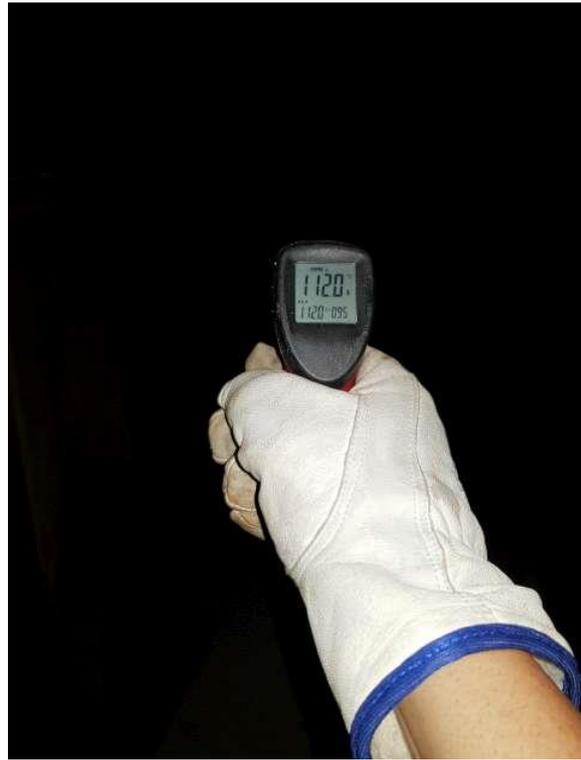
Photographs taken by the surveyor soon after boarding ^[4]

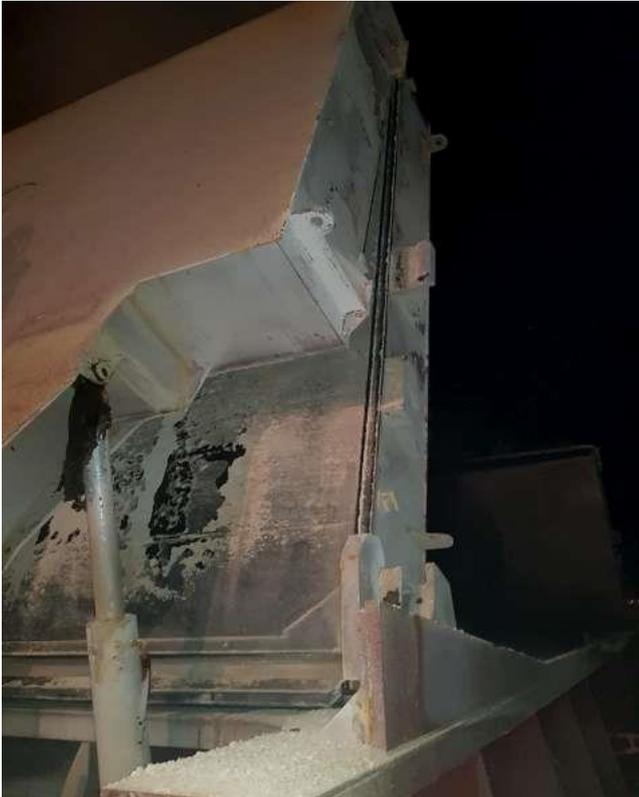
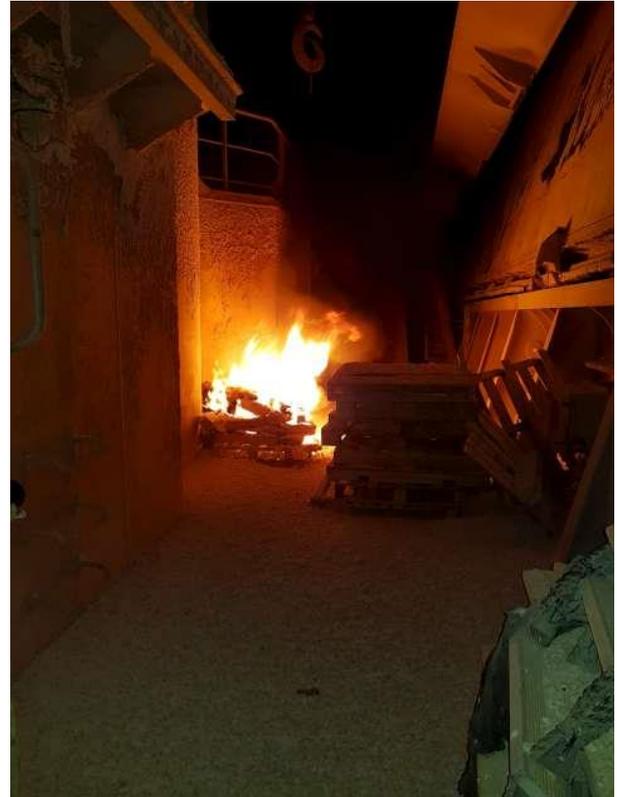
CH#4 hatch cover following the initial "explosion" and burning wood pallets ignited from hot cargo. ^[4]

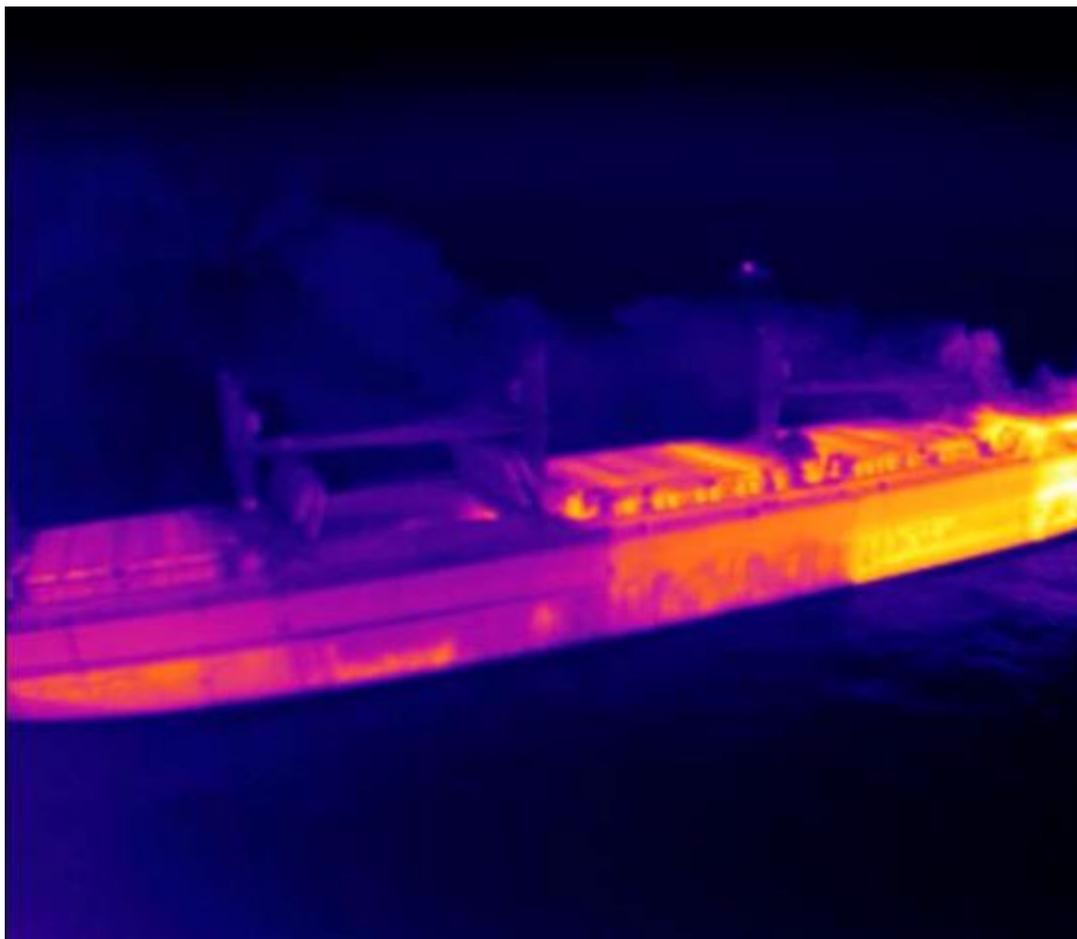
Thermographic and visible images of CH#5, #4, #3, #2, and #1 left to right (CH#1 hottest, CH# 4 coolest) ^[1]

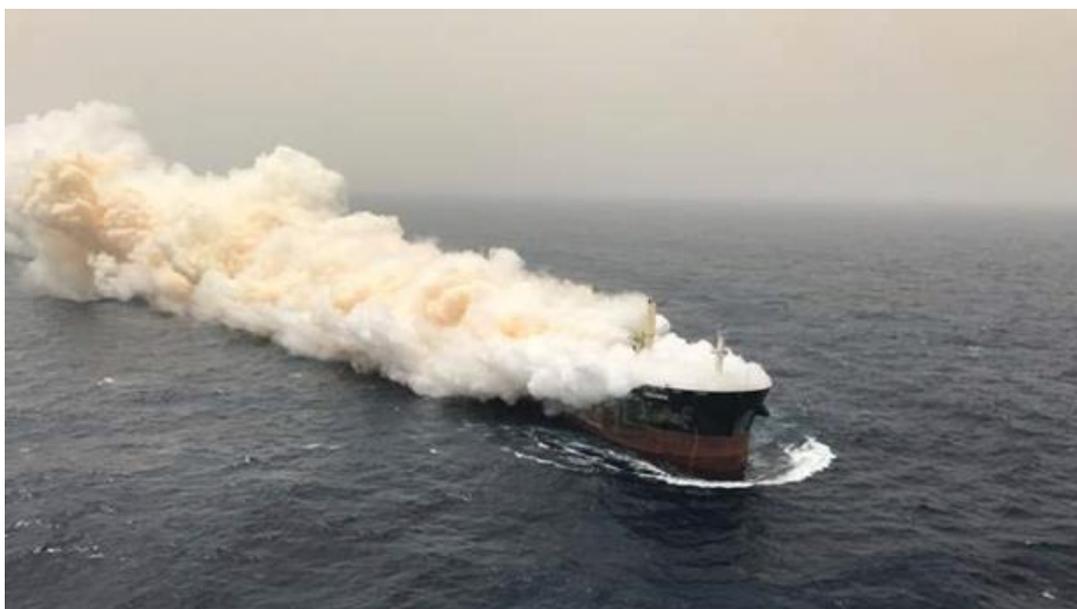
Although damaged in its entirety by the decomposition, approximately 23,183 tons (54%) of the cargo was consumed by the reaction and by toxic decomposition products being released to the atmosphere, only 19,471 tons (46%) remained on board after the event. ^[1]

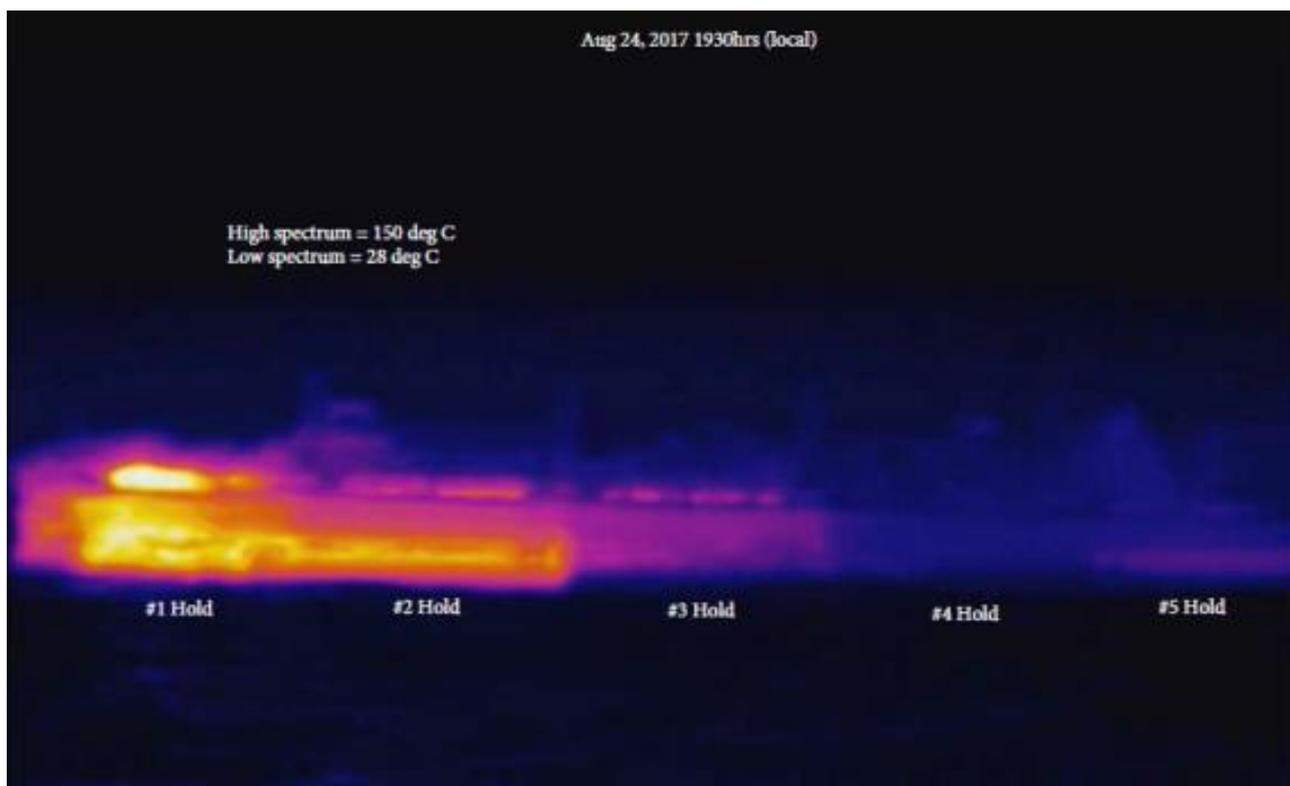
Thermographic and visible images of CH#1, #2, #3, #4, and #5 left to right, prior to initial salvage access. CH#1 is hottest followed by #2,(CH# 3, #4 and #5 reactions have largely run their course and CH#4 is now the coolest hold) ^[1]

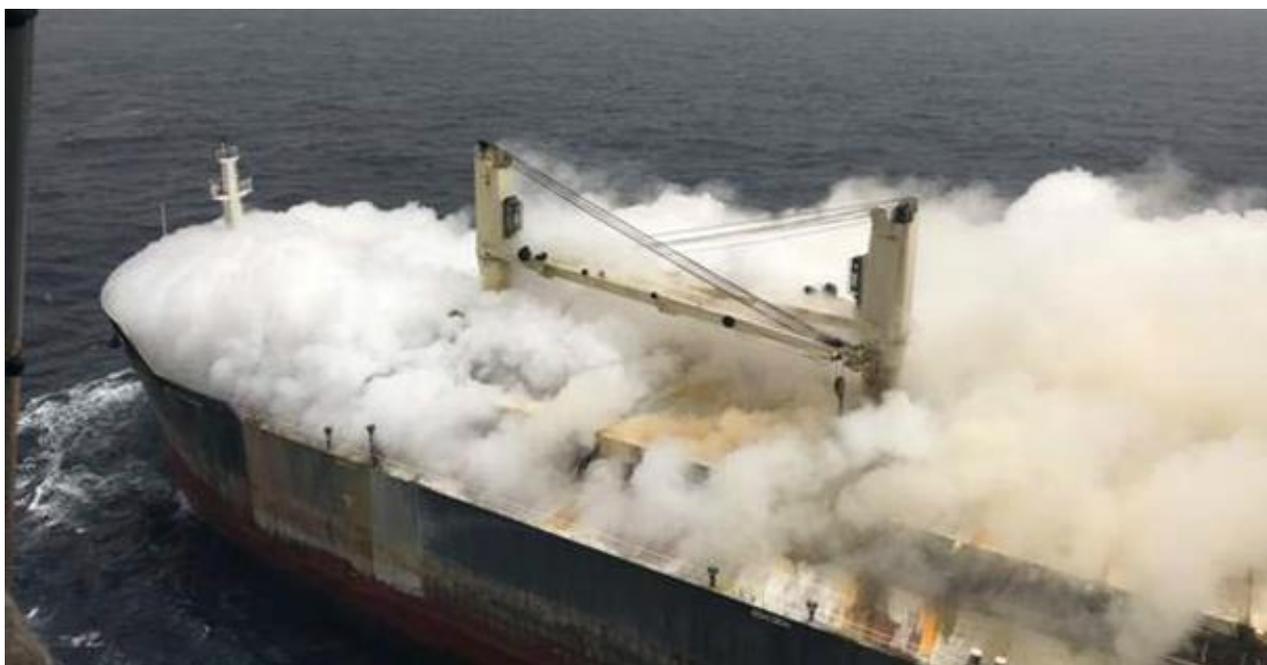
Not smoke but toxic gas that is harmful to life ^[1]

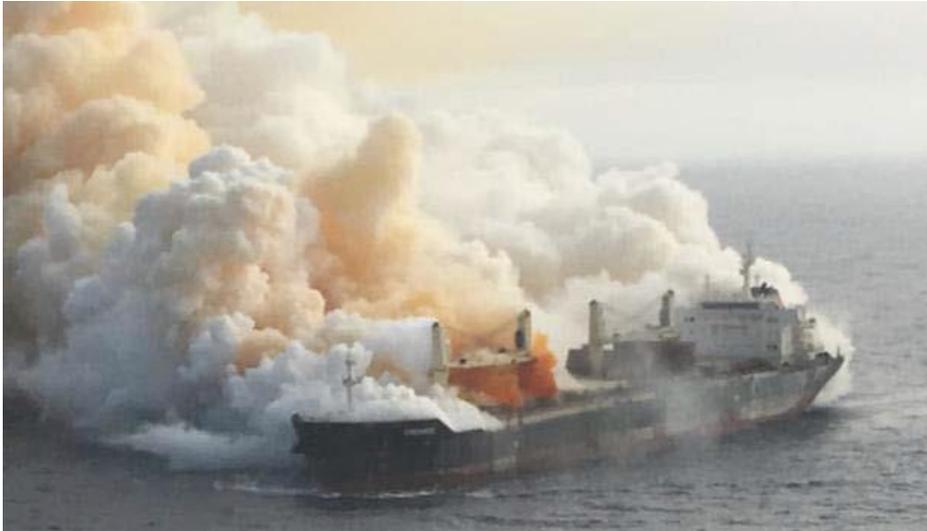
Initial salvage access to vessel, by gas colour CH#2 is seen to be at a more advanced stage of decomposition than CH#1^[1]

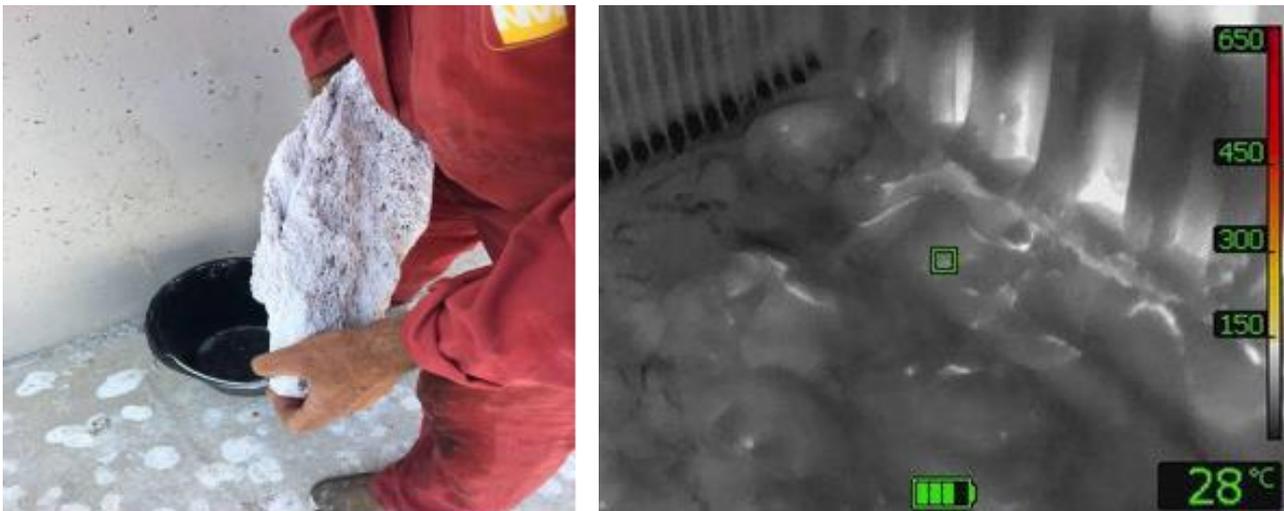
Although the fertiliser mass itself acts as an insulator, manufacturers advised Matrix formation could assist a decomposition reaction by retaining heat at the reaction front. It was observed that a Matrix had in fact formed over the decomposed cargo and had retained heat. One of the conditions placed on the vessel for safe discharge of cargo by Motril port authorities, was that any decomposed cargo landed on the quayside must be less than 50°C – this was to prove difficult due to the Matrix retaining heat and being hard, requiring it to be broken up to enable access to the hot cargo below it. As a result the unloading was expected to take a long time.

Insulating Matrix formed over the cargo retaining heat ^[1]

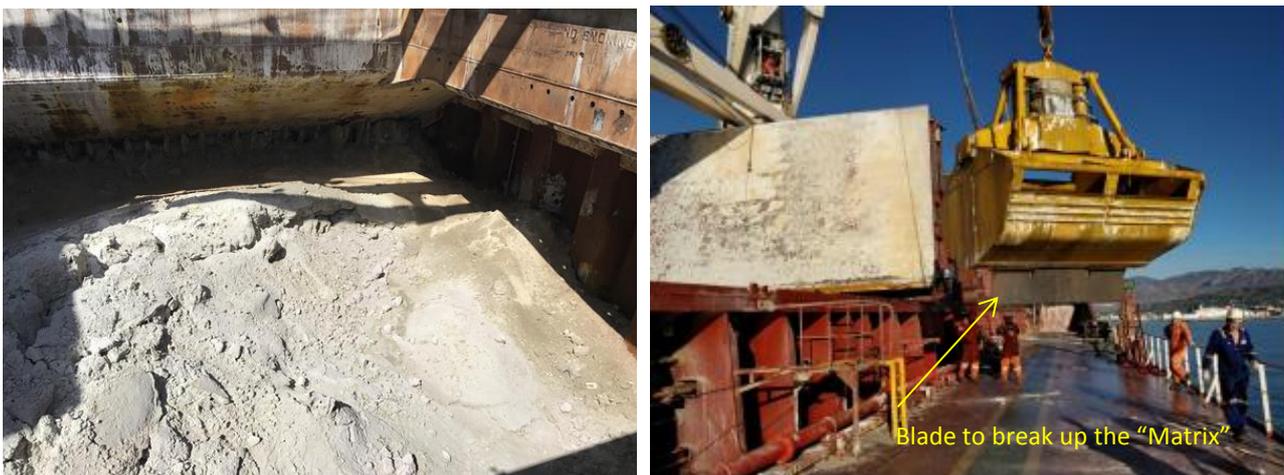
Matrix formed over cargo and blades welded to cargo grabs to help break it up ^[2]

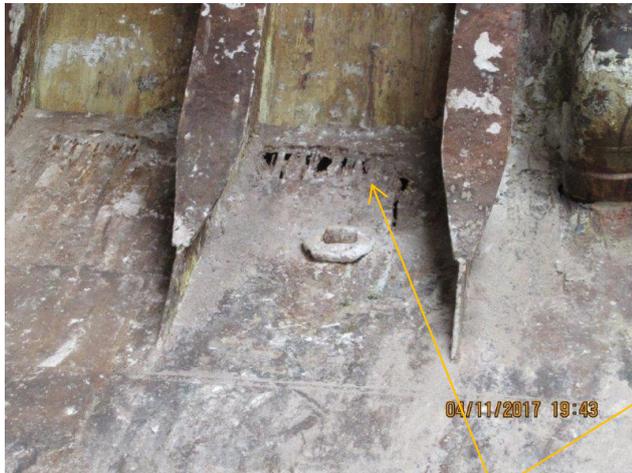
It was becoming more and more clear that significant structural deformation had occurred in addition to the visibly obvious structural damage and on 4th December 2017 under the vessel’s hull and machinery policy, the underwriters declared the vessel a Constructive Total Loss (CTL).

Cargo hold no.2 structural damage. [3]

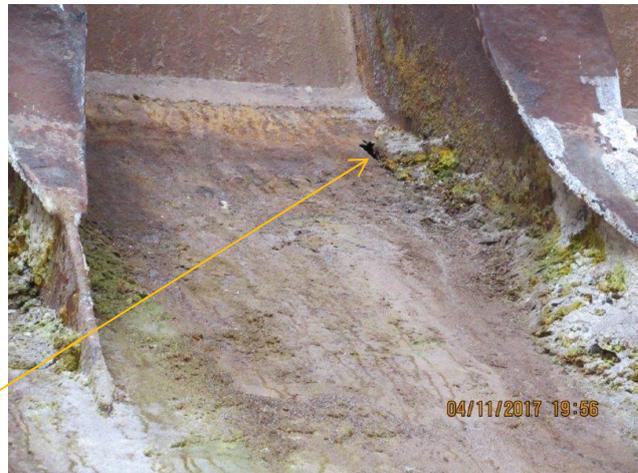
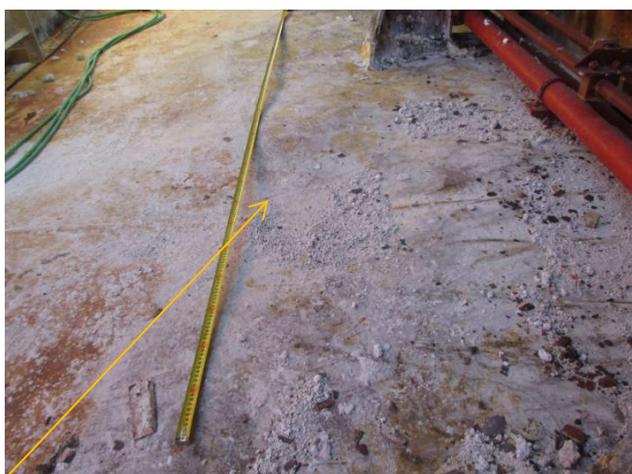
Deformed/rippled cross decks. [1]

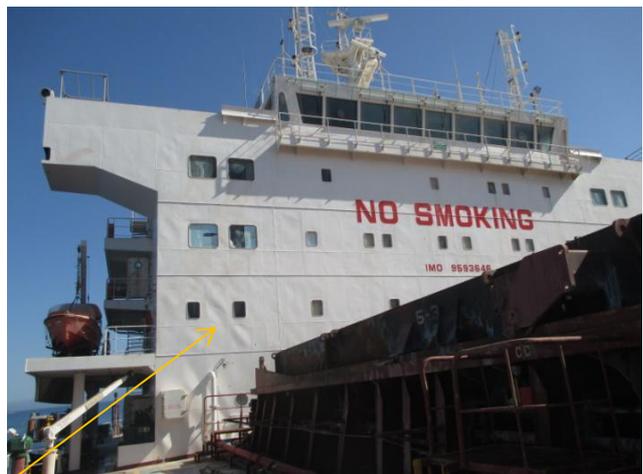
Deformed/rippled superstructure [1]

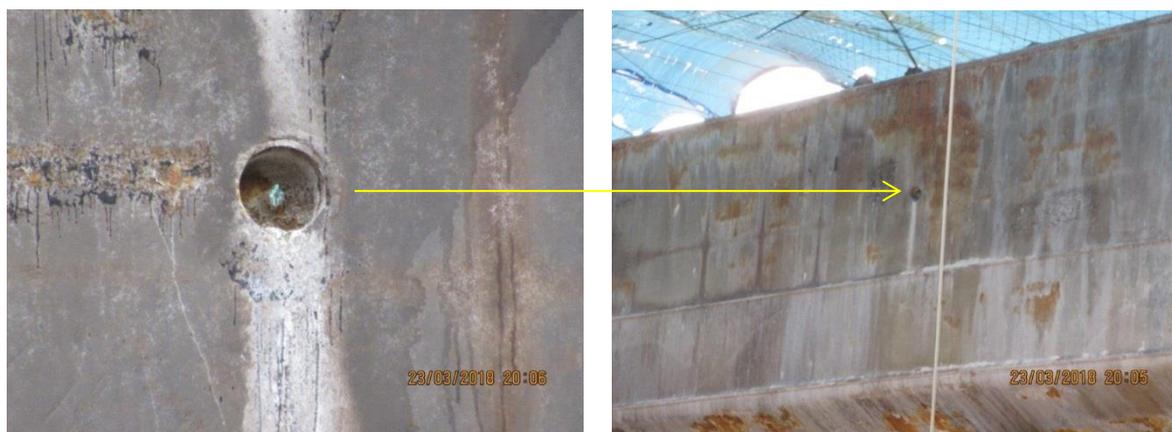
Analysis – In the days prior to the obvious signs of a decomposition and “smoke” being evident coming from CH#4 drains and openings, for some reason a cargo hold fire detection alarm was not listed in the alarm history and the deck area fire detection zone is not recorded as having been isolated. There is an open system fault (16.55hrs 23.05.17 onwards) on the log maintained on the bridge by ship’s staff recovered after the incident ([link](#)) – but the description does not make it clear how the fault might have affected the system.

Comment – Specific maintenance records have not been located, no spare parts were ordered and an explanation of a simple failure to close the record once power was restored to the system has since been offered by the C/O. Photographs taken following the incident show what may be a blockage on the sampling line/cargo hold connection points and may possibly explain this failure to alarm, but this blockage is most likely a result of the cargo activity (sampling points were higher than the cargo and would not be expected to have been blocked), accordingly at this time the Author is unable to explain why an alarm is not shown in the alarm logs pertaining the cargo area and therefore did not raise awareness of a problem, in the period since departure.

CH#4 smoke detection sampling points (the cargo surface lay below the sloping surface at the bottom of the second picture, upon completion of loading). ^[3]

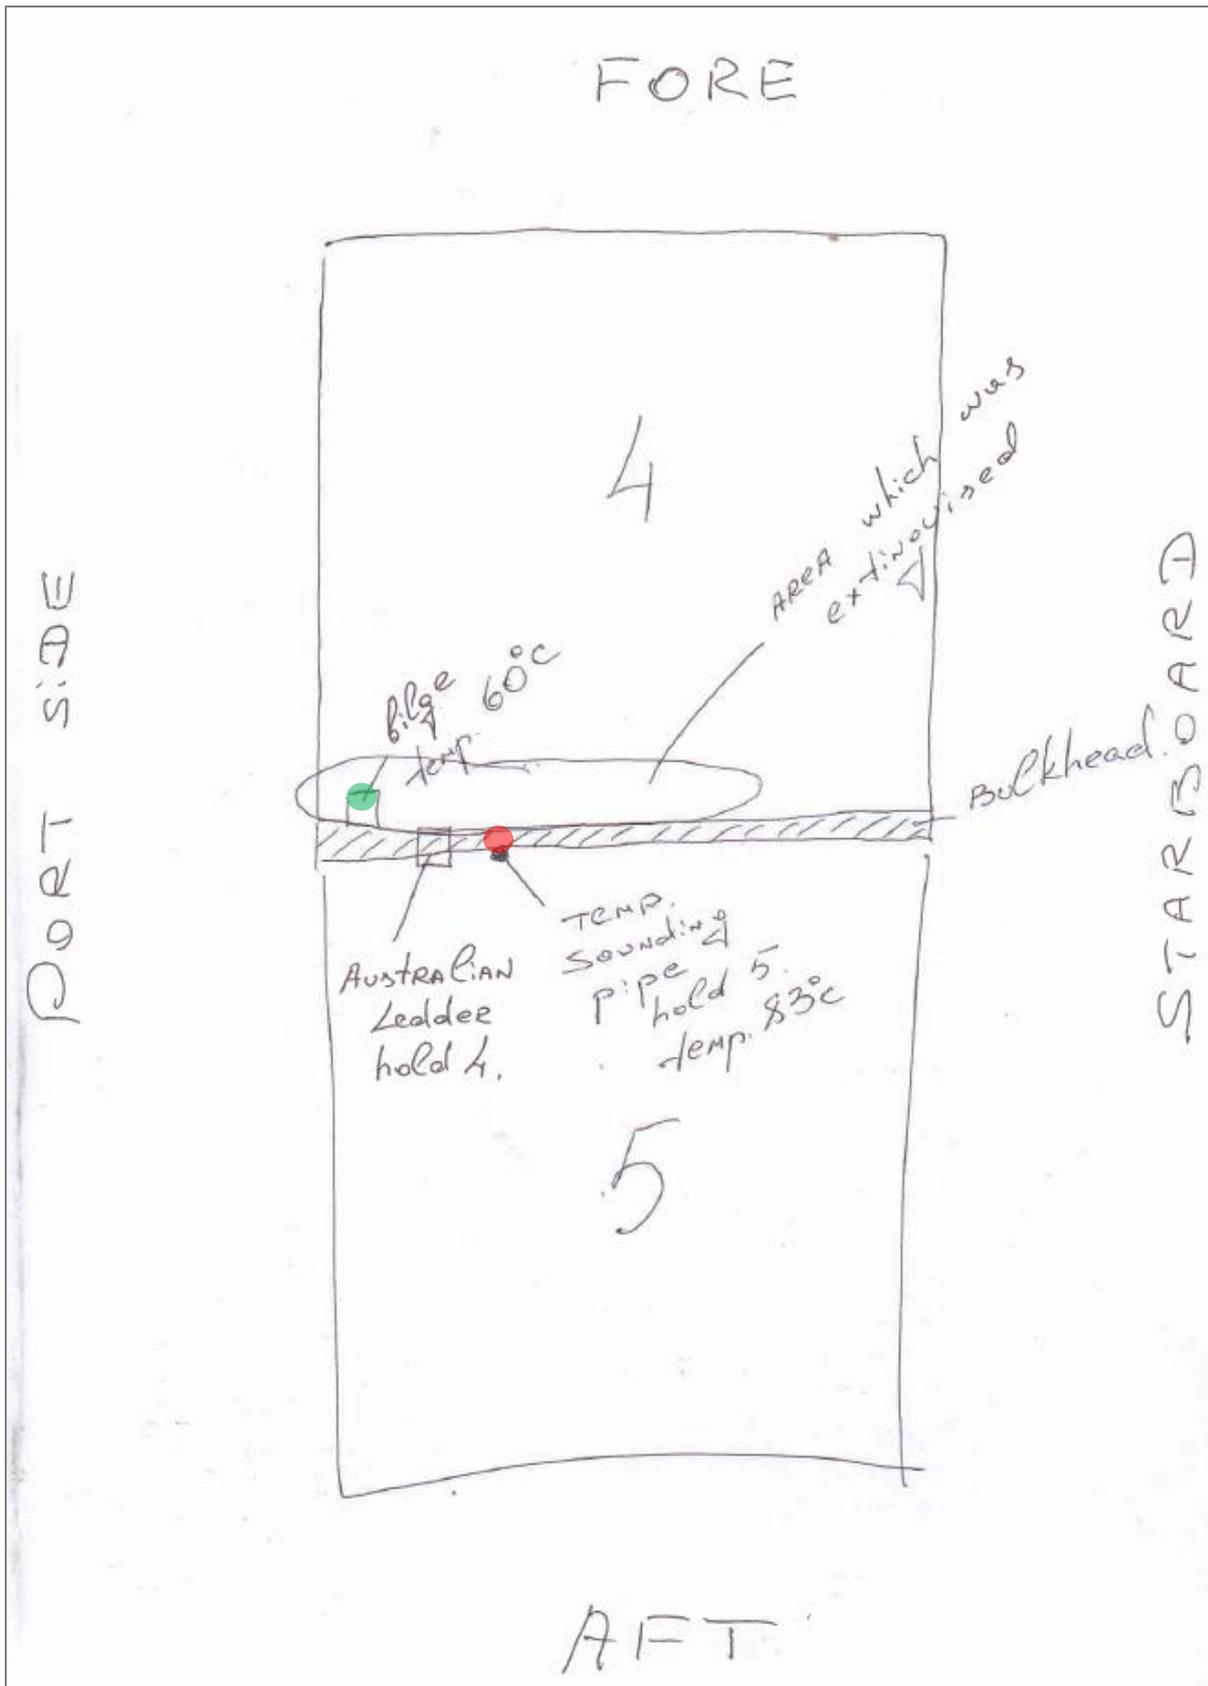
Sketch of initial hot-spot location and cooled area. [3]

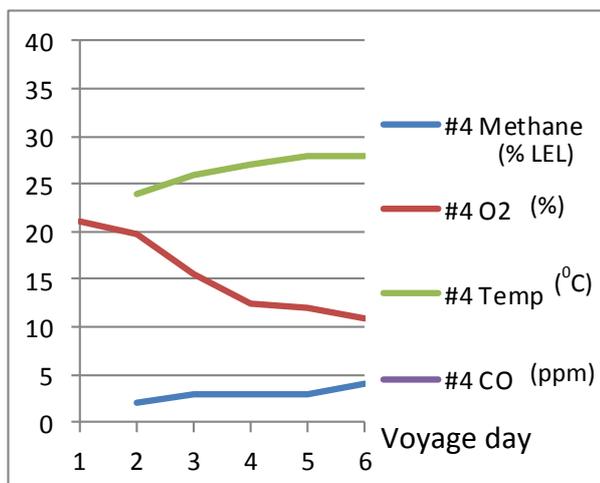
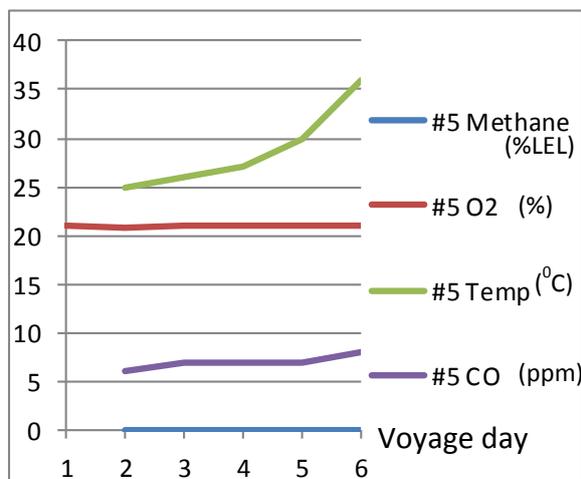
#4 Carbon Monoxide ppm off scale when measured (all days)

Quickly rising temperature in #5 from 9th Aug (voyage day 4)

Hold atmosphere conditions trended from information obtained during the investigation.
