Summary of Casualties, Accidents and Incidents on Isle of Man Registered Vessels

2018

Isle of Man Government Department for Enterprise

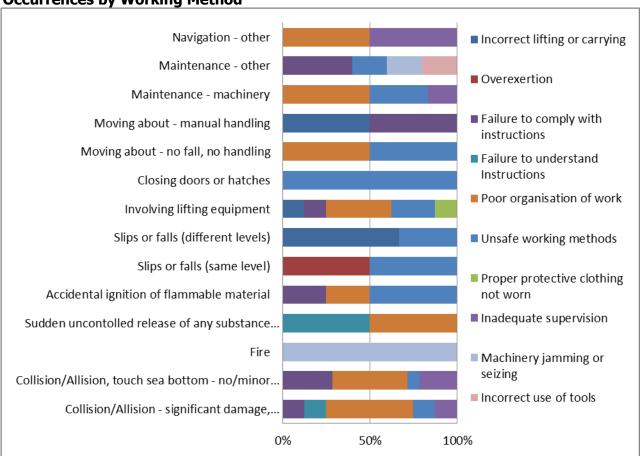
10.1 Occurrences by Working Method

In 2018 the predominant working method cause has been attributed to "poor organisation of work" followed closely by "unsafe working methods".

Seafarers should plan their work and safety precautions adequately and avoid taking shortcuts in order to get the job done more quickly. This highlights the importance of effective risk assessment. A seafarer should not feel they must put themselves in a dangerous situation to complete the job or to save a few minutes of time.

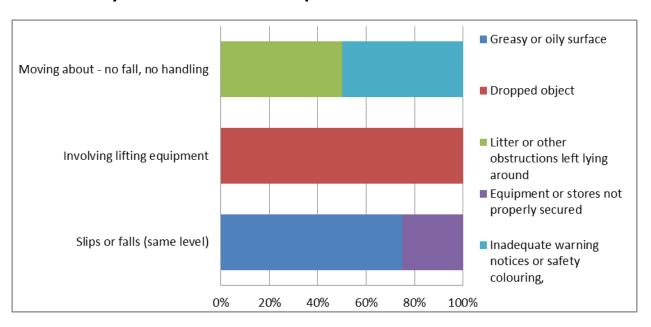
10.3 Occurrences by Movement about the Ship

In 2018 "greasy or oily surface" was the predominant cause associated with moving about the vessel.

Crew members should also take note of warning signs highlighting risks and dangers. Slips and falls on slippery surfaces was the predominant cause in 2018. Crew members should be aware of any associated risks of slipping when moving about the ship under various conditions.

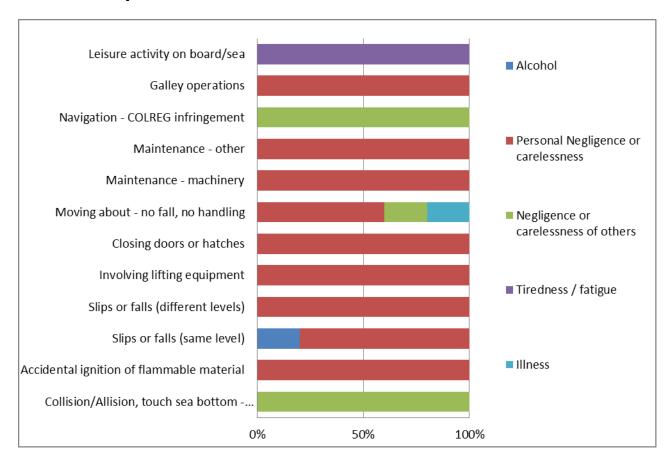
10.4 Occurrences by Human Factor

In 2018 the predominant human factor cause has been attributed to "personal negligence or carelessness". By "human factor" we mean the act or omission of a person to do something that leads to the occurrence happening. This stresses the need for adequate knowledge and training associated with the particular work activity, for the crew member to be made aware of any associated risks and for crew members to pay attention to what they are doing.

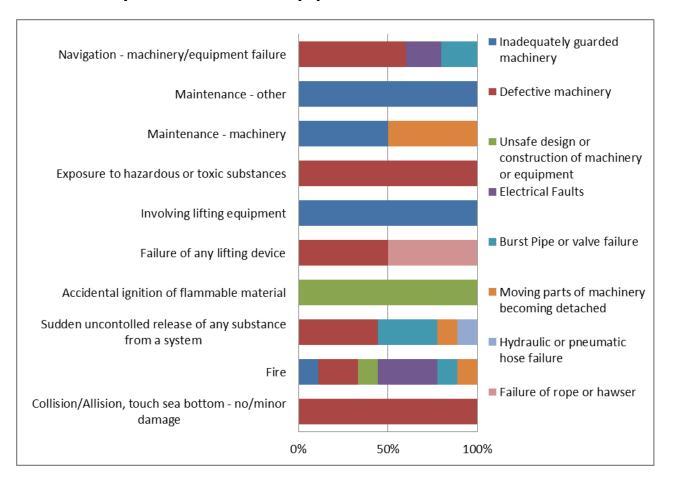
10.5 Occurrences by Mechanical & Other Equipment

In 2018 the predominant mechanical & other equipment has been attributed to "defective machinery". Equipment failure stresses the need for effective inspection and maintenance to ensure they are in good condition and fit for purpose.

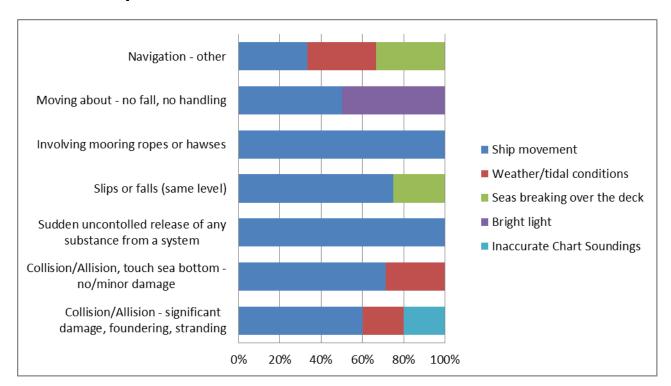
10.6 Occurrences by Other Miscellaneous Causes

In 2018 the predominant 'other miscellaneous cause' has been attributed to "ship movement". Crew members should take into consideration the movement of the vessel in the prevailing sea and weather conditions when planning and carrying out work activities. If the movement of the vessel is too great the work activity should not be attempted or consideration should be given to manoeuvring the vessel to reduce the vessel's movement to an acceptable level.
