Isle of Man Ship Registry

Casualty Investigation Report No. CA 133

“Heather Maid”

Fire

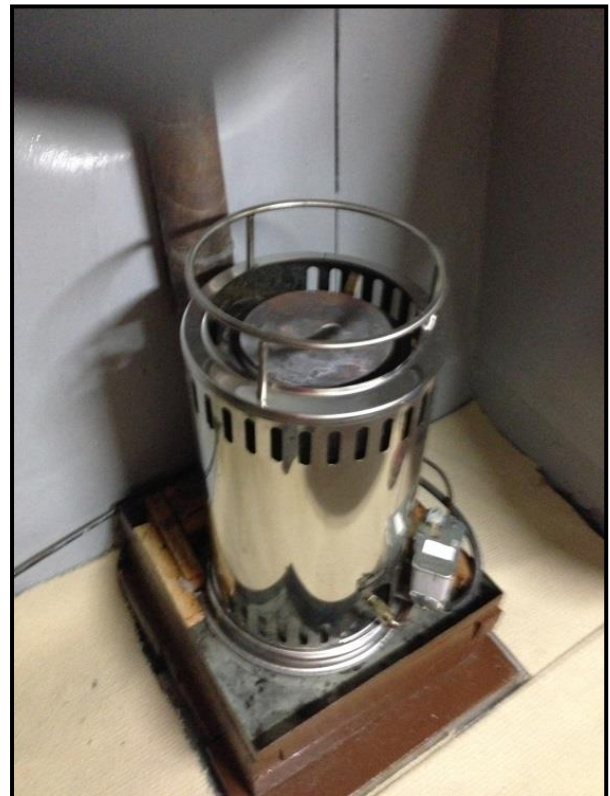
The oil stove, picture was taken in June 2018

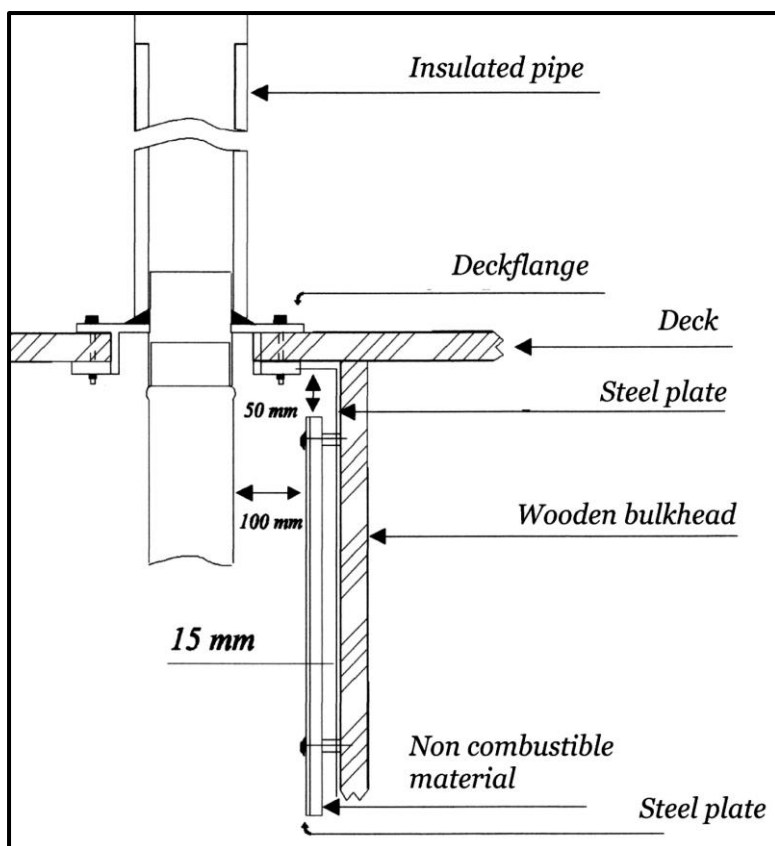
Picture 1. Manufacturer's instructions for installation

Picture 1 illustrates the requirement to have a minimum distance of **100mm** between the chimney and steel plate in front of the wooden bulkhead.

It also shows that there shall be a layer of steel plate and a distance between it and the bulkhead of 15 mm.

The space between the steel plate and bulkhead is designed to allow an air circulation which should create a natural insulation.

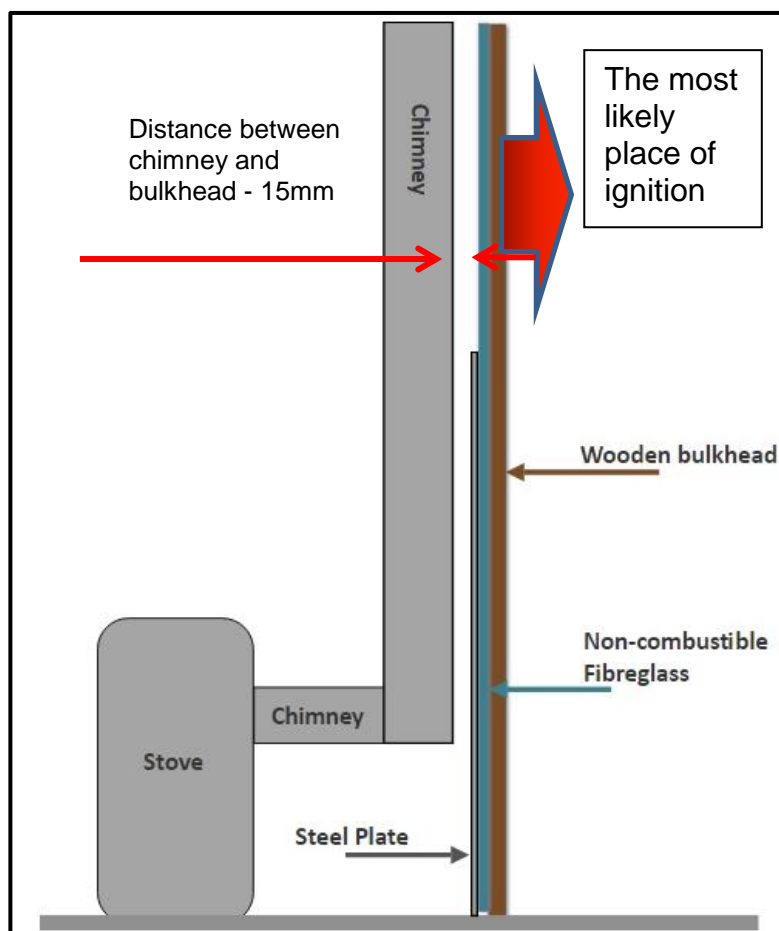
Picture 2. Actual arrangements onboard

Picture 2 illustrates the actual arrangement which was onboard.

The steel plate was installed, but it was not covering the whole surface of the bulkhead (there plate was 1.6 m high, and the 75 cm of the bulkhead remained exposed).

The distance between the chimney and the bulkhead was around 15 mm (100mm is required).

There was a layer of fibreglass material, but its insulation and heat resistance quality is unknown. It was also reported that there was a diminution of resin in the top parts of the fibreglass layer.

There was no space between the steel plate and the bulkhead, as required by manufacturer's instructions.

The lack of insulation and close proximity of the chimney to the bulkhead most likely resulted in direct conducting of the heat to the wooden bulkhead.

1. The results of this investigation are recommended to be released to boat owners and skippers urging that immediate actions shall be taken to ensure that heating appliances are installed in accordance with manufacturer's instructions.

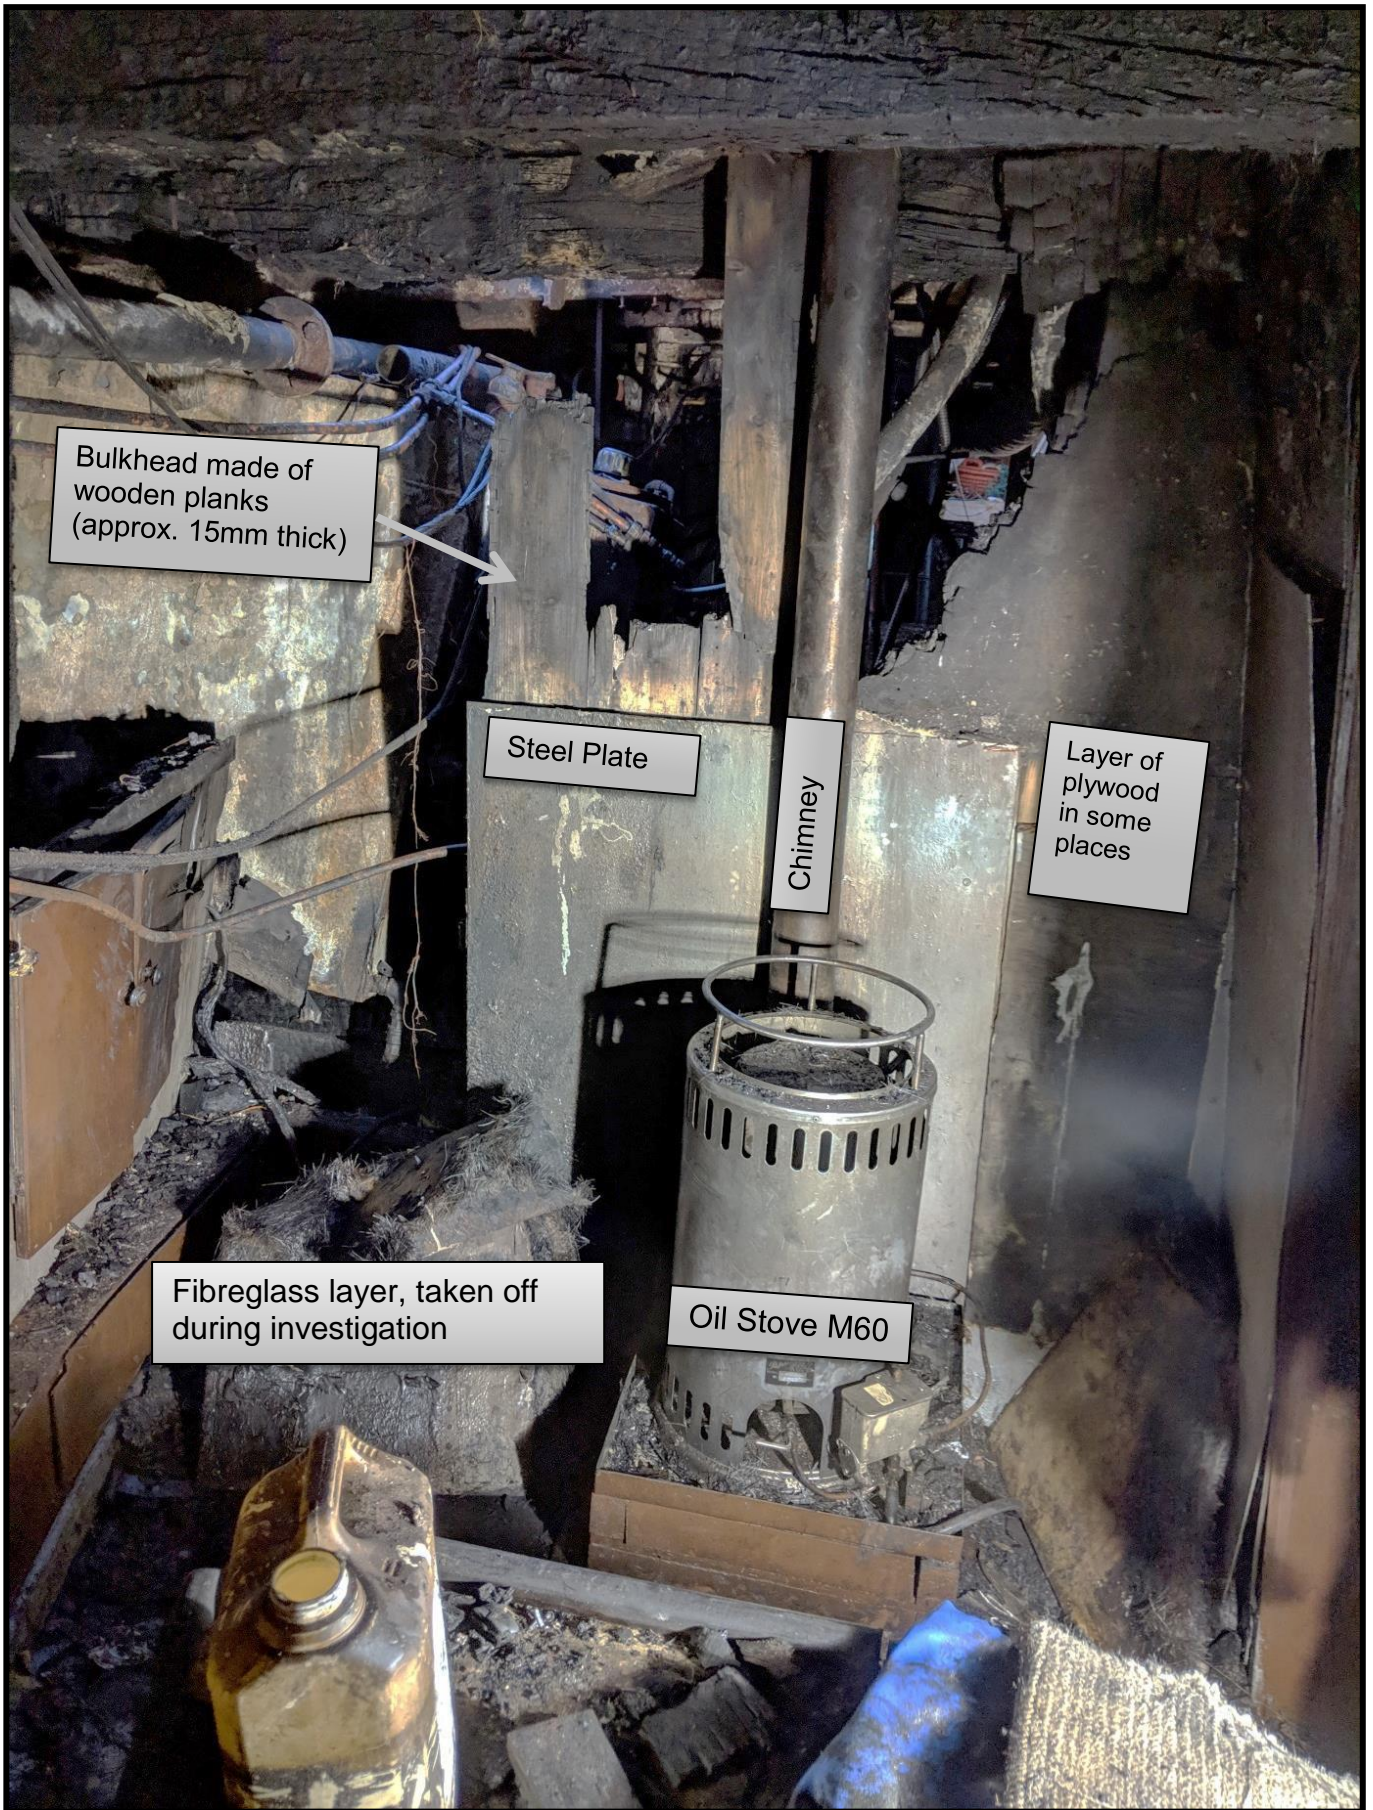
An examination of the fire damage was undertaken by Ship Registry Surveyors and officers of the Isle of Man Fire & Rescue Service. The fire patterns and affected materials indicated that the fire most likely started in the area of the bulkhead, adjacent to the top part of the chimney. The analysis of the manufacturer's manuals revealed that the surface of the chimney on maximum setting can reach 250°C. According to "*Kirk's Fire Investigation*" (7 ed., by John D. DeHaan and David J. Icove), the various contents of wood are subject to *pyrolysis** at the temperatures of 200°-500°C.

It can be concluded that prolonged exposure to the heat most likely resulted in decay and charring of the wood and subsequently to smouldering/combustion of the wooden bulkhead.
