Isle of Man Ship Registry

Casualty Investigation Report No. CA 135

"POLARIS"

Sinking

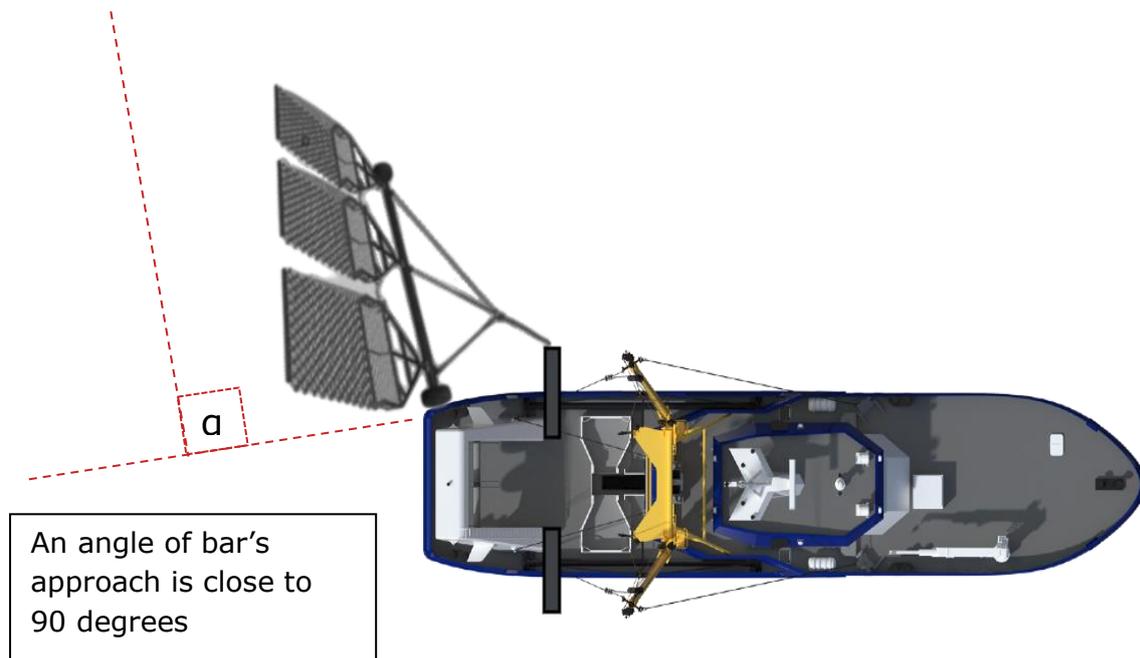
Example of heaving (pulling) the dredges and securing them on board at right angles

When bar approaches at right angles, it involves more risks due to inevitable contact with the vessel's hull. Situations like this shall be avoided, however due to sea conditions and rigging arrangements it may not always be possible.

Figure 5, angle of approach. Models' source - Scottish Marine and Freshwater Science Vol 3 No 7, and www.pngbarn.com

According to statements provided by the skipper, the flooding started after or during picking up the dragging gear, but it was noticed when the gear was already out of the water and in the process of being secured alongside. The skipper also confirmed that the towing bar approached the hull at the right angle (approximately 90°) and could hear the gear hitting the hull. It was explained that it happens often and it was assumed the boat was designed to withstand the impact.

3. Skippers and crew shall be mindful about gear's speed and direction during final stage of recovery and the potential damage the gear can make to the hull when approached at right angle.

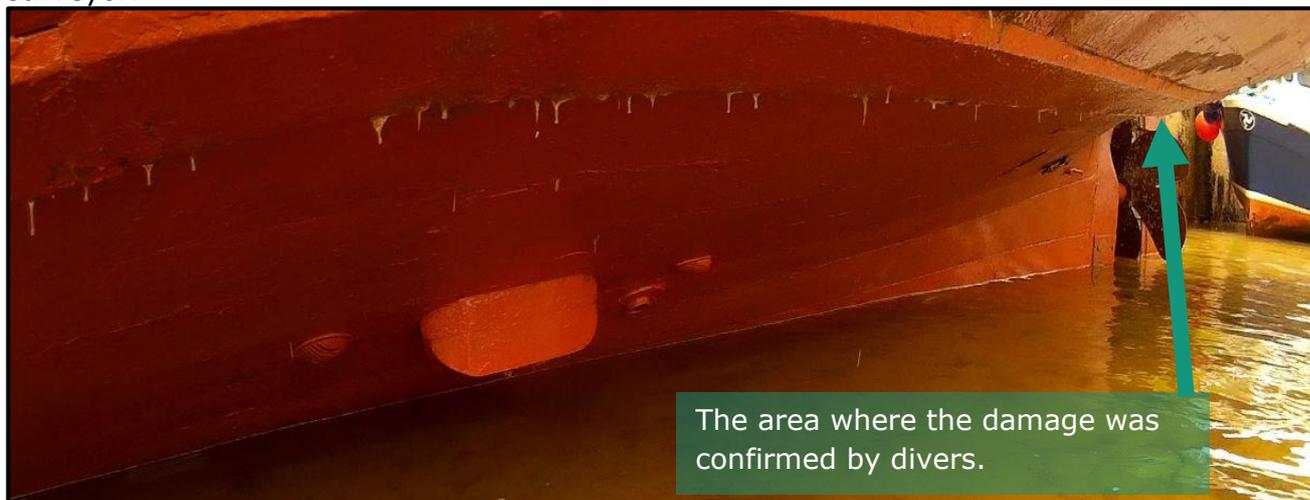
Figure 6. Port quarter/ May-2018

The hull was made of wood (planks with caulking in between planks). The hull was last inspected in May 2018 during out water inspection and found satisfactory by the attending surveyor.

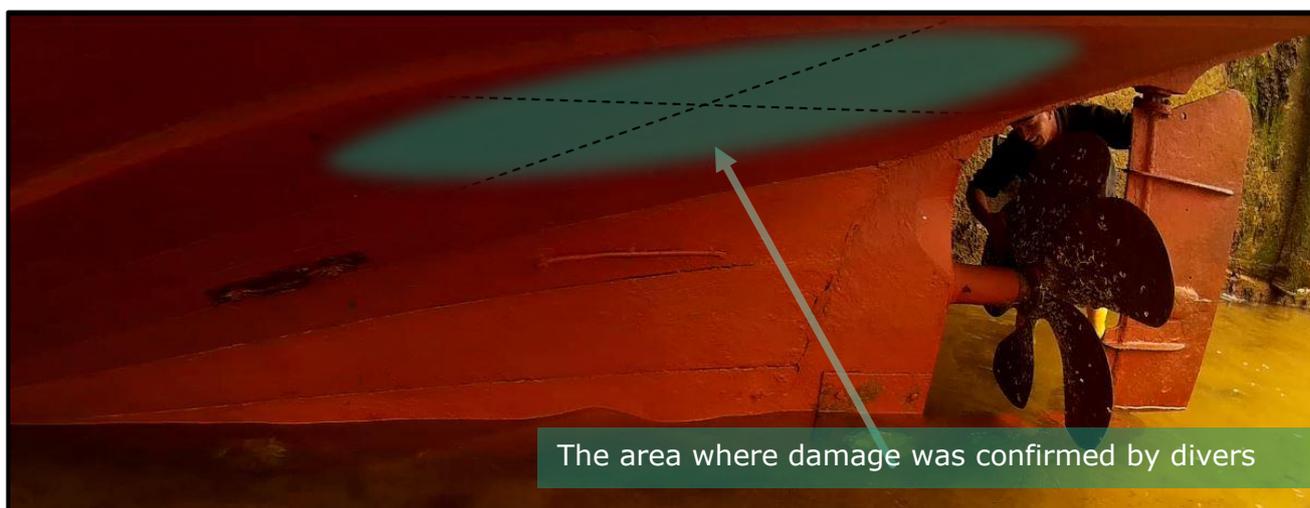
Figure 7/ Port quarter / May-2018 / The area where damage was confirmed by divers

Divers inspected the wreck on 23rd January at a depth of 40.5m (+/- tide). The visibility was poor due to sediment. The findings confirmed what was suspected by the skipper- there was hull damage (a hole) in the area of the port quarter. The size of the hole was approximately 1m².

The underwater survey revealed that the plank was missing on the port side and the edges of the neighbouring planks showed evidence of forcible loss with splintering damage. The damage most likely occurred before the vessel touched the seabed because there were no missing planks in the vicinity of the hole.

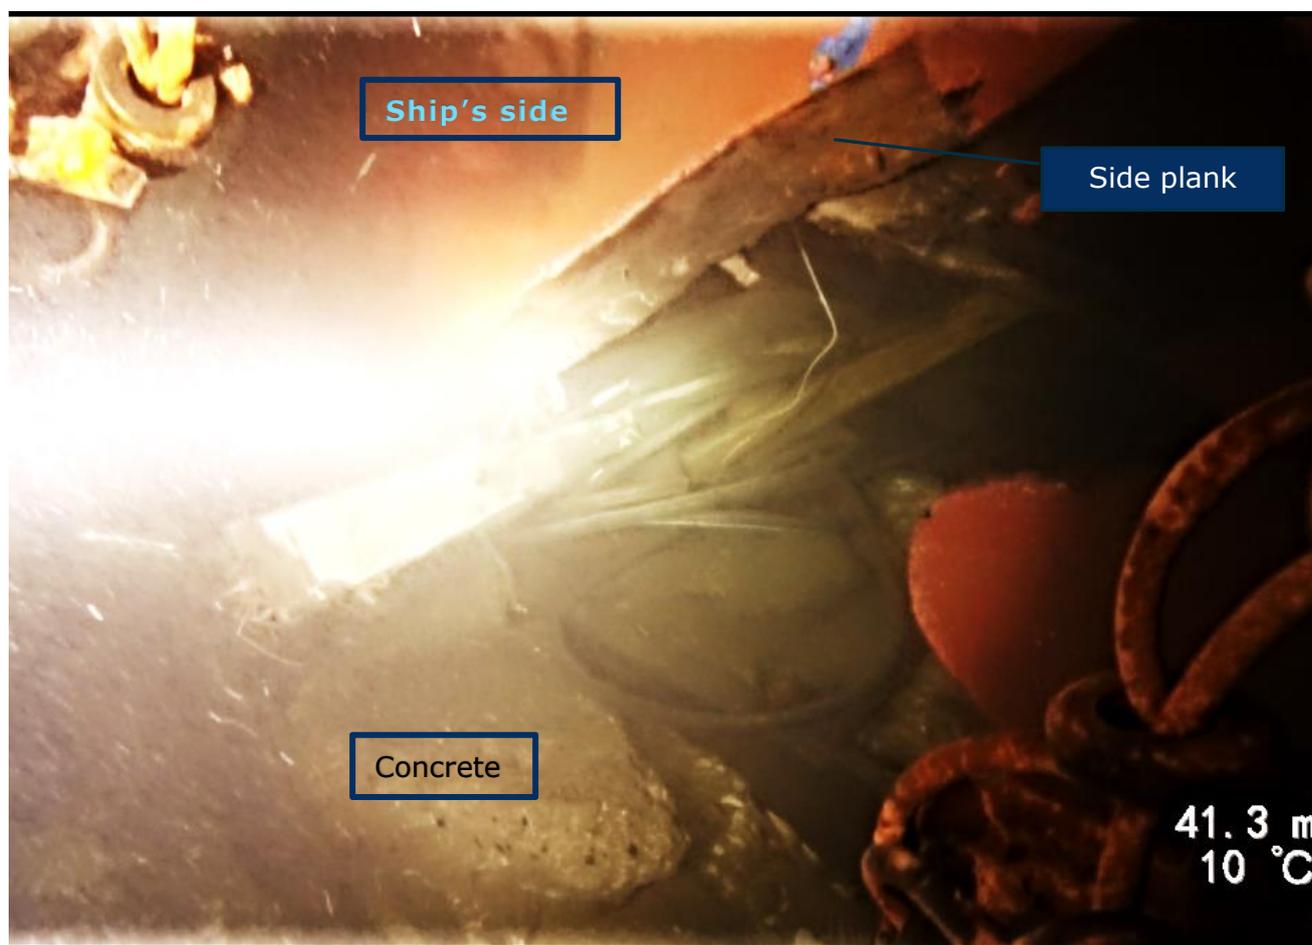
Figure 8 / port quarter damage

The presence of **concrete** blocks under the damage indicates that it was most probably used as ballast and was put over the wood planks on the inner side of the hull. This was also confirmed by the skipper, that concrete was in place and put there by one of the previous owners. The shape of the edge of the damaged **side plank** may indicate that the wood was weakened by rot. However, it cannot be concluded that this was the primary and the only reason of hull failure.

3. The visual appearance of the planks in the damaged area, and the fact of unexpected hull failure may indicate that the hull was affected by rot. The presence of concrete may indicate that areas of inner hull which were covered by it could not be accessed for visual inspection and therefore potential deterioration could not be identified. This, however, may not be the primary reason for the damage to the vessels hull.

1. The use of concrete as permanent ballast on wooden boats shall be avoided where possible. If use of concrete is the only option to meet stability criteria, consideration should be given by the owners to how the inner part of the hull can be inspected. In any case, preference shall be given to concrete in bags or blocks, which can be safely secured and removed for inspection of hull.
