Isle of Man Ship Registry

Casualty Investigation Report No. CA 114

M/V ELBE MAX

MAN-OVERBOARD FATALITY

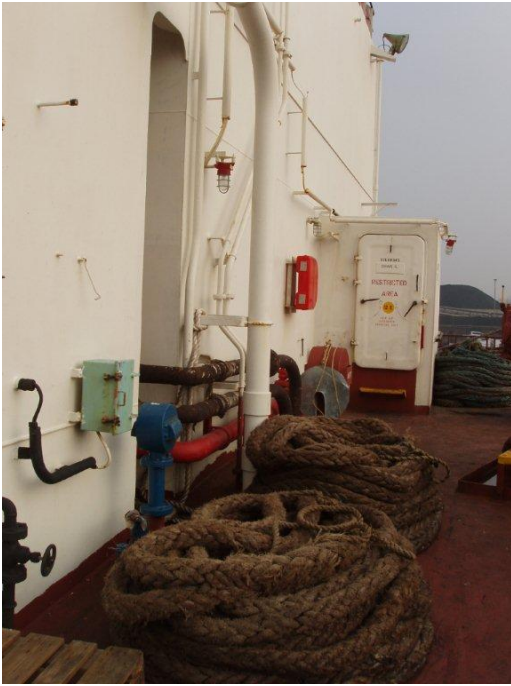
Three mooring lines were stowed on wooden pallets adjacent to the port side of the aft bulkhead of the engine casing in accordance with common practice on board this vessel. Lines were secured in place using lashing ropes attached to adjacent piping and to steel lugs temporarily welded to the deck, a 'herring-bone cage' pattern of lashings being reportedly typical. It was stated that lashing ropes do not pass through coils' centres.

Aft deck mooring lines - stowage location looking to starboard. Provision of temporary lugs and lashing ropes not shown.
(photographs taken post incident)

- Amend procedures to require that all mooring lines be stowed below decks during long passages and most particularly when there is a risk that the vessel may encounter heavy weather.

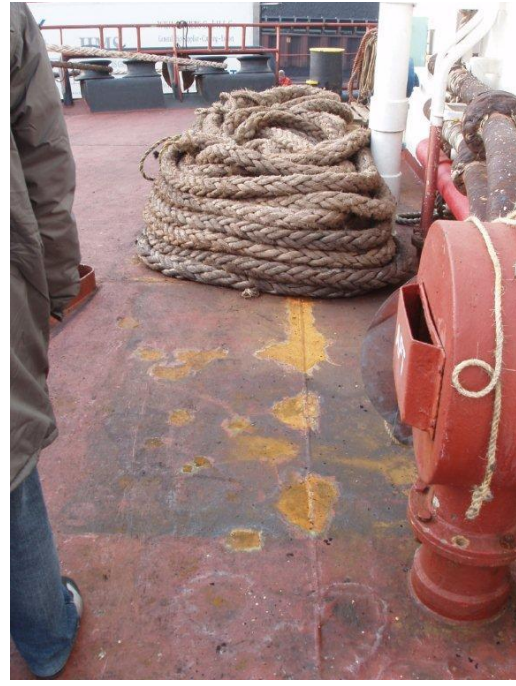
Aft deck mooring lines - stowage location looking to port

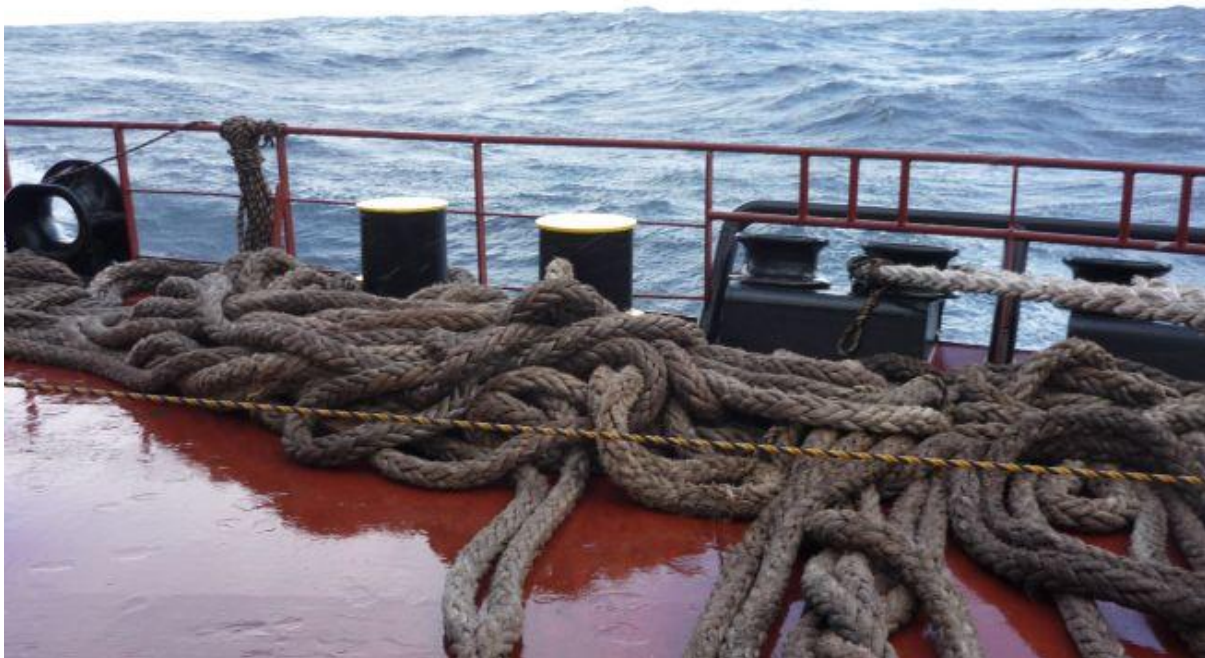
On 16 February, it was noted that one of the vessel's aft mooring lines had become partially detached from its poop deck stowage position.

Loose mooring lines – photograph taken by crew on 16 February

- Issue fleet instructions regarding the method by which mooring lines are to be secured for ocean crossings particularly when heavy weather is expected, either by:

- More effective securing on deck
 - Stowage of mooring lines under deck in forward and aft stowage spaces.
- Consider the replacement of the make/type of smoke & light float found on board Elbe Max and on other vessel's within its fleet following consultation with the manufacturer.

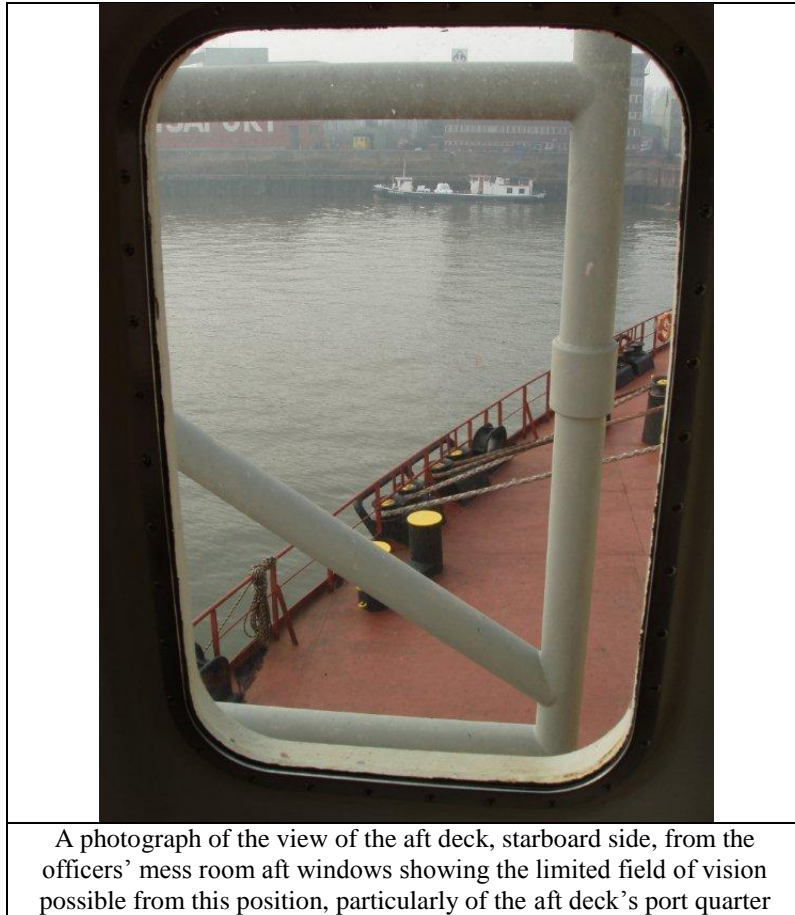
A photograph of the view of the aft deck, starboard side, from the officers' mess room aft windows showing the limited field of vision possible from this position, particularly of the aft deck's port quarter

that the third officer might not be able to hear his VHF radio clearly if he were stationed on the open deck. From this vantage point however, the third officer's view of the port quarter, the direction from which waves were most often meeting the vessel, was restricted – waves could not be seen from this position until very shortly before they struck the vessel. Positioning a lookout within the crew mess room on the port side of the vessel, from which a view of the prevailing sea conditions would have been better, was not considered.

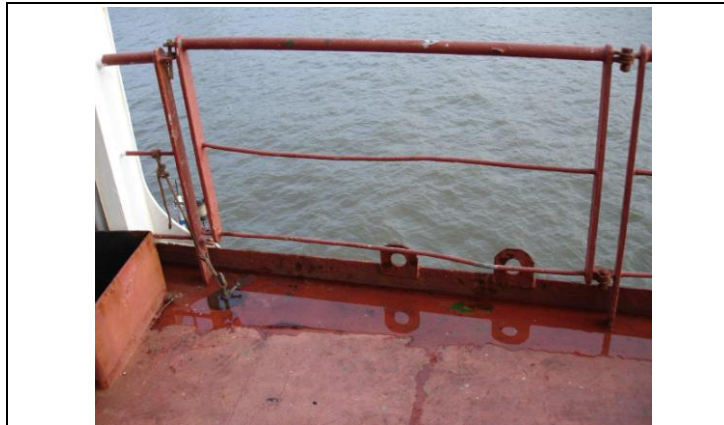
The bosun and chief officer were the first to emerge from the gymnasium to the athwartship passageway between engine casing and accommodation aft bulkhead. After clearing some loose dunnage which was blocking their route to the aft deck, the bosun and chief officer noticed that the hinged rail section of the aft starboard bulwark was open, having apparently been struck by a loose pallet. The hinged section of bulwark rail was slightly deformed. The bosun proceeded to close and secure the hinged rail section as best he could.

A photograph of the aft starboard hinged rail section showing deformation reportedly caused by the loose pallet
