Isle of Man Ship Registry

Casualty Investigation
Report No. CA116

**Isle of Man Registered “Iron Queen”
Enclosed Space Fatality and Near Fatality**

25th November 2011

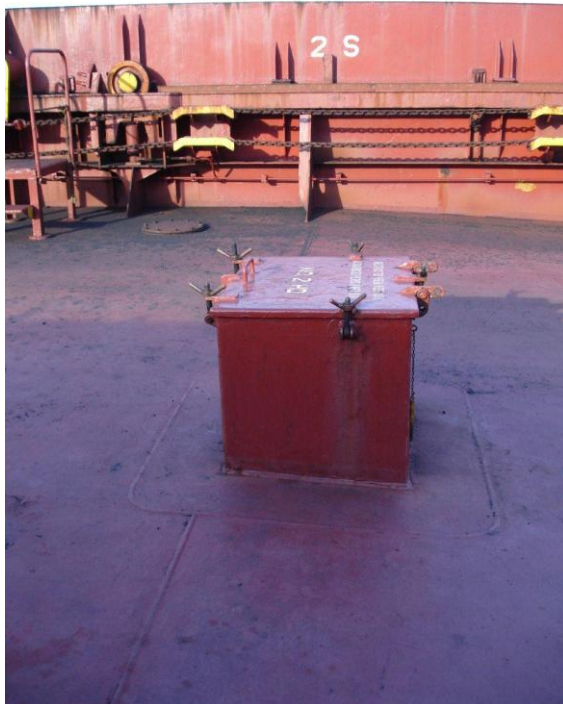
Hold #2 Aft main deck access hatch

Entering the hold access space under such atmospheric conditions is extremely dangerous since the atmosphere is not sufficient to support human life. Human life expectancy in such conditions is severely limited without appropriate safety equipment and procedures. IMSBC Code 13.2.12 references IMO Res A20/864 “Recommendations for Entering Enclosed Spaces Aboard Ships” – see Appendix 2. These recommendations are therefore a requirement when entering a cargo hold space when coal cargo is being carried on board ships.

- There is single entry;
- Poor ventilation;
- The cargo hold was full of coal that caused oxygen depletion;
- Crew members would not have a need to enter the space under normal operating conditions after the cargo hold had been loaded;

In order for a person to safely enter the space without the aid of safety equipment the space needs to be thoroughly ventilated with the access hatch and main cargo hatch covers open and only when the cargo hold is empty or nearly empty. This condition frequently arises when the ship is in port discharging cargo and the crew would use the access space for hatch cleaning and inspection.

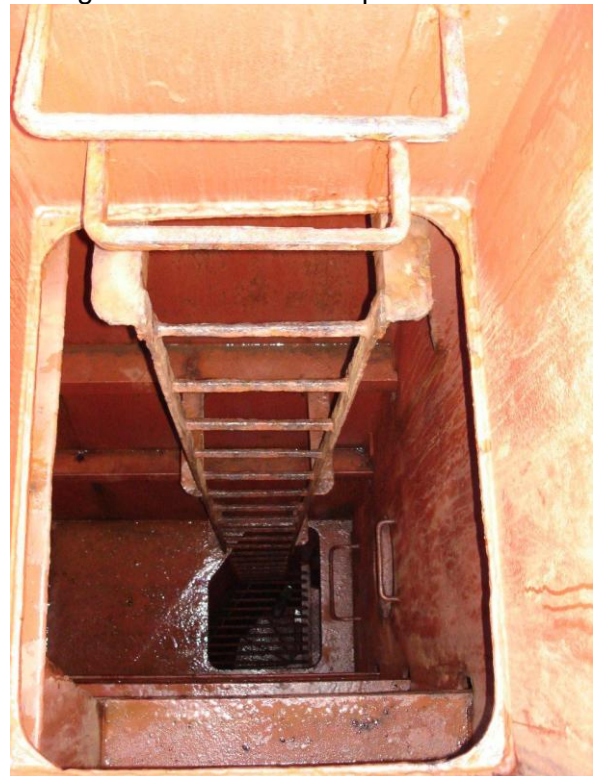
Looking down hold #2 aft access hatch from the main deck

When the vessel arrived in Rotterdam on the 25th Dec 2011 the atmosphere of hold#2 aft access space was tested, the results were as follows:-

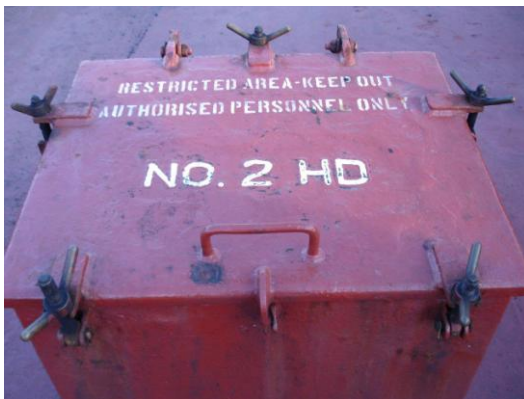
The hold access hatch lid was secured using the clamps (not locked to prevent access). There were no notices displayed indicating the danger of entering the space. A breakable security seal was fitted to the lid following a stowaway search earlier in the day.

The notice stated on the access hatch lid is a security notice specifically aimed at non-crew members.

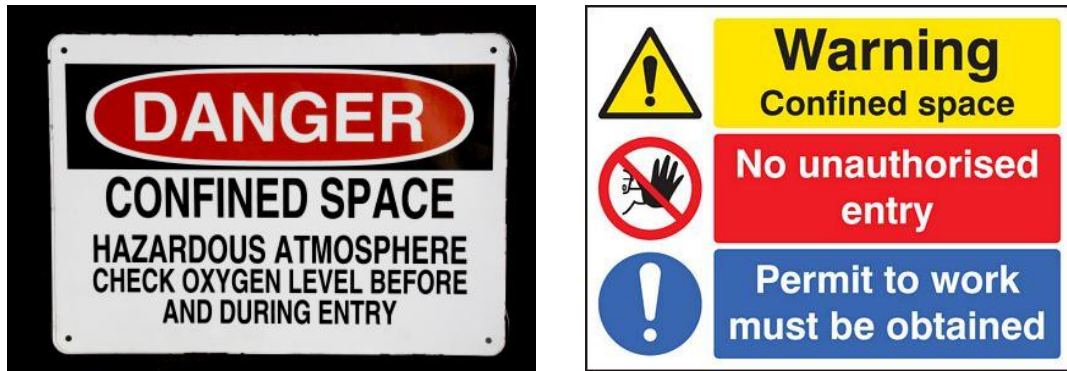
There are no specific notices prescribed by IMO signifying enclosed spaces however several types of enclosed space notices exist commercially such as the following examples.

It was noted that some of the crew members could not speak English. If such a notice (in English and native crew language) were in place to remind the crewmen of the dangers it is speculative how effective a deterrent this would have been to prevent the crew members entering the space.

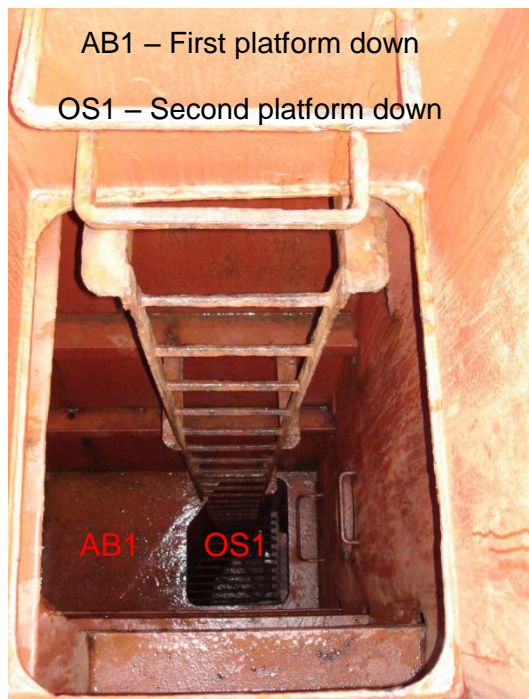
The first rescuer entered the space on-air with a safety line attached approximately 8 minutes after the alarm was raised. He noticed AB1 collapsed and unconscious on the first platform down as shown below.

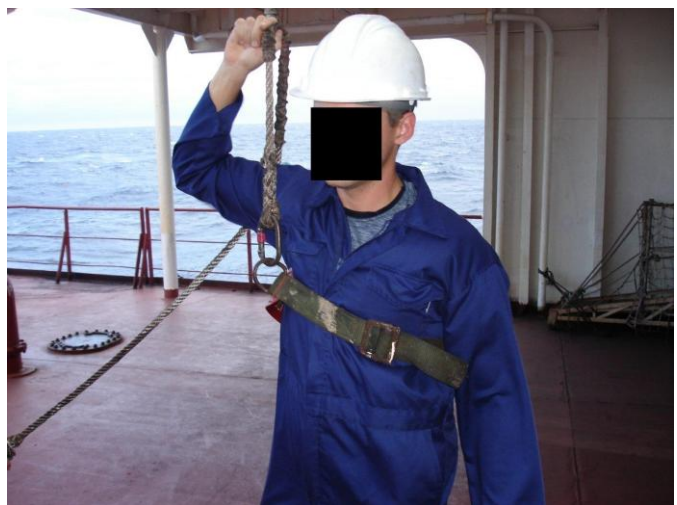
Picture below shows how the injured crewmen were extracted from the space.

On reaching the first platform the rescuer attached a safety belt under AB1’s arms similar to the above picture. AB1 was hoisted out of the space by crew on the main deck whilst being manoeuvred by the rescuers in the space. AB1 was raised to the main deck 4 minutes after the first rescuer entered the space. The rescuers re-entered the hold access space straight
