Report on the investigation of
the grounding of the ro-ro freight ferry

Arrow

in the approach channel of Aberdeen Harbour
on 25 June 2020

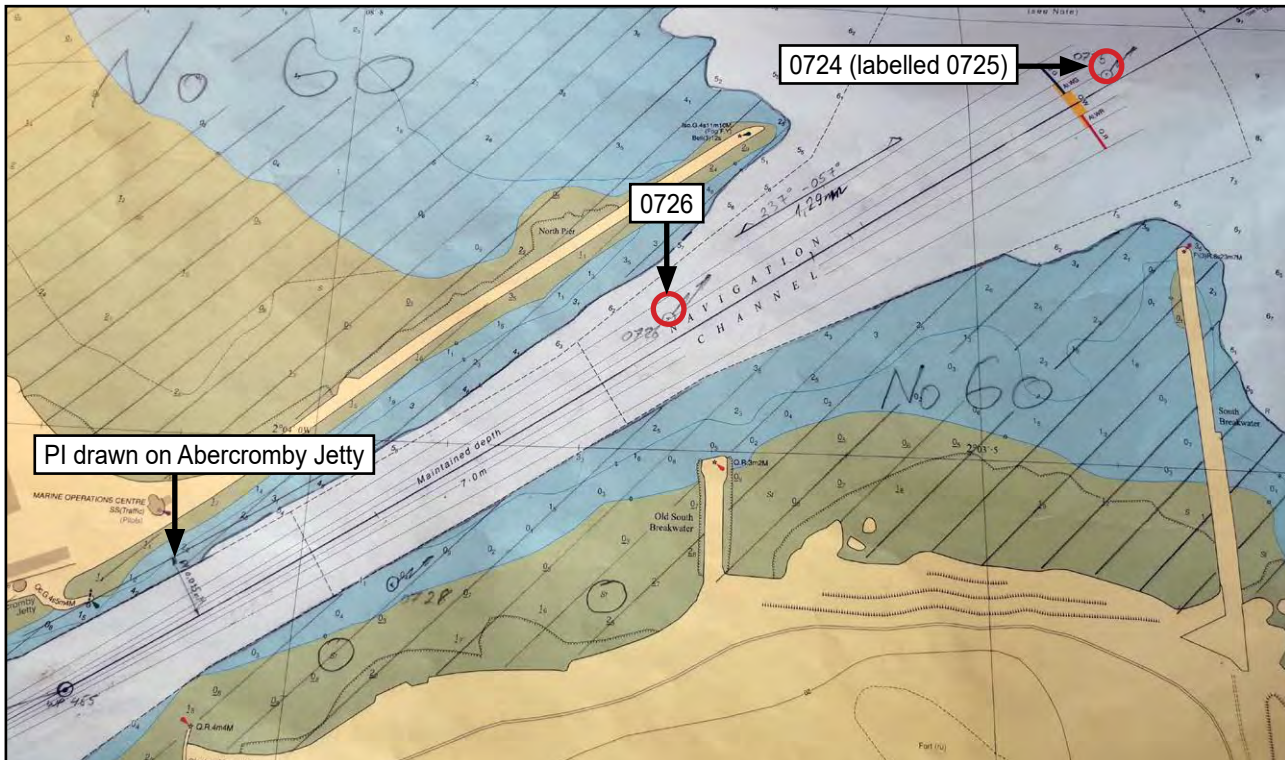
Figure 10: Extract from Chart 146 showing fixes at 0724 and 0726, both to the north of the centreline

At 0724, *Arrow's* 3/O plotted a Global Positioning System (GPS) position on the chart which was marked as 0725. The position indicated that the ship was north of the planned track (**Figure 10**). A further fix was plotted at 0726, showing the vessel just to the north of the centreline. This position was not recorded in the log, and it is not clear if this was reported to the master and the PEC holder.

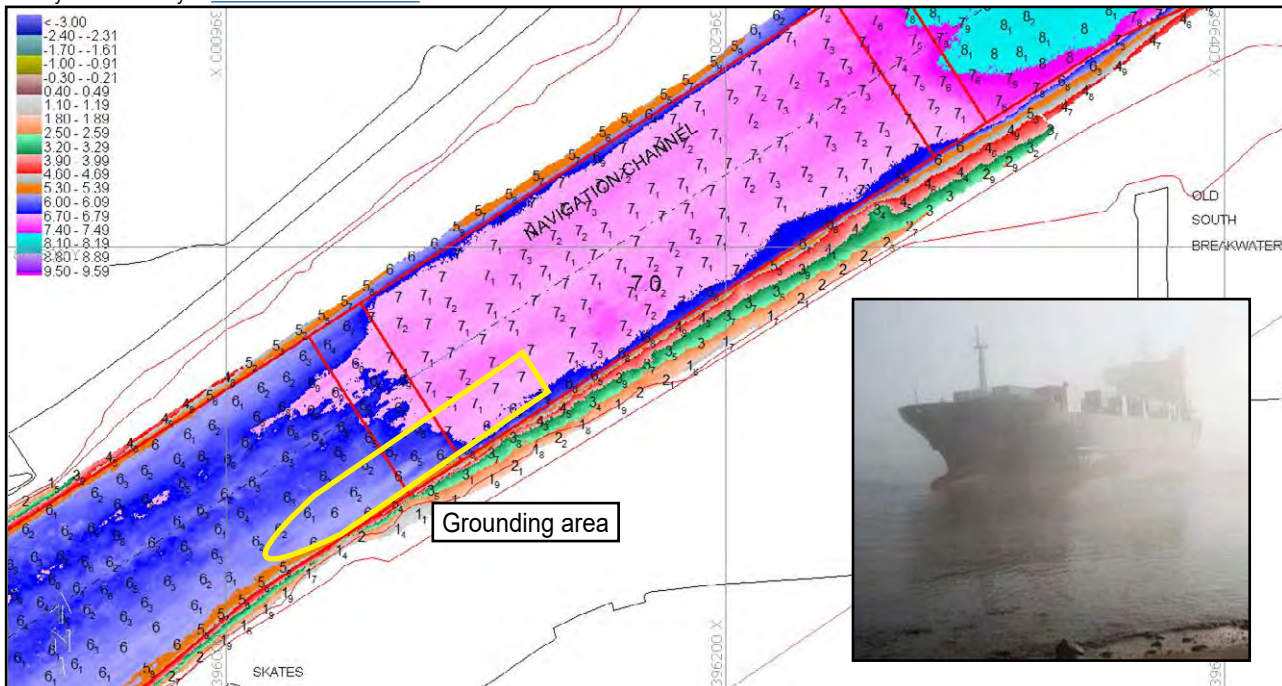
Figure 11: Aberdeen Harbour survey chart of Navigation Channel and *Arrow* aground

Arrow's PEC holder applied about 10° of port rudder to bring the ship back towards the planned track. In response to prompting from the master, the PEC holder applied more helm until there was 30° of port rudder applied. The effect of the helm altered the vessel's heading to 215°, 22° off the 237° base track. *Arrow* rapidly crossed the narrow channel, and after 15 seconds, the PEC holder realised the new danger and applied maximum starboard rudder (35°) to turn the bows away from the channel edge. By now, *Arrow's* bow was very close to the steep southern edge of the channel and while the bows turned to starboard, the alteration was too late. *Arrow* left the channel and grounded at 6.5kts, raking along its port bow and port side before coming to a stop on the southern edge of the Navigation Channel (**Figure 11**) at 0727:10.

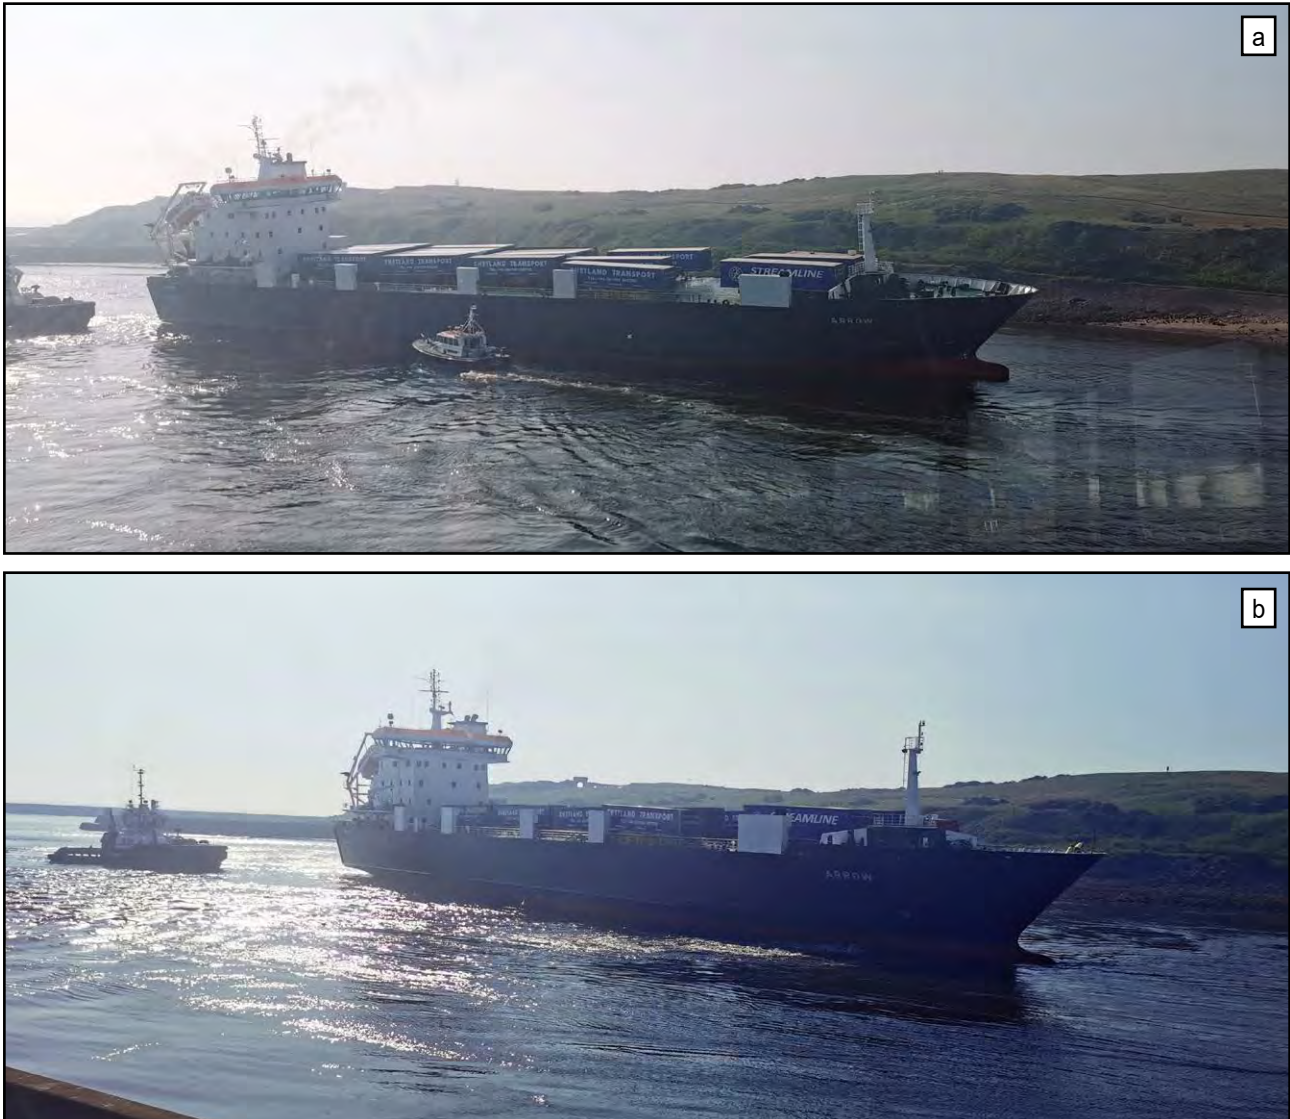
Figure 12: *Arrow* just before re-floating (a) and after re-floating (b)

ferry off the bank. Power from the tug and thrust from the engines and bow thruster were gradually increased until at 0811 *Arrow* slowly moved off the bank and into the Navigation Channel (**Figure 12b**).

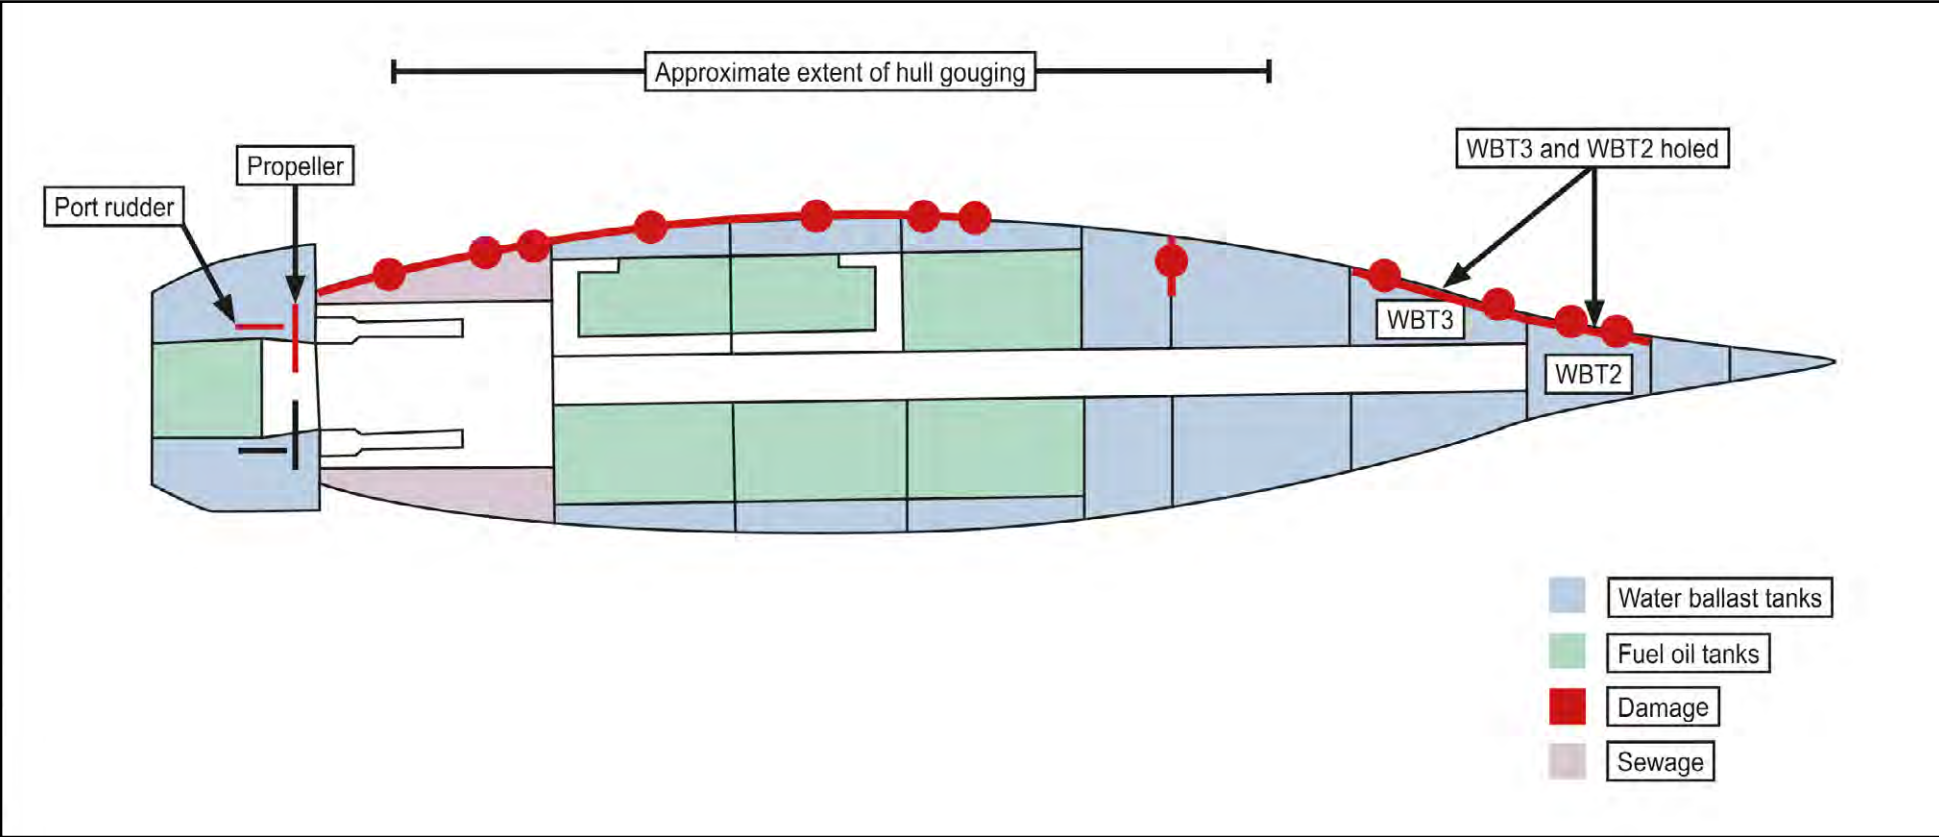
Figure 13: Arrow's bottom tank arrangement showing areas of damage

Once docked, a full assessment of damage revealed holing to Water Ballast Tanks (WBT) 2 and 3 requiring new shell plating (**Figures 13 and 14**), together with further shell repairs to cracks in several other areas on the port side. The port bilge keel was deformed in several places and there was significant scrape and dent damage to extensive areas of the port hull, which needed re-preserving, and in some areas, welding and flush grinding (**Figure 15**). All four port propeller blades showed signs of damage and the port rudder and rudder stock required repairs. *Arrow* was out of service for four weeks.

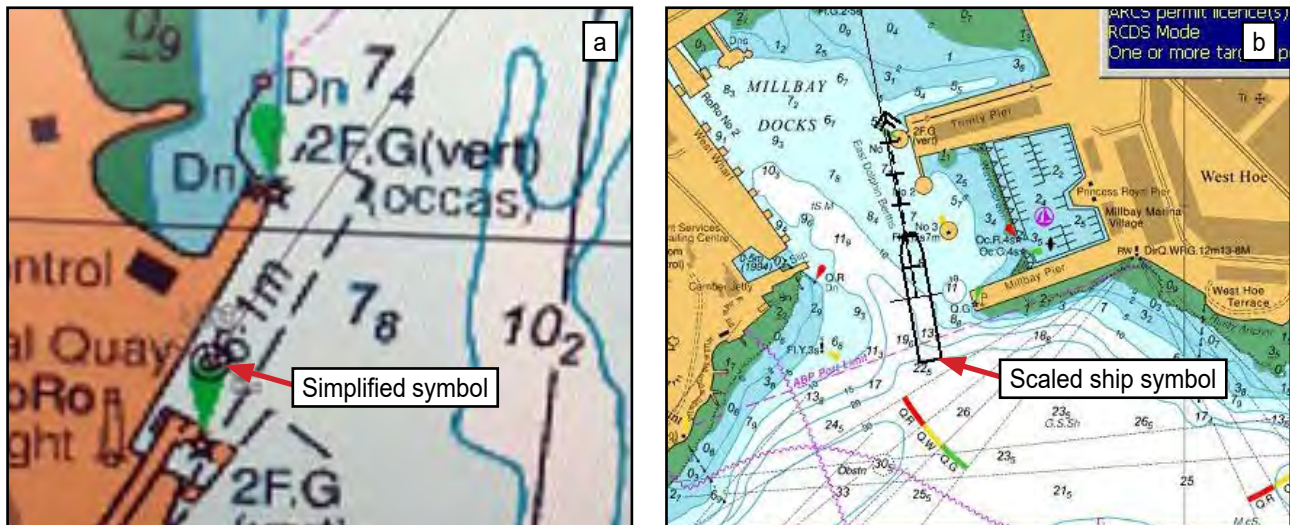
Figure 16: Navmaster ECS software with simplified symbol (a) and scaled ship (b)

On 25 June, no additional information had been loaded into *Arrow's* ECS and the system was displaying a simplified symbol (**Figure 16a**) to indicate the ship's position. Some versions of the Navmaster ECS were capable of displaying a ship outline (**Figure 16b**), provided it was enabled with the correct ship dimensions and antenna position. The shape scaled with the scale of the chart and the system reverted to a simplified symbol at smaller scales. The version of Navmaster ECS installed in *Arrow* did not have this capability. This had been identified by the crew, and enquiries with the manufacturer had been made early in 2020 to try to enable it but had not been successful.

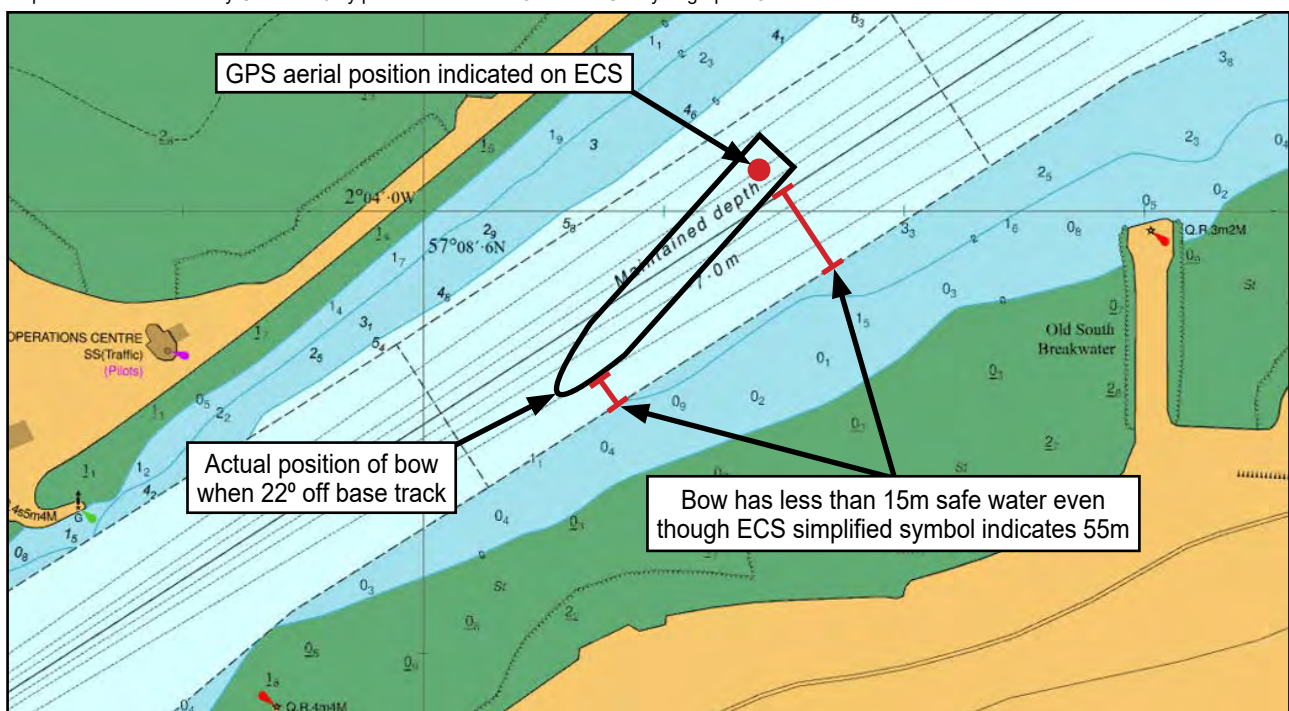
Figure 23: Diagram showing relative position of GPS and radar aerials compared to the bow of *Arrow* when 22° off base track in Aberdeen Navigation Channel

The ECS was not able to display a representative scaled ship shape, only displaying the position of the antenna. On board *Arrow*, the antenna was approximately 100m from the bow, and in such a narrow channel, this can render the display less helpful (**Figure 23**). To be useful in such confined pilotage situations, ECDIS and ECS should be configured to show the shape of the ship, with the correct antenna offsets input into the system. For operations close to navigational dangers, and particularly in restricted visibility, this feature can be valuable as it provides the mariner with a better representation of the position of the whole ship in relation to hazards.
