## ACCIDENT REPORT

REPORT NO 1/2025

### Fatality of the chief engineer on board the motor yacht *Baton Rouge* at Falmouth Harbour, Antigua on 23 February 2024

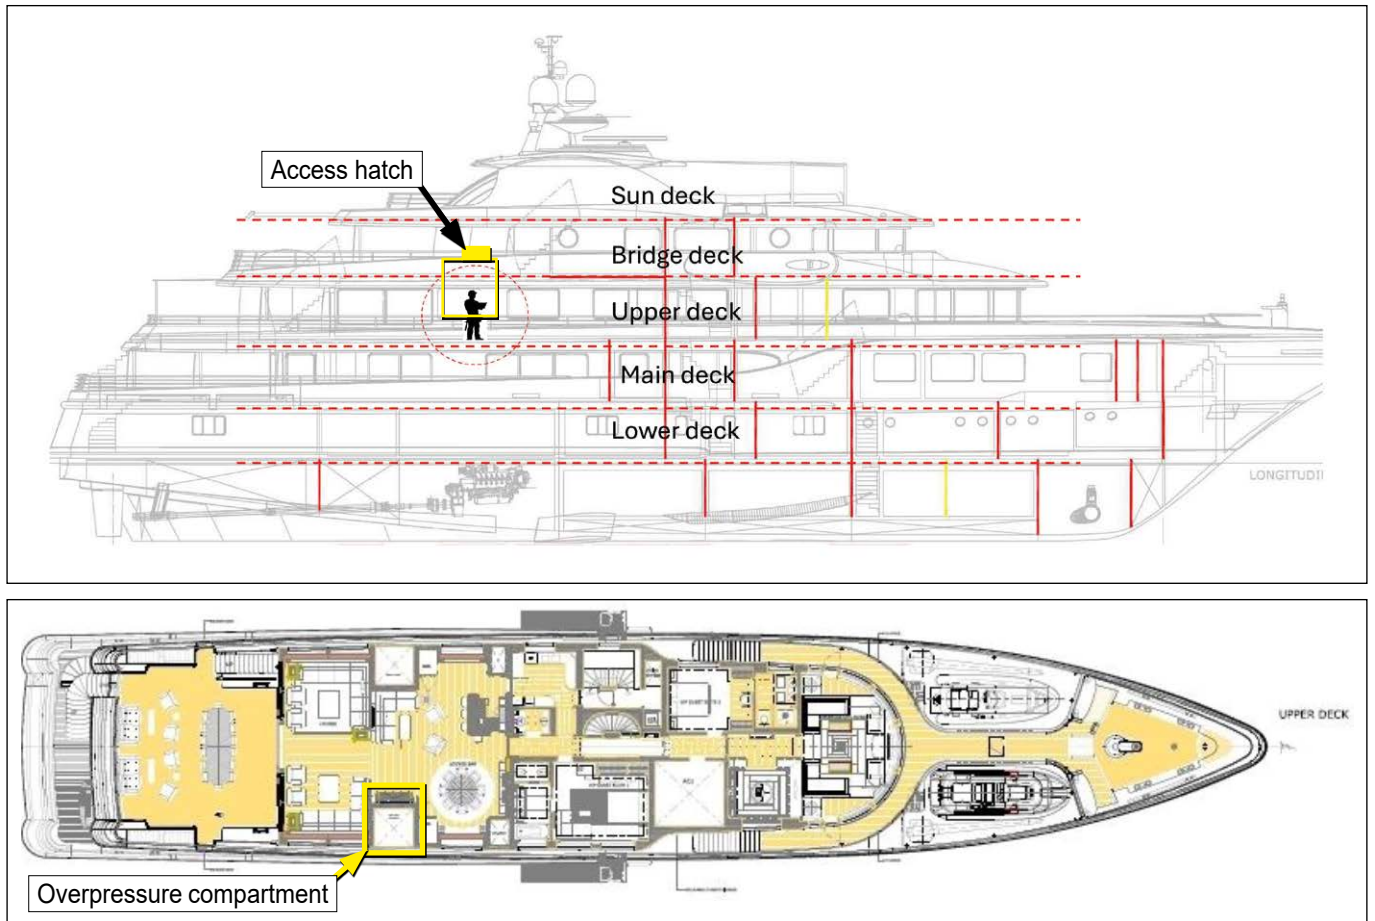
**Figure 1:** Location of overpressure compartment on upper deck

The overpressure duct compartment was approximately 1.74m wide x 1.78m long x 2.12m high. The compartment's bolted hatch cover was located inside a locker behind a bar (**Figure 2**) on the bridge deck. A vertical ladder led down to a platform in the compartment. The overpressure duct compartment contained ventilation trunkings, exhaust uptake pipe work and ventilation fans. The exhaust air from the engine room flowed through the duct and was vented to the atmosphere via a shipside louvre in the compartment. There was no fixed lighting in the duct compartment.

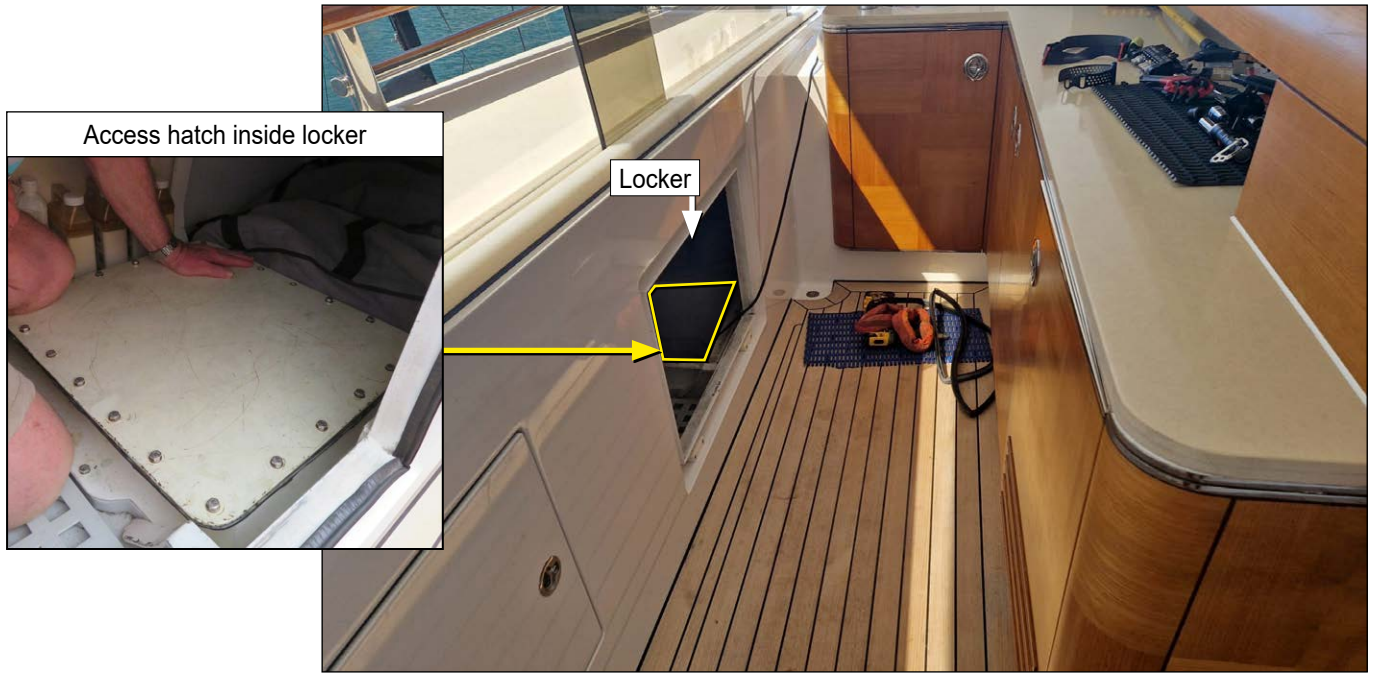
**Figure 2:** Access to overpressure duct compartment

At approximately 2200, the chief engineer (C/E), assisted by the second engineer (2/E), removed the bolted hatch cover (**Figure 2**) and the C/E entered the overpressure duct compartment to inspect the failed ventilation damper. No permit to work (PTW) was issued for this task.

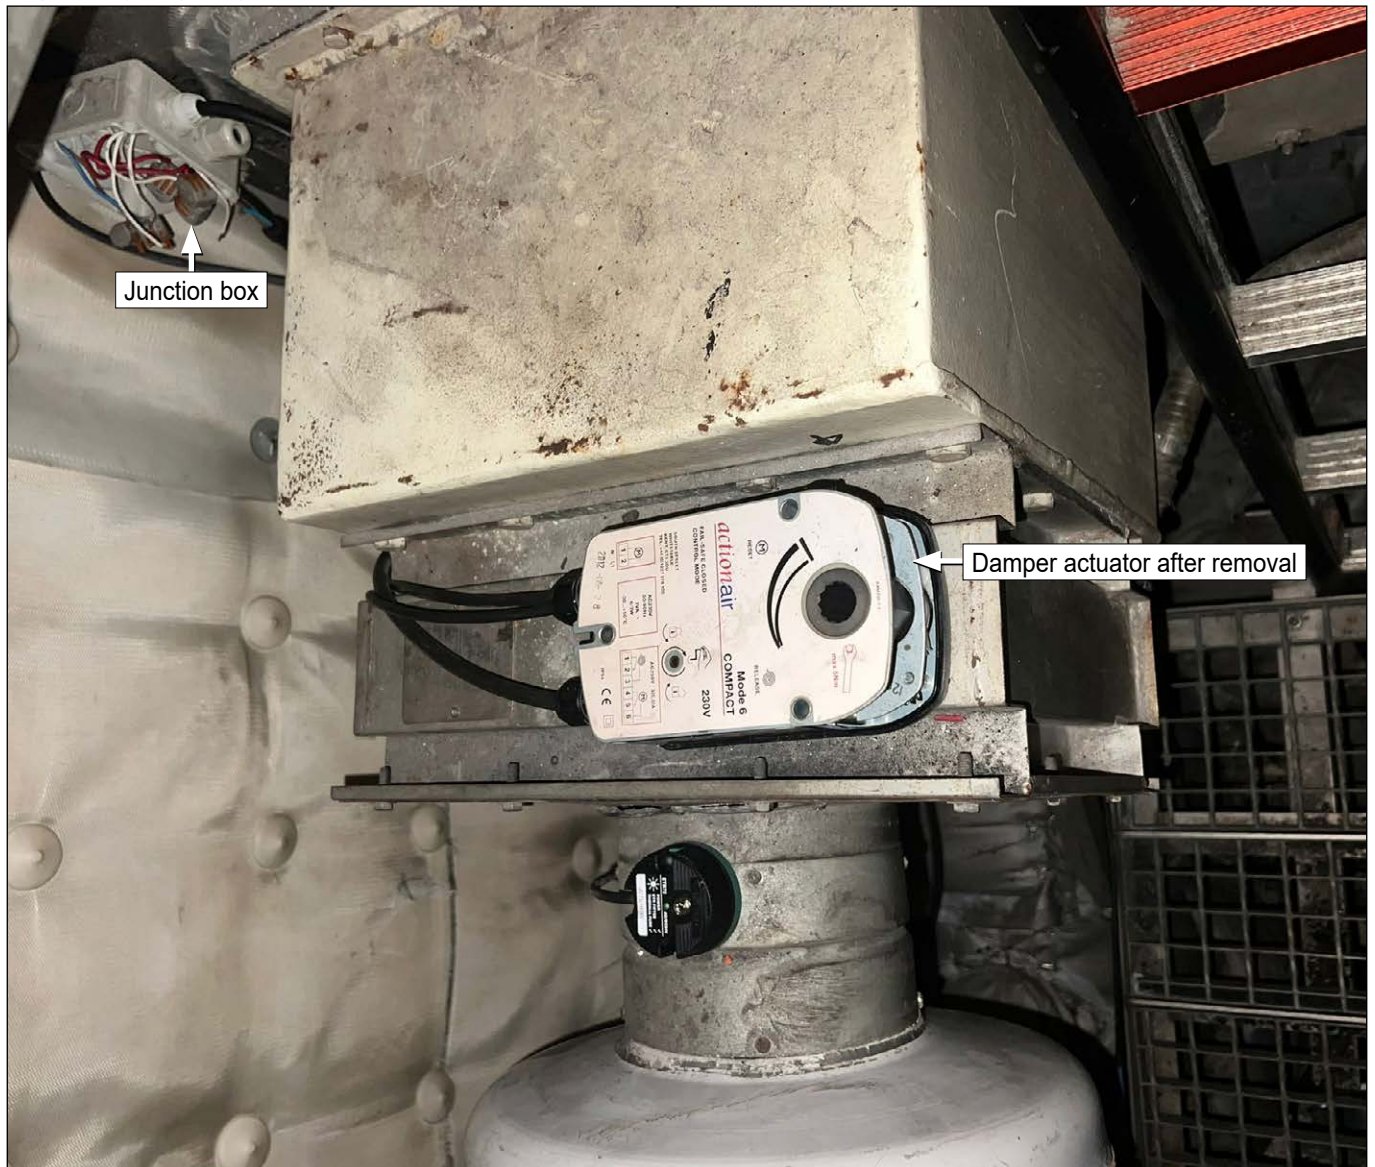
**Figure 3:** Removed damper actuator and junction box showing the wiring

The C/E removed the failed actuating mechanism and opened the damper, leaving the actuating mechanism connected to the 230-volt alternating current (VAC) electrical power supply (**Figure 3**). The C/E then exited the overpressure duct compartment, leaving the hatch cover off to allow for airflow through the duct. The C/E and master discussed the repair and decided the work would be continued the following day.

The UPS was designed to prevent the ventilation dampers closing during a loss of power. However, in this case the UPS failed to prevent the damper closing when the blackout occurred. When the power was restored, the failed actuator prevented the damper from opening, necessitating the replacement attempted by the C/E. The causes of the actuator and UPS failures could not be determined as both had been replaced following the accident and before the investigators were able to attend.

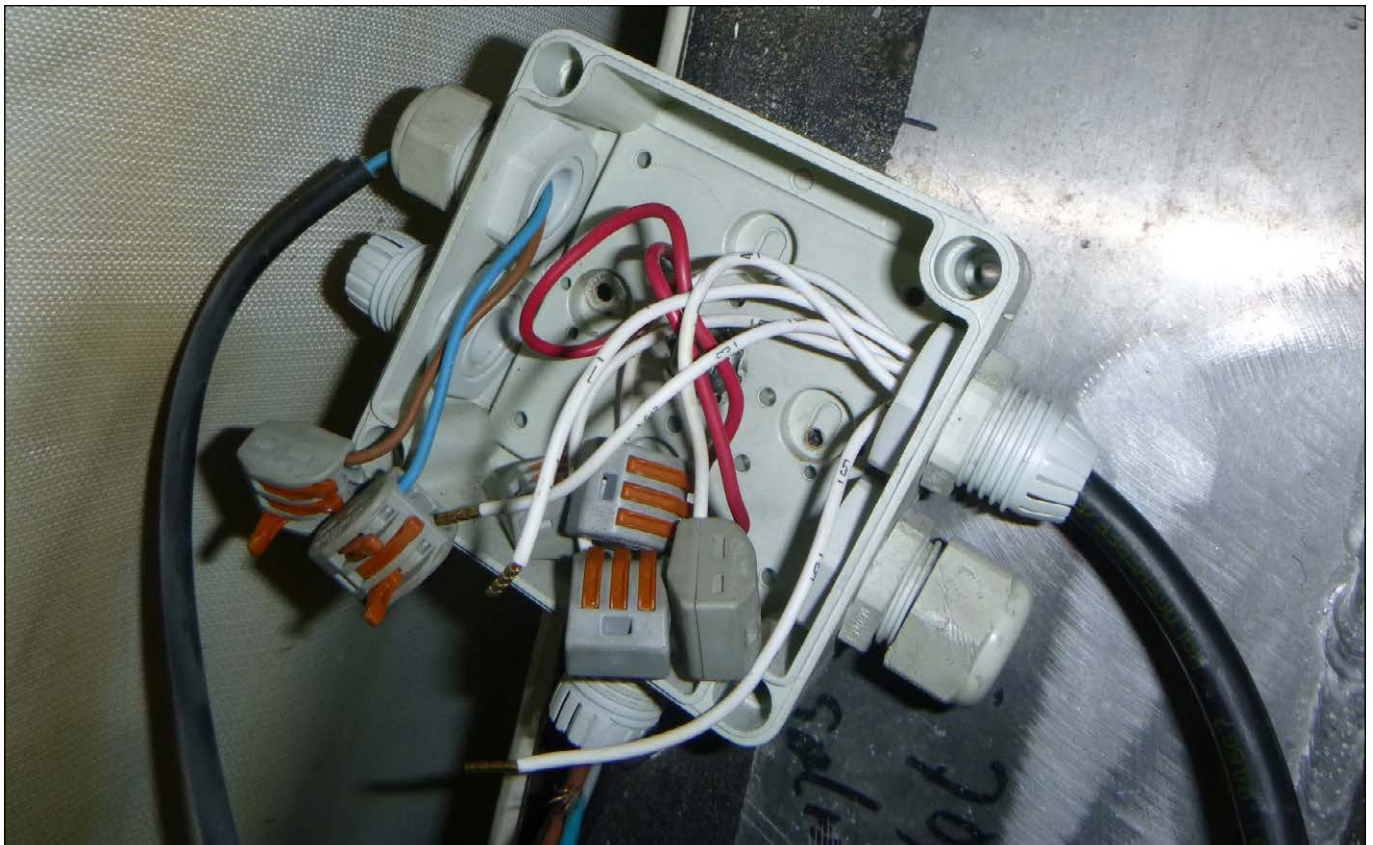
**Figure 4:** Junction box

At 0856, a series of engine room ventilation system alarms were activated on the machinery monitoring system. The 2/E, who was completing tasks in the engine room, observed the alarms and ran to the overpressure duct compartment entrance to inform the C/E. When the 2/E arrived at the entrance they saw the C/E slumped over the ventilation trunking in the space. The 2/E shouted to the C/E but received no response so ran to the crew mess to raise the alarm. At 0858, the alarm was raised via the UHF radio and the C/O immediately ran from their office to the overpressure duct compartment and climbed down the ladder to reach the C/E. The C/O received an electric shock from the C/E when they touched him.

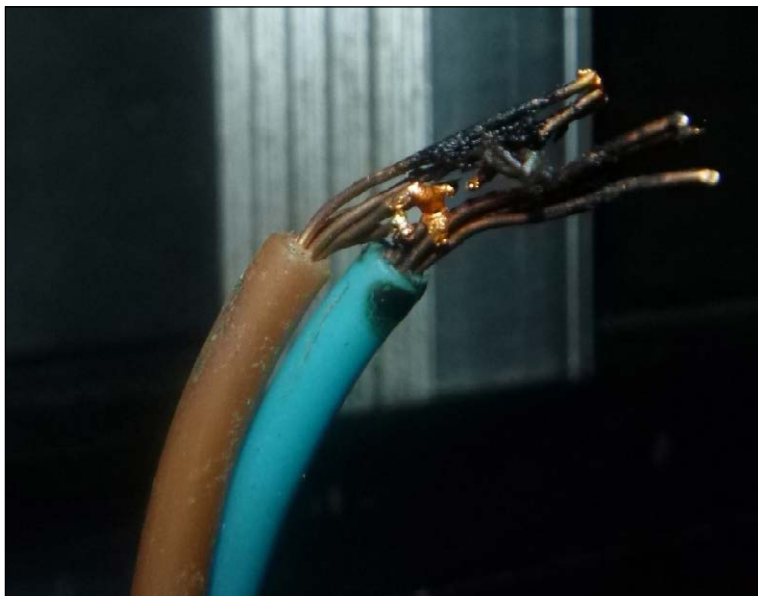
**Figure 5:** Exposed live wires

Following the accident the scene was photographed before the engine room ventilation system was restored. The images showed an open junction box with various wires disconnected from the terminal block (**Figure 4**). The 230VAC feed wire was completely removed from the junction box and was lying on the deck. The exposed live and neutral conductors were melted together and showed signs of burning (**Figure 5**). The replacement actuator mechanism had been fitted to the ventilation dampers but not connected to the electrical circuit.

The electric circuit breaker for the power was in the *on* position. The electric circuit uninterruptible power supply (UPS) was subsequently found to be defective and replaced.

There were no witnesses to how the C/E came to be slumped over the ventilation trunking in the overpressure duct compartment. However, his injuries were consistent with him coming into contact with 230VAC and the burns indicated the entry and exit points of the current as it flowed through his body to earth. The length of time that the C/E was in contact with the live supply can be estimated as a period of several minutes: from the point when the engine room ventilation alarms activated to the point when the C/O received an electric shock upon touching the C/E. Given the level of voltage and the time the C/E would have been in contact with it, this most likely caused the fatal cardiac arrest.

- The C/E was electrocuted because he came into contact with live 230VAC conductors while working on the ventilation damper electric circuit. The reason why the C/E came into contact with the live conductors is unknown.

- Amended its PTW for electrical work to provide greater emphasis on: the elevated risk of electrical shock on board ships; the necessary precautions to be taken before working on electrical equipment; and the need to avoid working on live electrical systems wherever possible.
