Isle of Man Ship Registry

Casualty Investigation

Report No. CA 138

Head injury to crew member from failed lifting equipment

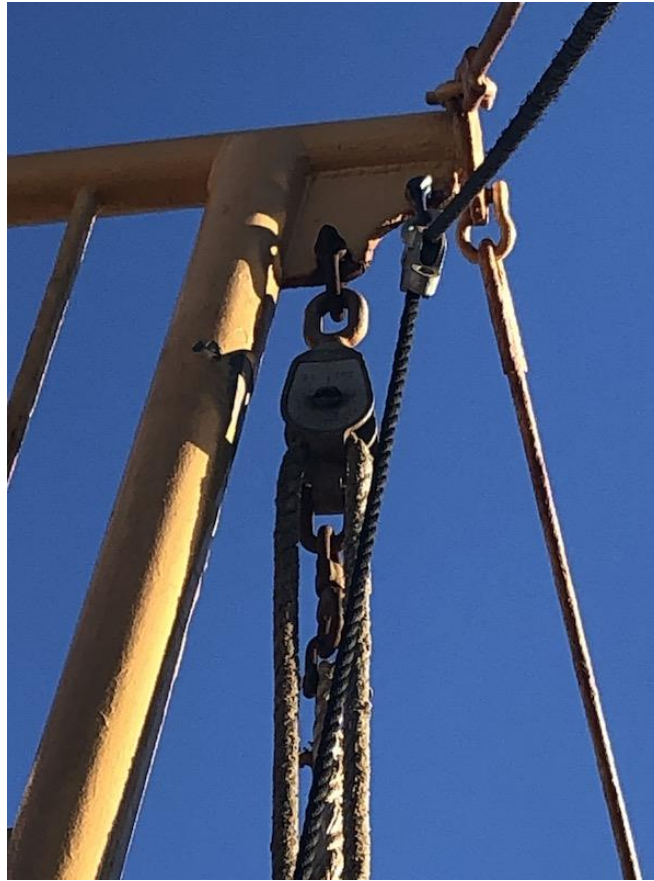
Fig 3 – Upper hauling block attached to port side of H frame

(Sheaves have been ejected)

3.3 - The Skipper heard a noise and saw the crew member had dropped to the deck. The Skipper could see the upper hauling block had failed and the crew member had been hit by something from it.

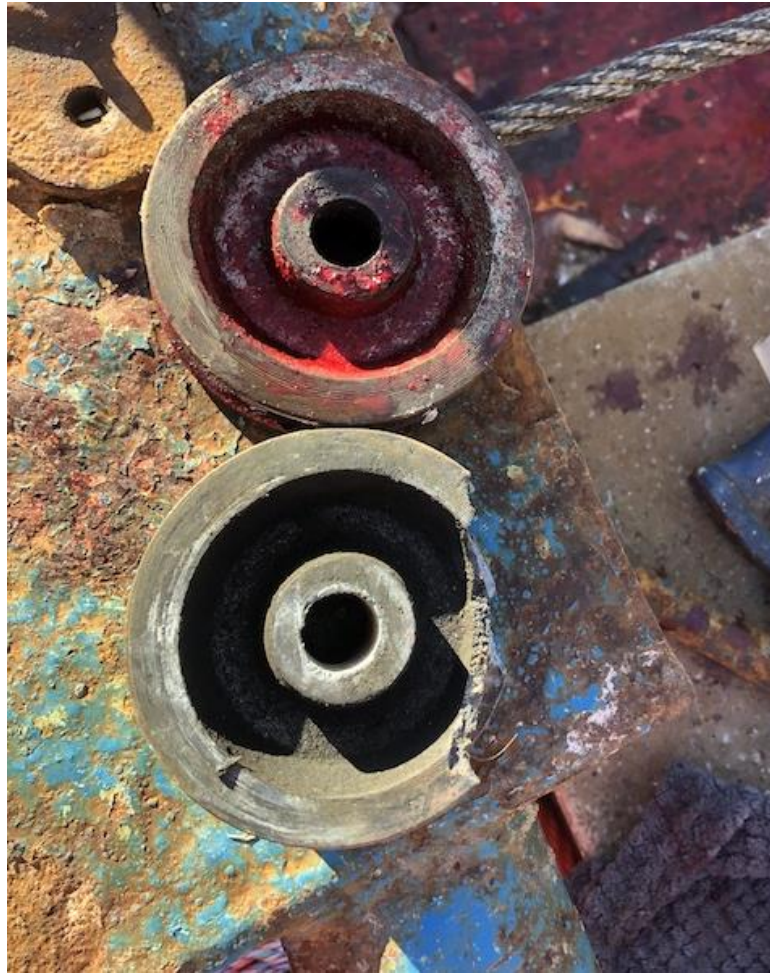
Fig 04 - the two sheaves from the block

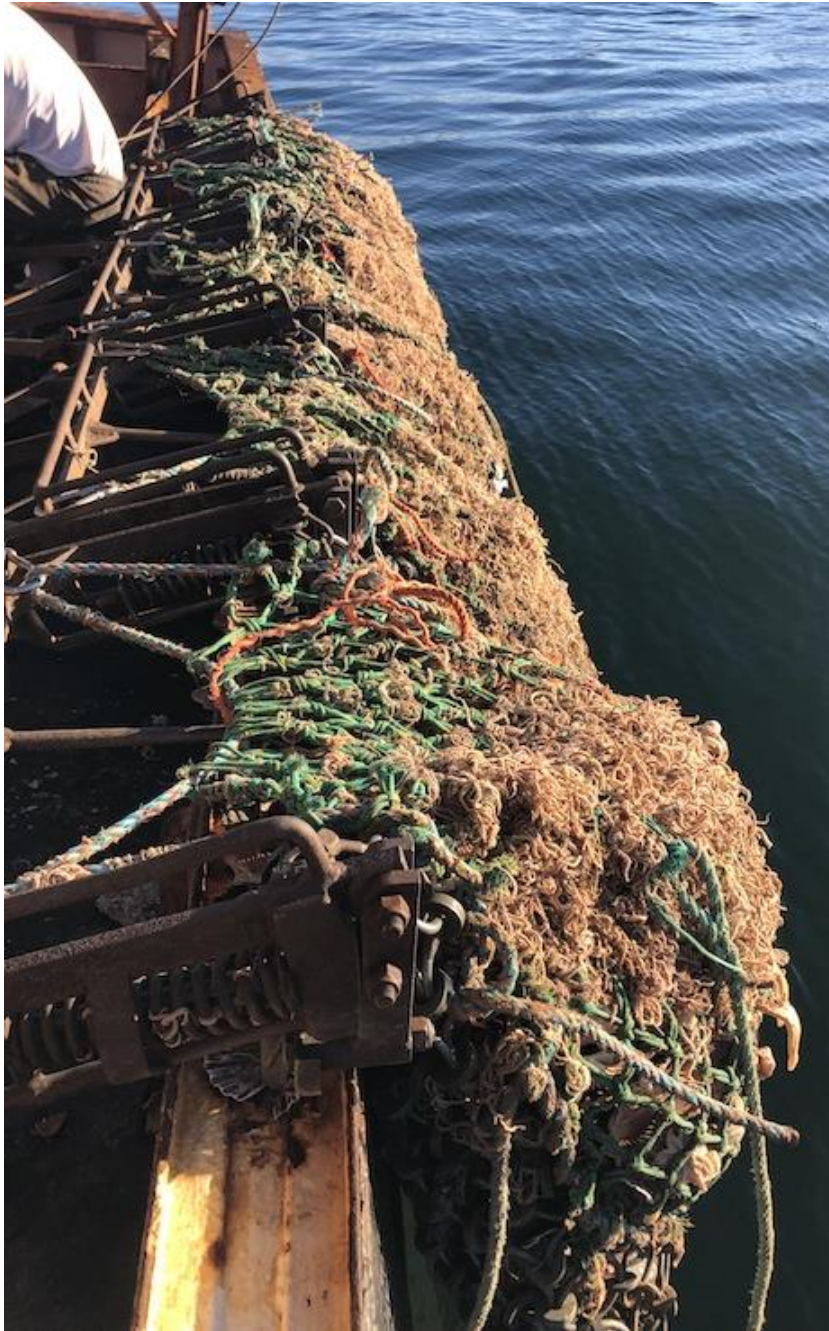
When the Investigator arrived on the Silver Viking immediately after the accident, the dredges were secured on the port side of the vessel and were found to be full of scallops and loose stones, which had been picked up from the seabed (see Fig 05 below).

Fig 05 - Port side dredges photographed when vessel was alongside Douglas on 08/12/2022.

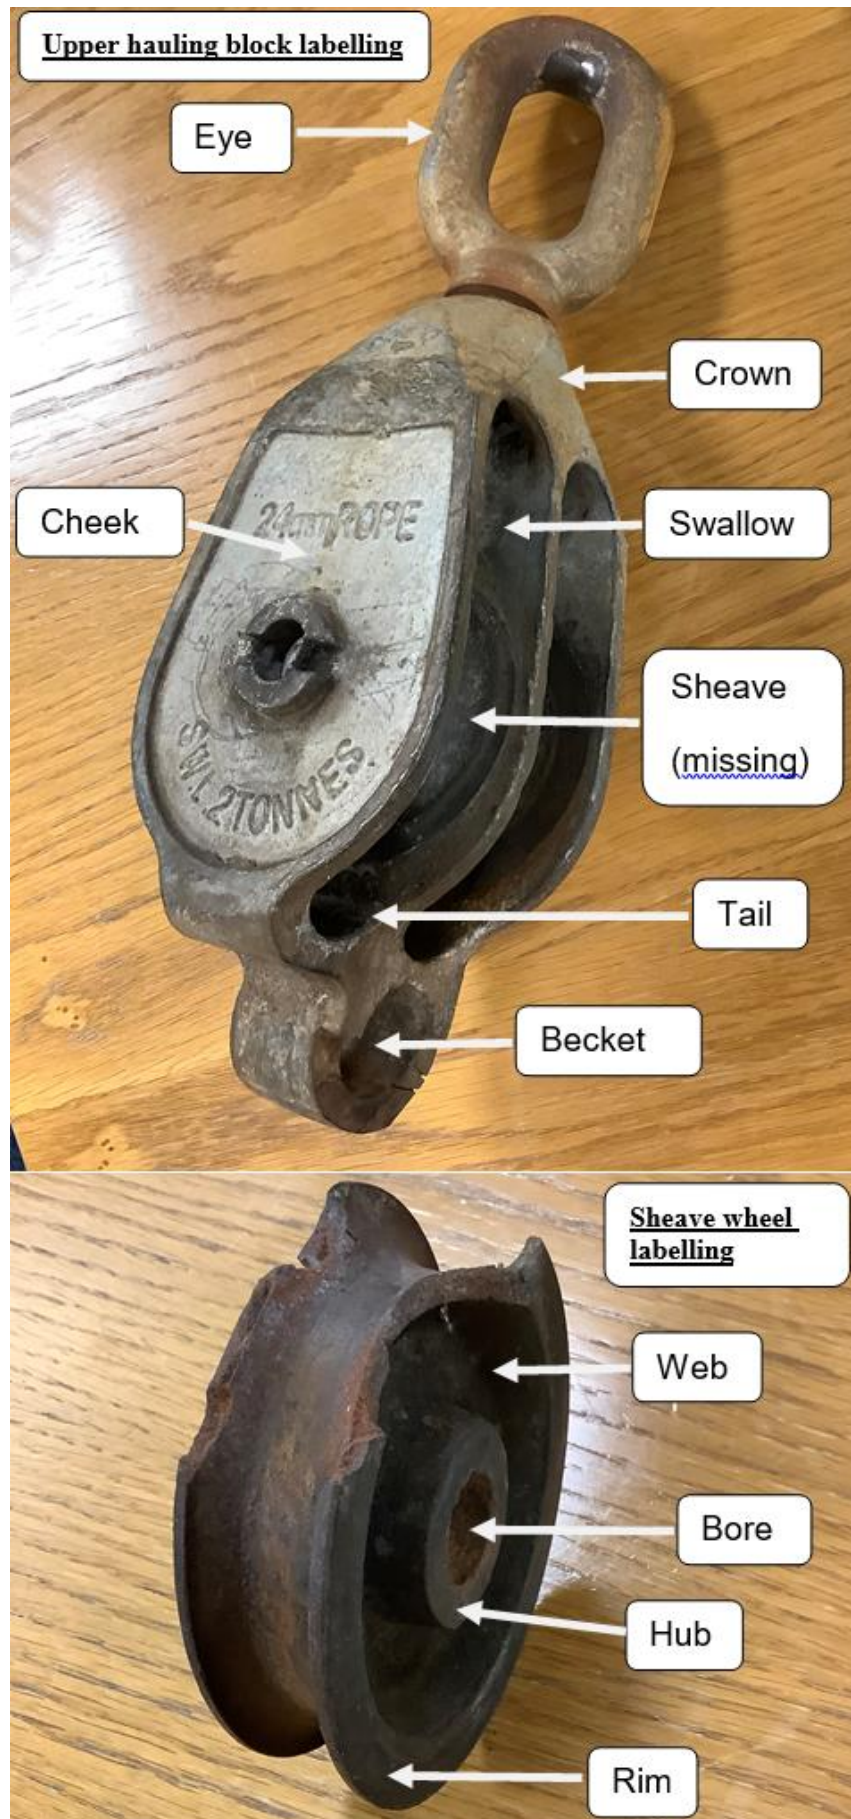
The block is a 6-inch double wheel pulley block with a swivel oval eye. Within the housing are 2 sheave wheels both with an external diameter of 90mm (see Fig 08 & Fig 09). The sheave wheels are located within the block housing on a sheave wheel pin acting as an axle for the 2 sheave wheels. The sheave wheel pin is secured in place by split pins on either side of the block housing (see Fig - 09).

Fig 08 – Upper hauling block and sheave labelling.

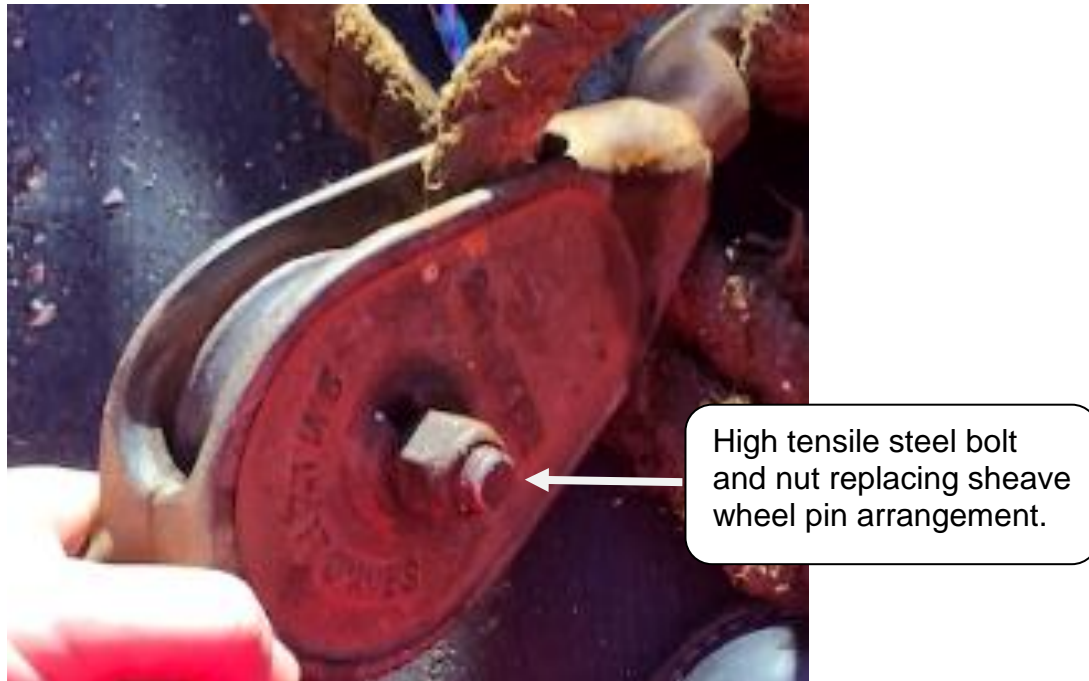
From the interview with the Skipper of the Silver Viking and several other members of the Isle of Man fishing community it was stated that the split pins often failed on these blocks over time. The common replacement is a high tensile steel bolt and nut used to replace the sheave pin and split pins (see Fig 10).

Fig 10 - An example of a block where the Sheave Wheel pin and split pins have been replaced by a nut and bolt.

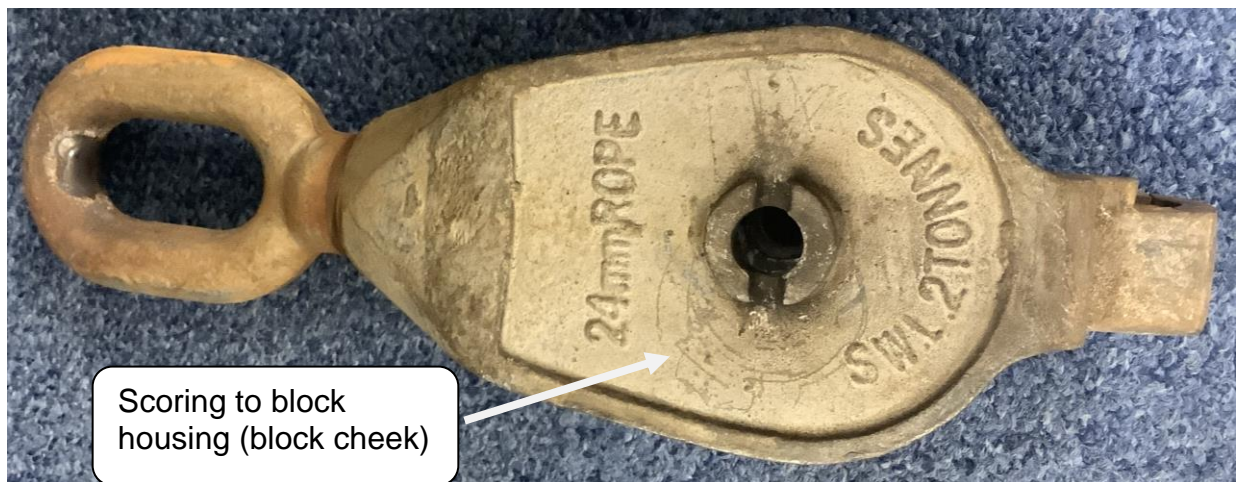
The block housing was intact however there were signs of scoring on one side of the block cheek where the split pin securing the sheave pin would have been. There were no records of the split pins being replaced since the block had been purchased. Therefore, it is likely the split pin had become loose and has scored the side of the block (block cheek) (see Fig 11).

Fig - 11 – Upper hauling block from Silver Viking with block cheek scoring.

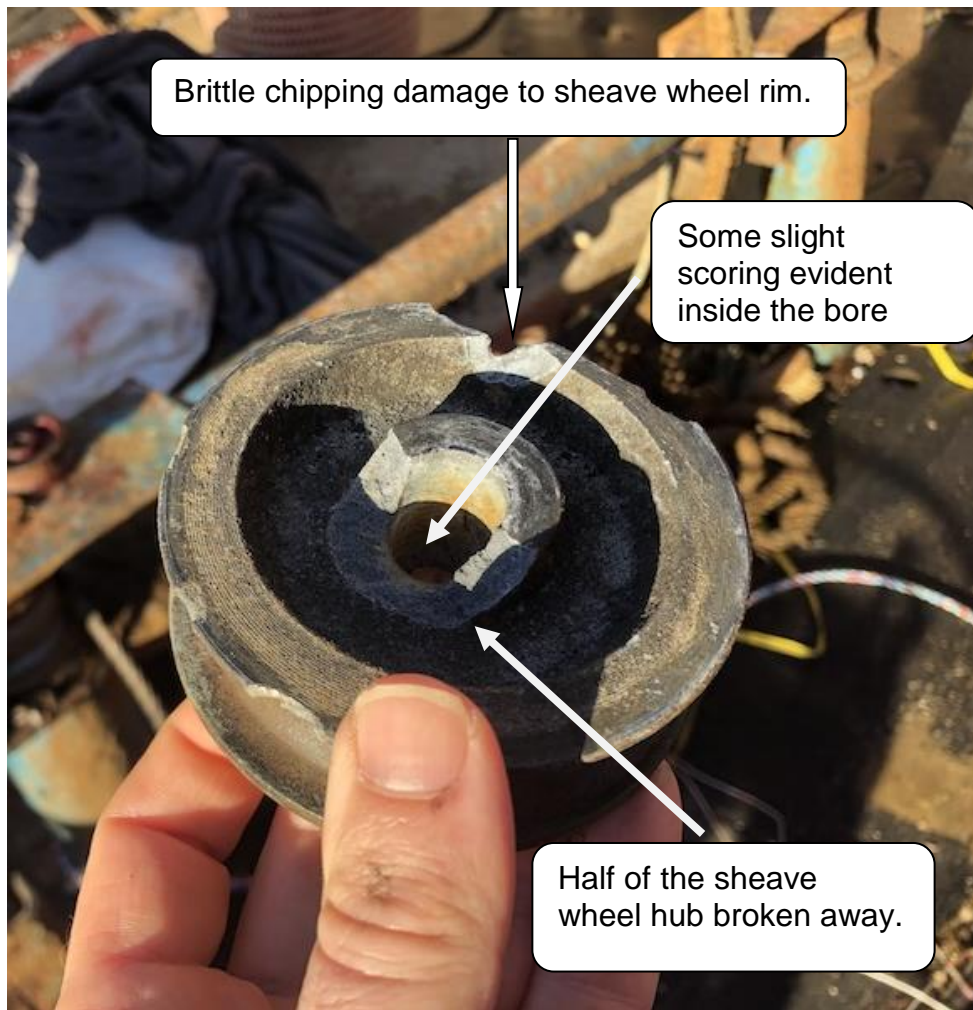
One of the sheaves was intact and the other sheave was significantly damaged, both externally on the edge of the sheave wheel rim and by the side of the sheave wheel hole (bore) where the sheave pin passes through the sheave wheel (hub). However, the sheave had not completely failed so this was not found to be the cause of the sheaves becoming detached from the housing (see Fig 04 in narrative section for the two sheave wheels together, Fig 08 for labelling and Fig 12 below for damage to the hub and rim). There is evidence of pin shaped scoring within the sheave bore. This scoring inside the bore and damage to the hub indicate the end of the sheave wheel pin was sliding out through the bore of the sheave wheels. This would also explain how half of the sheave hub was broken away (see Fig 12).

To conclude, from the sheave wheel damage as described above (see Fig 12 below) it is highly likely the sheave wheel pin was out of position due to the failure of at least one of the securing split pins. This would mean the pressure of the load under tension (approximately 850-900kg) was being applied in an unstable manner to the sheave wheel pin and sheave wheel hub.

At the point of failure, the end of the sheave wheel pin is highly likely to have slid part way through the sheave wheel braking off half of the hub due to the focused point of the load pressure within part of the bore of the sheave wheel.

Fig 12 - Damaged sheave ejected from block.

- Carry out an inspection and maintenance schedule of equipment on the fishing vessel and in particular the lifting equipment; and
- Provide and ensure hard hats are to be worn during any lifting operations.

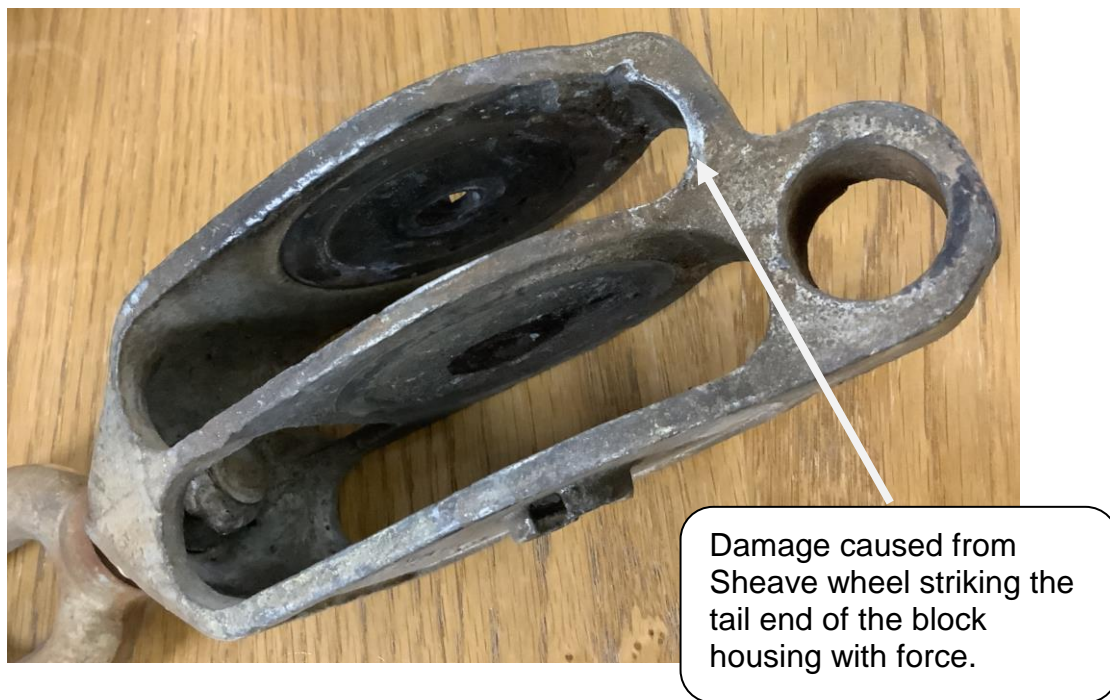
This would suddenly release the sheave wheel with significant force causing the brittle chipping on the sheave wheel rim (see Fig 13 below) from the force of striking the block housing as it ejected out of the block. It cannot be said with certainty which of the two sheaves pictured in Fig 04 in the narrative section of the report struck the casualty.

Fig 13- Damage to block housing from ejected sheave wheel
