Isle of Man Ship Registry Port State Control Notice

Q1 2026 PSC Analysis

Ref: 01-2026
Issued: 24-04-26

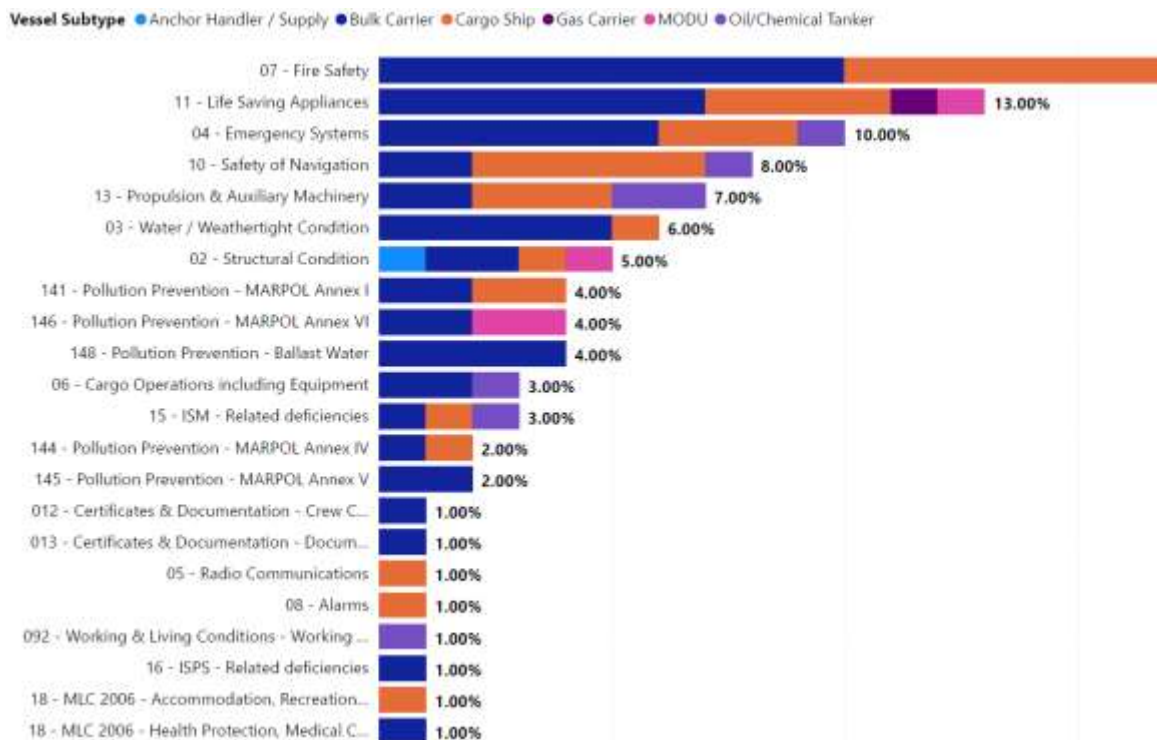
The following chart shows deficiency areas requiring corrective action raised in all MoU Regions as a percentage of total deficiencies recorded:
