Report on the investigation of a
fatal accident during mooring operations
on board the bulk carrier
Mona Manx
at Puerto Ventanas, Chile
on 26 August 2021

VERY SERIOUS MARINE CASUALTY

REPORT NO 18/2024

NOVEMBER 2024

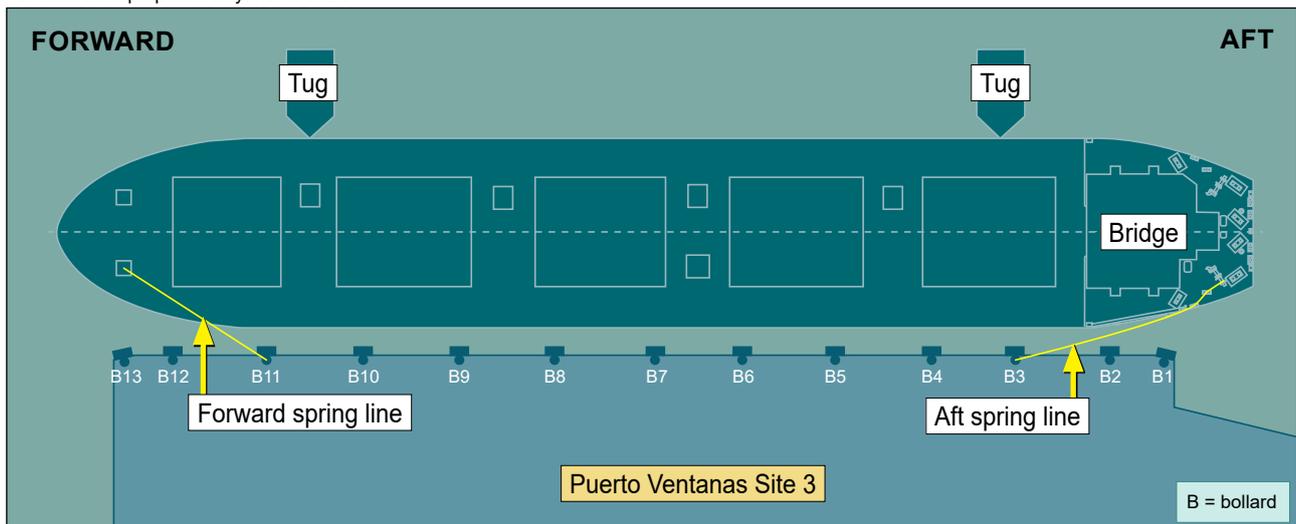
Figure 2: Representation, showing tugs holding *Mona Manx* alongside

Following the pilot's advice, *Mona Manx* was manoeuvred into position adjacent to the berth using its own engine and the attending tugs. At 0818, the starboard anchor was released to facilitate a 180° turn onto the berth. The engine control was set to *stop* when *Mona Manx* was positioned parallel to the berth and the two tugs were used to hold the vessel alongside against the berth's fenders (**Figure 2**).

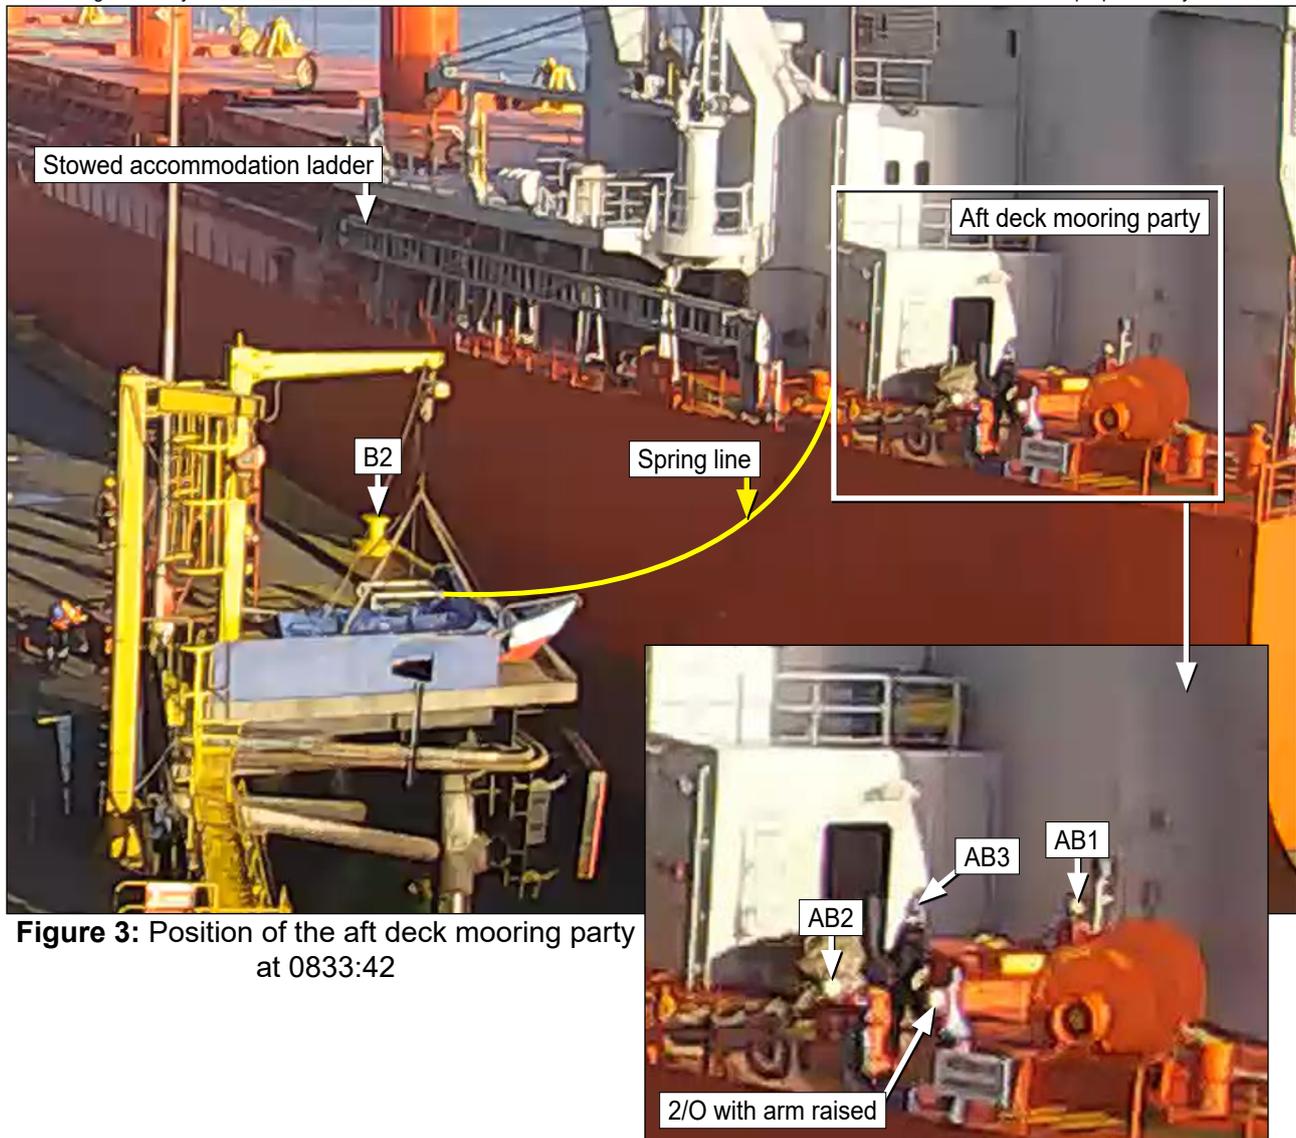
Figure 3: Position of the aft deck mooring party at 0833:42

At 0832:42, *Mona Manx*'s engine control was set to *dead slow astern*, and the vessel began to move astern, eventually reaching a speed of 0.5 knots. During the manoeuvre, the forward mooring party heaved in the slack on the forward spring and the aft deck mooring party slackened down the aft spring (**Figure 3**).

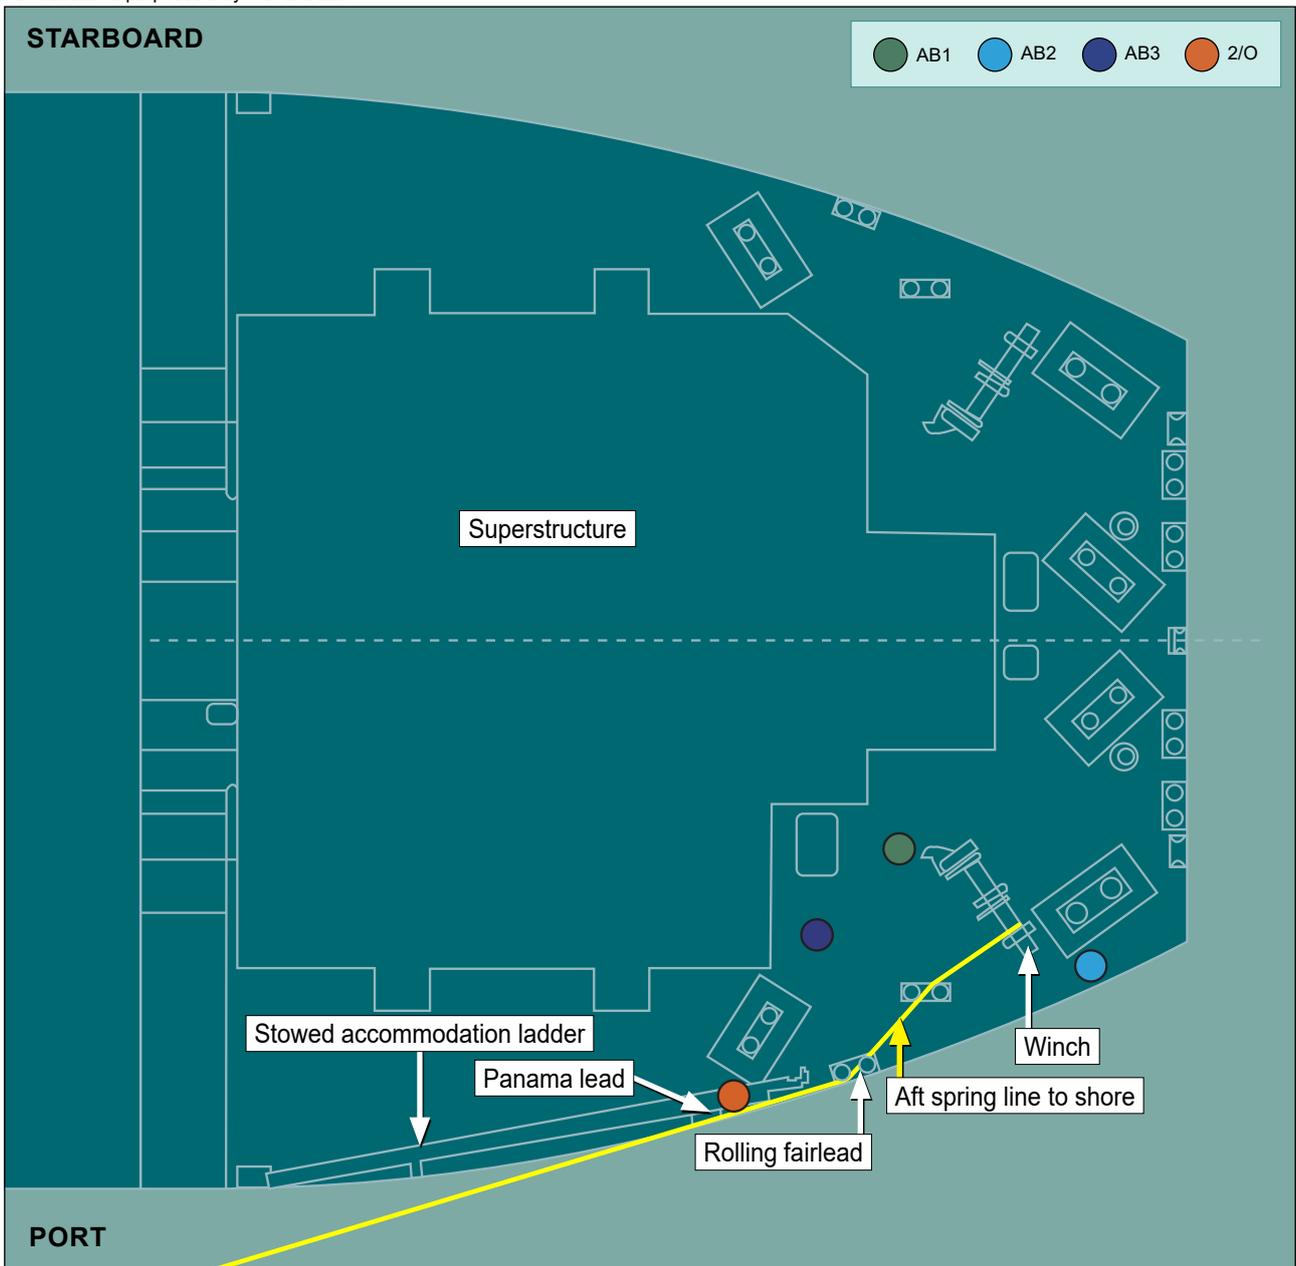
Figure 4: Position of the aft deck mooring party at 0836

At 0835:50, *Mona Manx* was almost in position and its engine control was set to *stop*. At the same time the 2/O moved forward to monitor the situation, stepping over the aft spring line on the mooring deck. As *Mona Manx* continued to move slowly astern the 2/O ducked under the stowed accommodation ladder to make his way forward to the Panama lead at the vessel's side, making a brief stop there at 0836 (Figure 4) before turning and moving forward again.

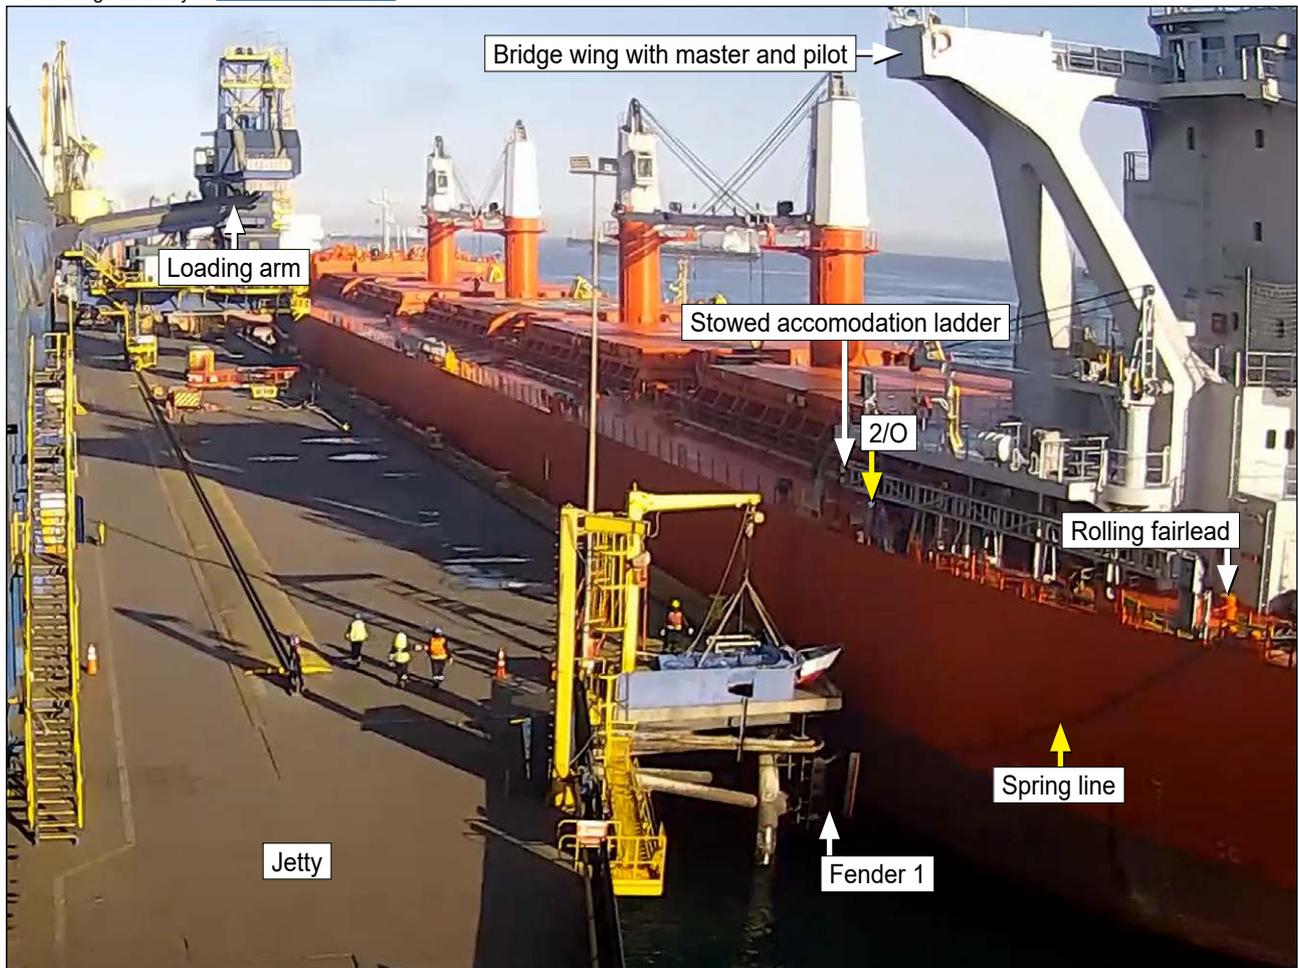
Figure 5: Position of the 2/O at 0836:11

At 0836:11, the 2/O arrived near the forward end of the accommodation ladder (Figure 5) and looked over the side rail directly above the slack spring line while using a very high frequency (VHF) radio (Figure 6). A few seconds later, the spring line tightened and then slackened. At 0836:23, the 2/O appeared to use the VHF radio again as the spring line came under tension once more.

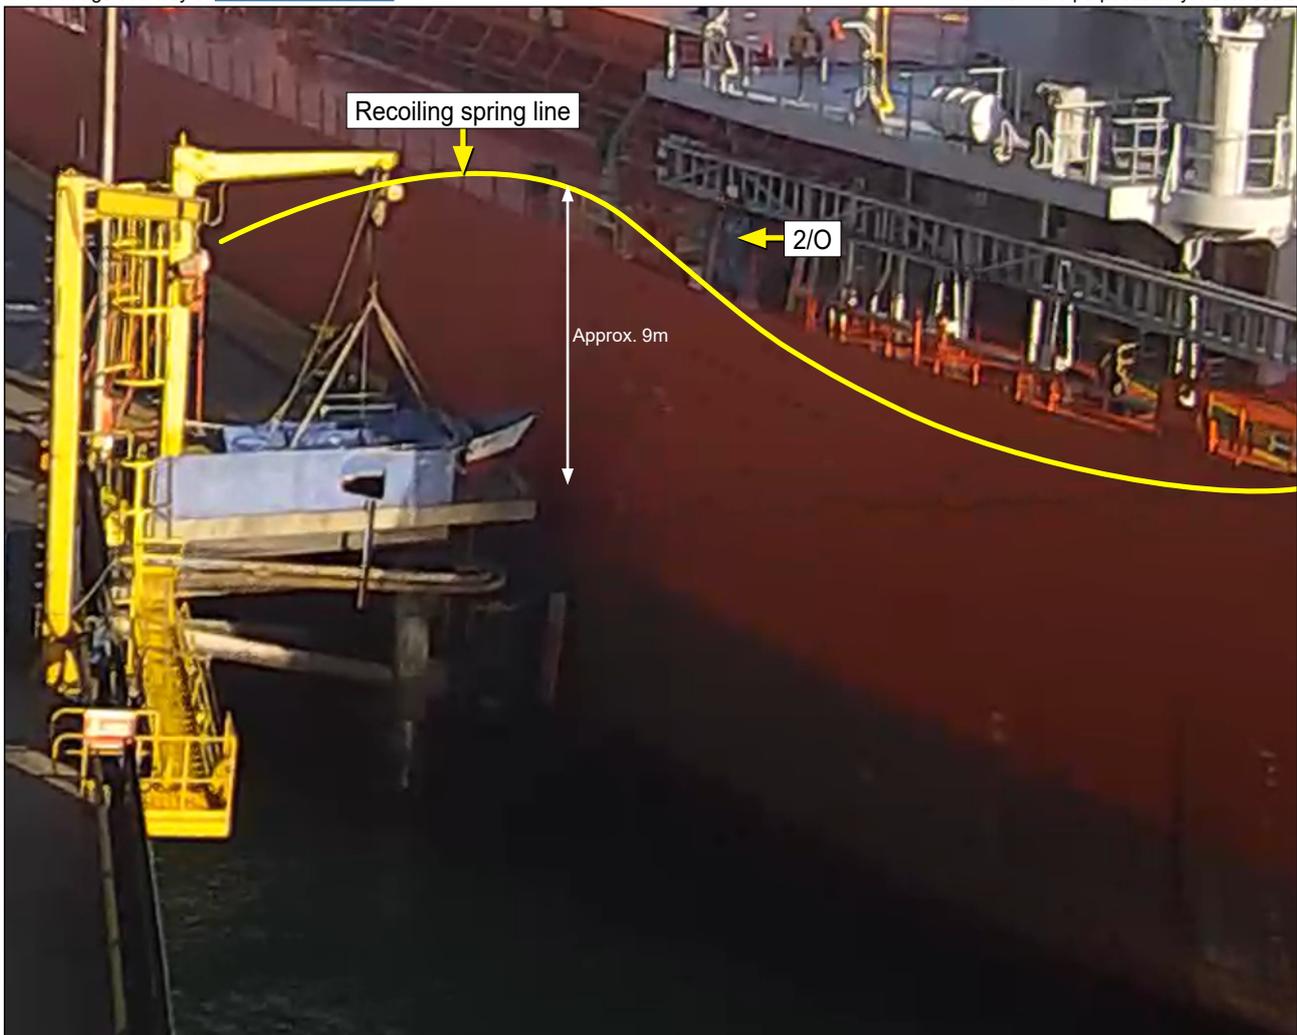
Figure 7: Aft spring line recoiling upwards at 0836:31

At 0836:31, a linesman on the quay was moving forward towards the tensioned spring line when a loud bang was heard as the line suddenly released and recoiled vertically upwards (Figure 7). The linesman quickly moved away but the spring line struck the 2/O under his chin and he was lifted off his feet and thrown backwards, causing his head to strike the accommodation ladder that was behind and above him. The force of the impact threw his safety helmet backwards, and his VHF radio was catapulted into the water as he collapsed onto the deck.

The working length of the spring line from the estimated point of entrapment to the aft rolling fairlead was about 29m. On its release, the spring line took less than one second to recoil approximately 9m upwards (see **Figure 7**) and strike the 2/O.

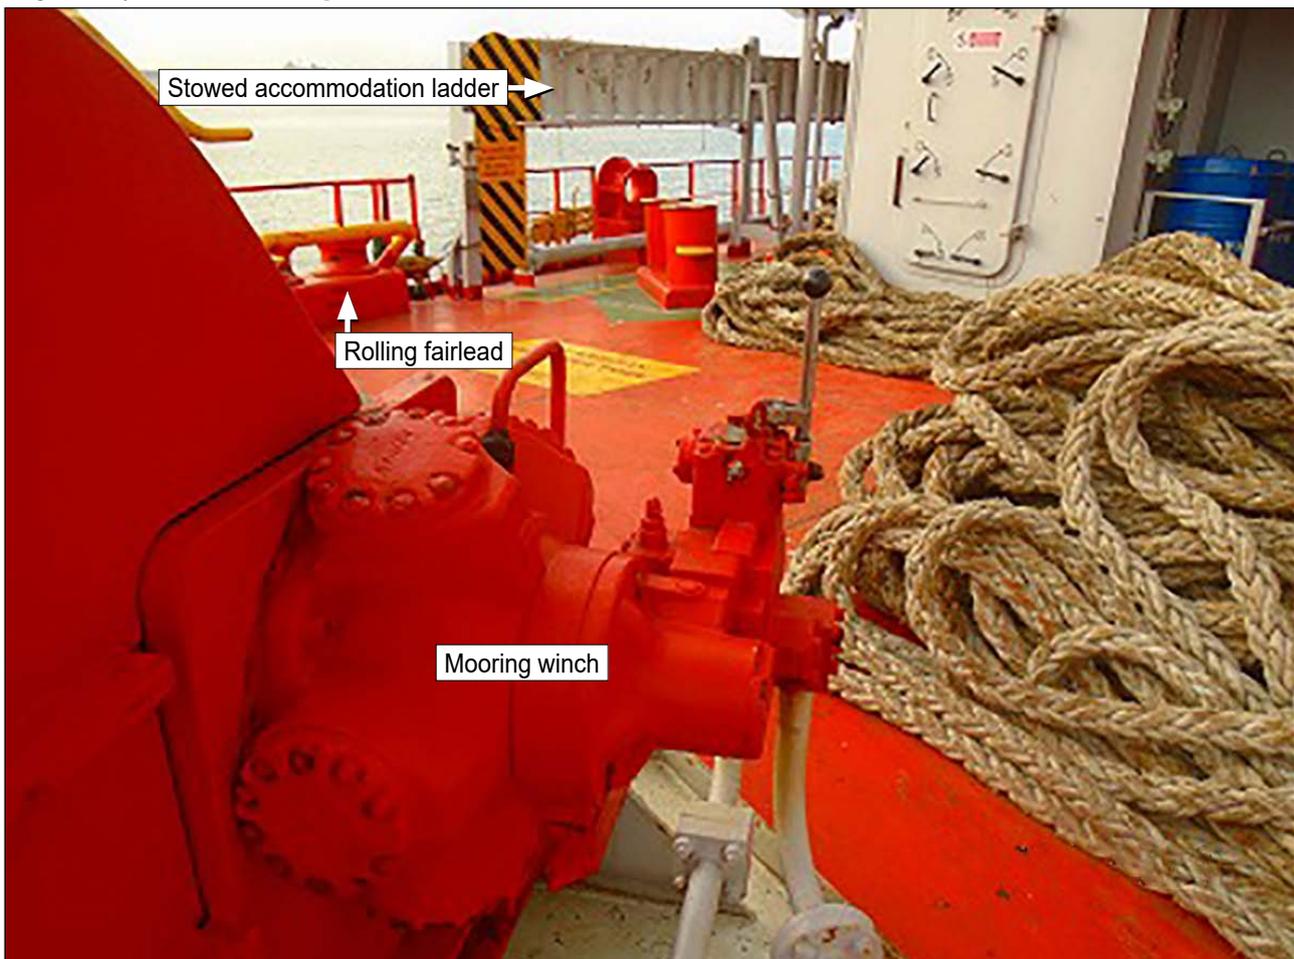
Figure 8: *Mona Manx*'s aft mooring deck (view to port forward)

The aft mooring deck equipment was arranged symmetrically, with the port and starboard side each comprising a single winch and a combination of mooring bitts, Panama leads and rolling fairleads. The port side winch was sited so that its operator would be facing outboard to port when standing directly behind the controls (**Figure 8**).

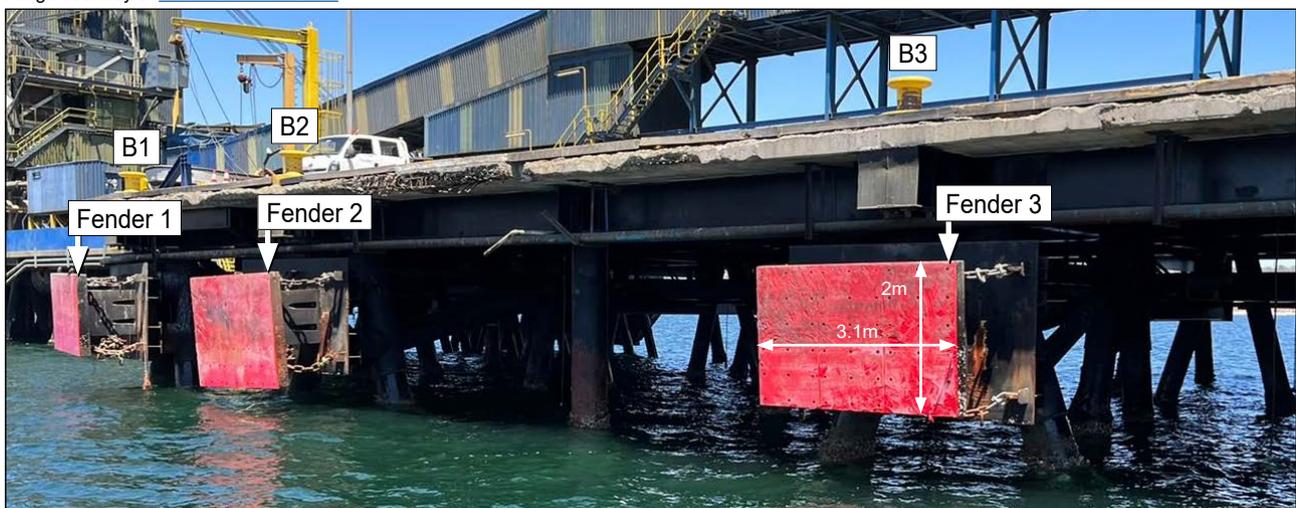
Figure 9: Fenders at Puerto Ventanas Site 3

Site 3 was located on the north face of the jetty and 13 rectangular fenders were fixed along its berth. Fitted in 1992, the fenders were constructed from rubber and steel and each one measured 3.1m wide and 2m high. The fenders were attached using flexible rubber mounts and chains and extended 1.2m from the face of the berth (**Figure 9**). At the time of the accident the sea surface level was about 3.28m below the jetty and the fenders were clear of the water.

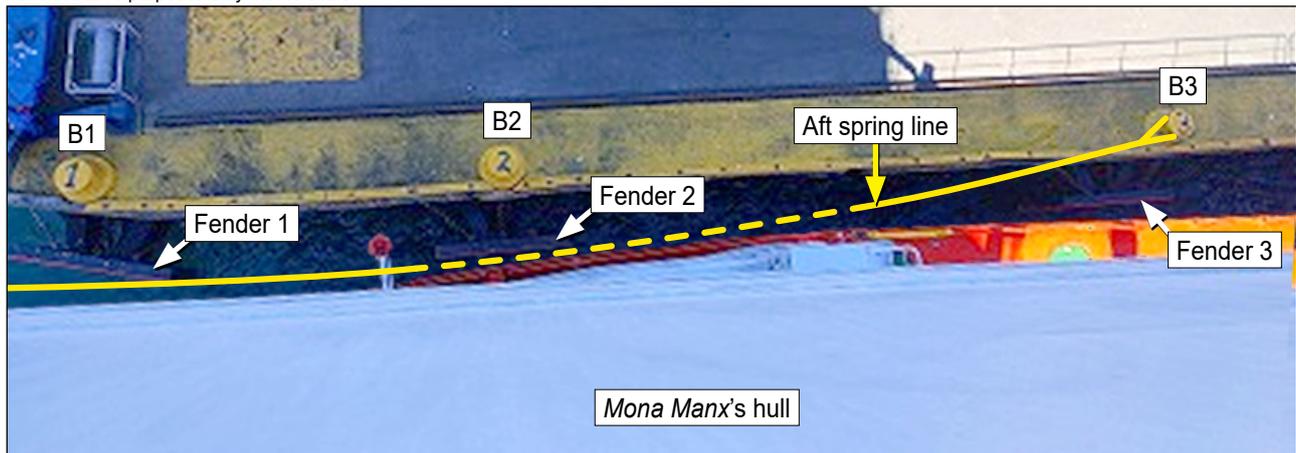
Figure 10: Representation of entrapment of aft spring line between *Mona Manx*'s hull and the second fender

As *Mona Manx* moved astern it was necessary for the aft deck mooring party to slacken down the spring line and it is apparent that the line became entrapped during this operation, either under the fender or between *Mona Manx*'s hull and the face of the fender (**Figure 10**). It is probable that as the vessel continued moving the line tensioned and *Mona Manx* momentarily moved away from the jetty, possibly due to the movement of the tugs' reducing thrust onto the vessel's side, allowing the bulk carrier to 'drift' off the fenders. The entrapped line released and the stored energy in the spring line caused it to displace upwards. The spring line deflected approximately 9m upward at an estimated speed of 18m per second, leaving the 2/O minimal opportunity to move out of its path.
