Report on the investigation of  
the deaths of three stevedores in a cargo hold  
access space on board the bulk carrier

***Berge Mawson***

at Bunyu Island anchorage, Indonesia

on 27 June 2022

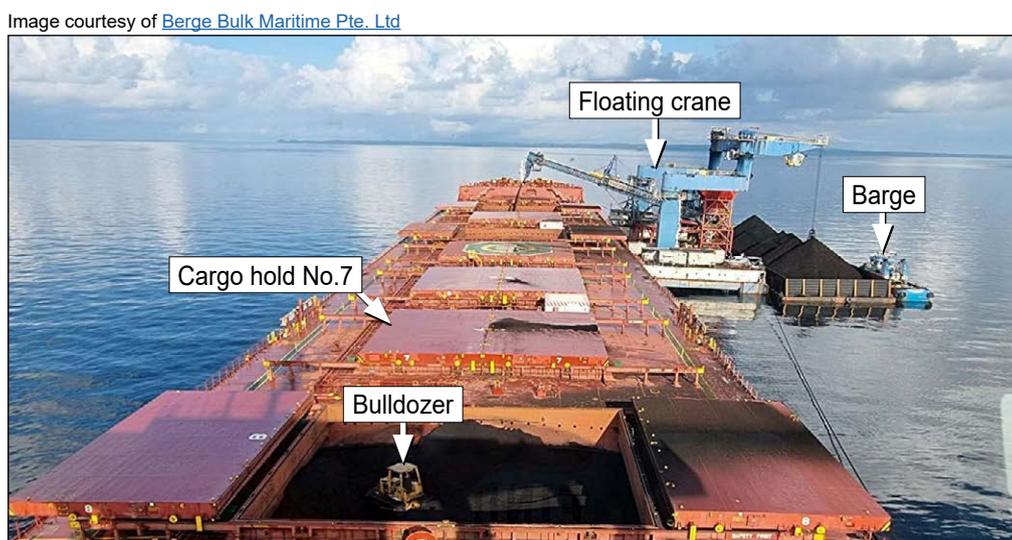
**Figure 2:** Cargo work at Bunyu Island

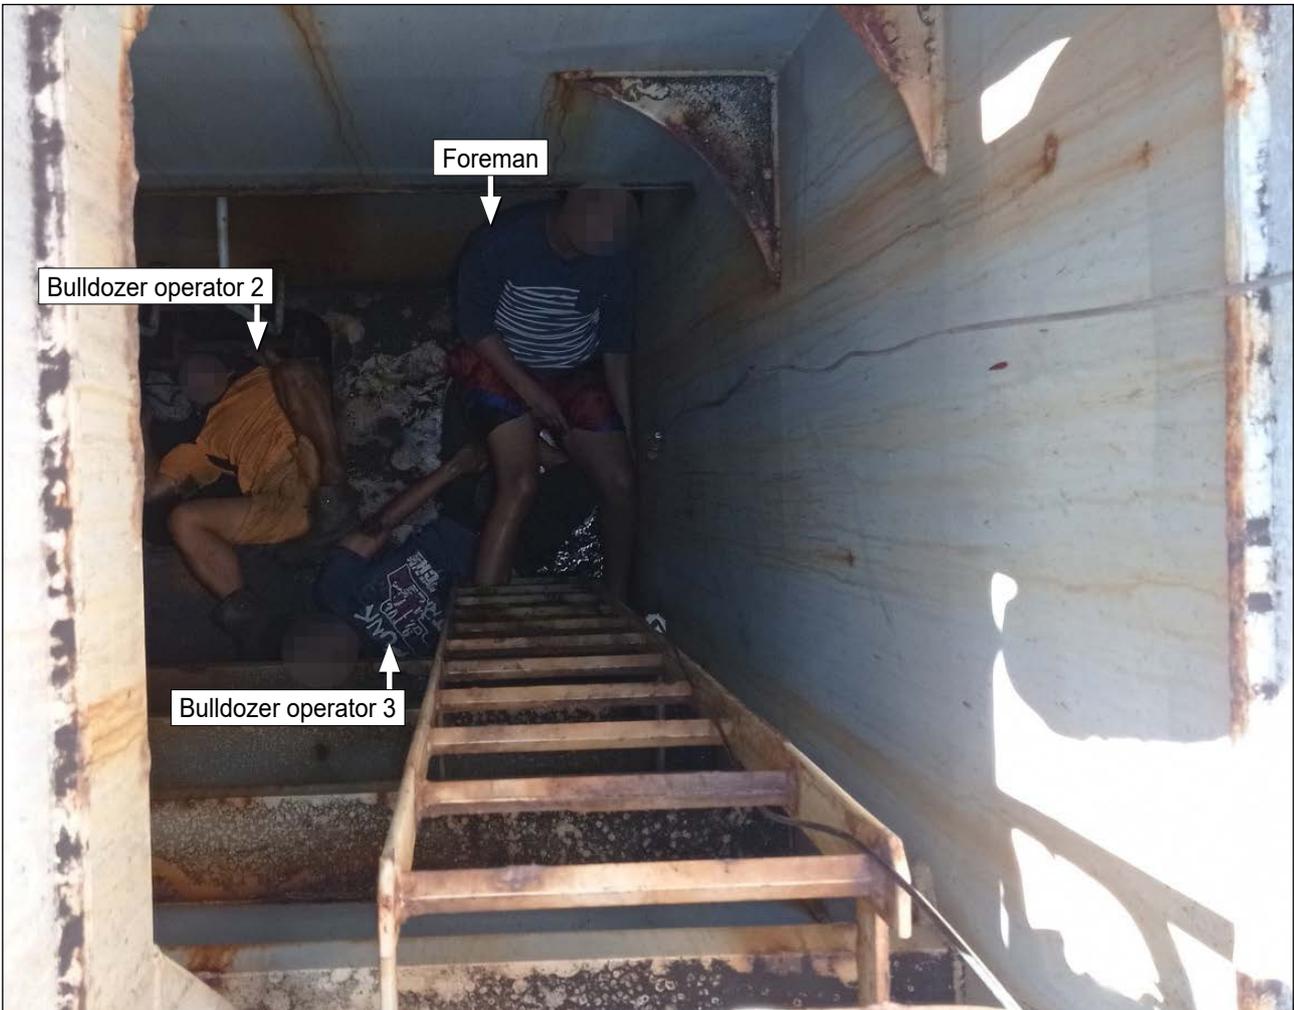
At 1330:14, *Berge Mawson's* BA team arrived on scene and saw that there were now three casualties in the space (**Figure 3**). The bosun then opened the cargo hold No.8 hatch covers. At 1340, the C/O lowered a gas monitor into cargo hold No.7 and cargo hold No.8 to test the atmosphere. The readings are summarised at **Table 2**.

**Figure 3:** Stevedores collapsed in cargo hold No.8 forward access space

Space	Methane (% LEL)	Oxygen (% vol)	CO (ppm)	Hydrogen sulphide (ppm)
Cargo hold No.7 aft access	0	20.7	0	0
Cargo hold No.8 forward access	36	0.9	2,147	3,100

Postmortem examinations were not conducted, and the cause of death was not confirmed. However, the atmospheric readings of the cargo hold No.8 forward access space taken after the casualties were found (see **Table 2**) show a deficiency of oxygen and a high level of H<sub>2</sub>S. It is highly likely that the noxious air breathed by the three stevedores caused them to be incapacitated upon entry into the cargo access space, and the resulting shutdown of their brain and/or lungs led to their death.

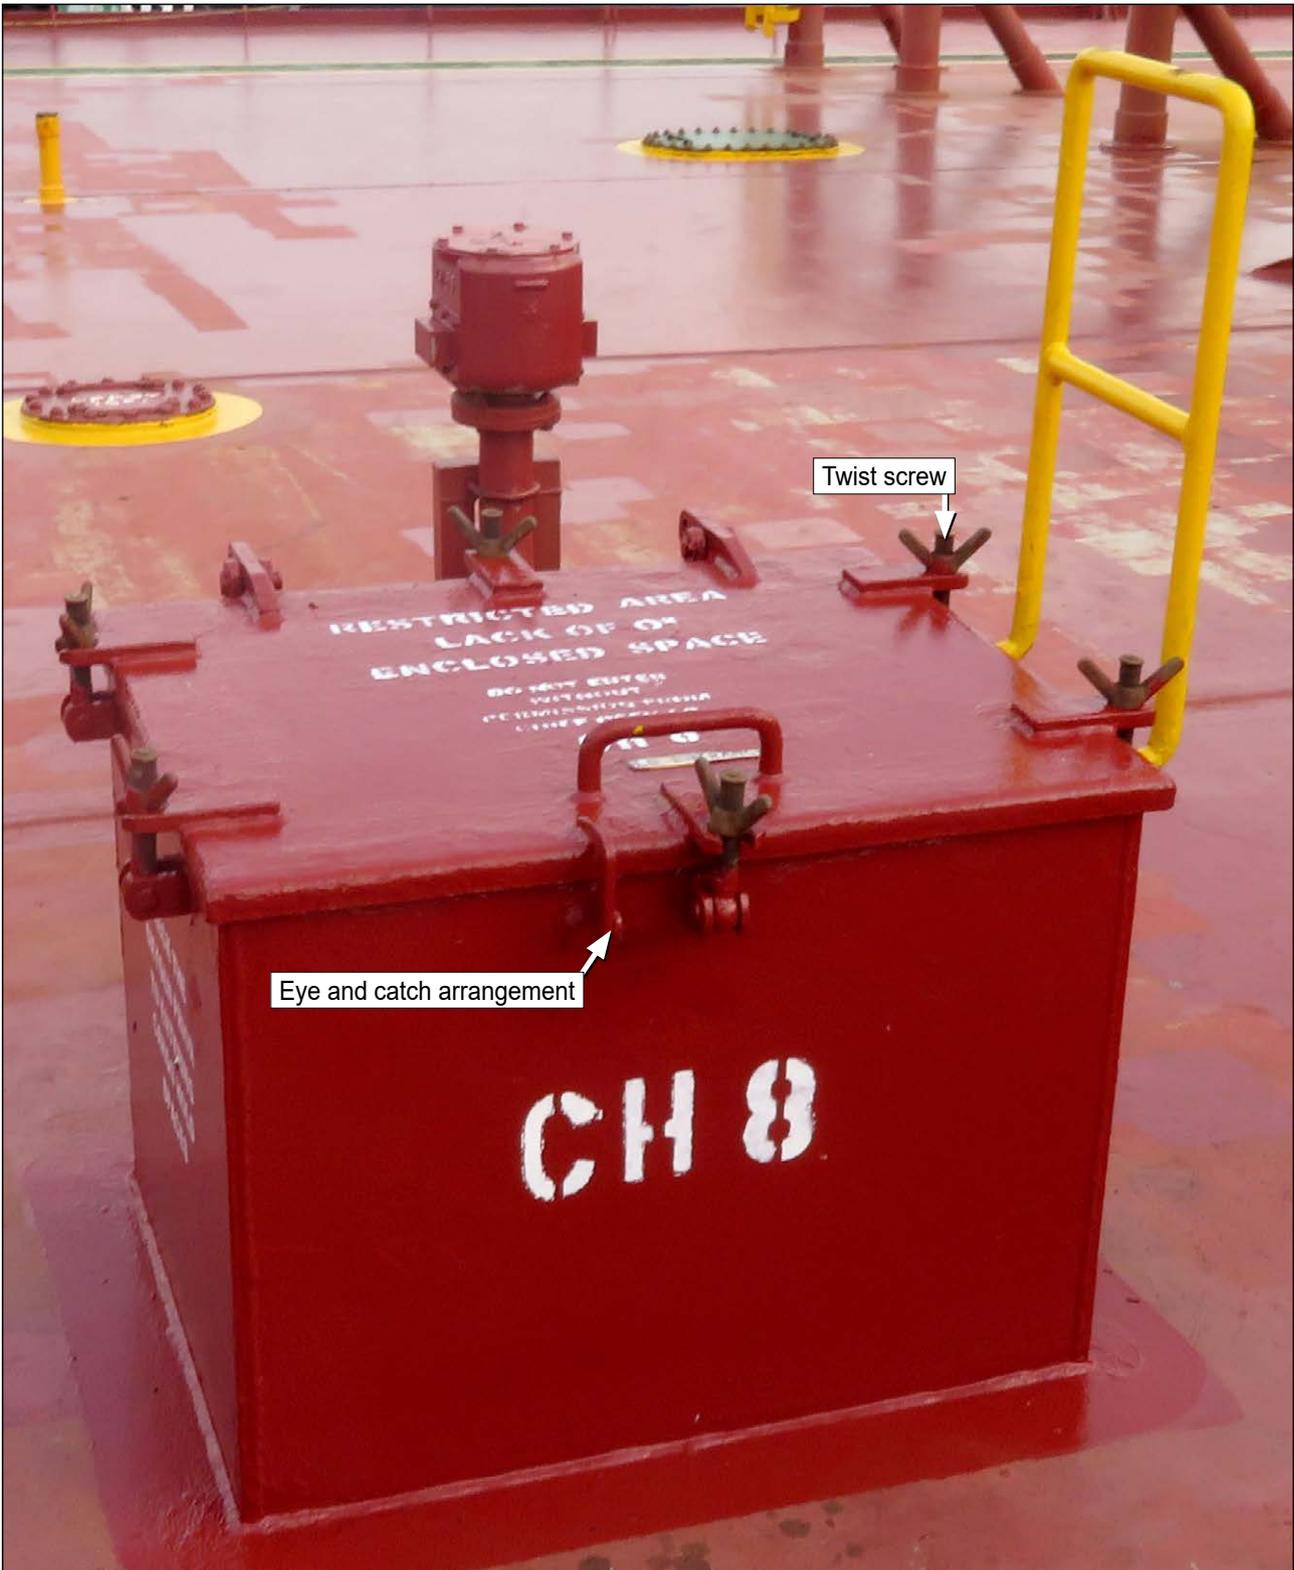
**Figure 7:** Cargo hold No.8 forward booby hatch

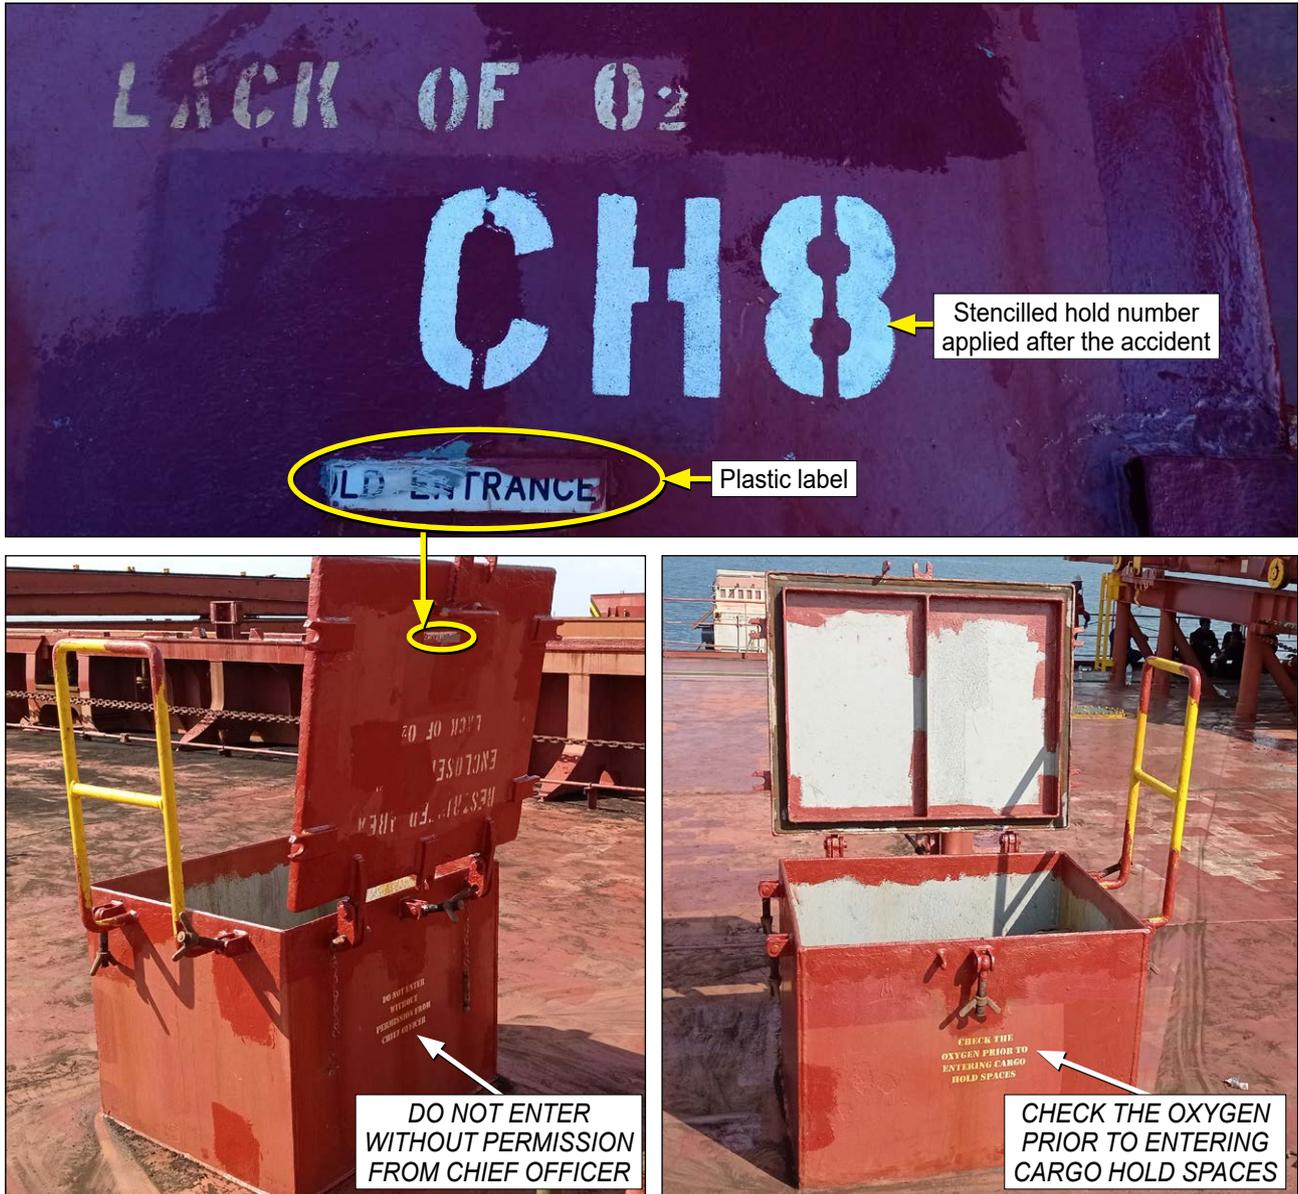
Each cargo hold was identified by a number stencilled onto its hatch coaming. The booby hatch lids had the hold number stencilled on them and a plastic label indicated whether it was the forward or aft access to the hold. The plastic label on some of the booby hatch lids, including that of cargo hold No.8 forward, had become obscured by paint or were broken so it was unclear which end of the hold the booby hatch led to. Cargo hold No.7 aft had a plastic label that read *No.7 HOLD ENTRANCE*. Several warnings were painted on the exterior sides of the booby hatches' coamings (**Figure 8**).

**Figure 8:** Cargo hold No.8 forward booby hatch signage

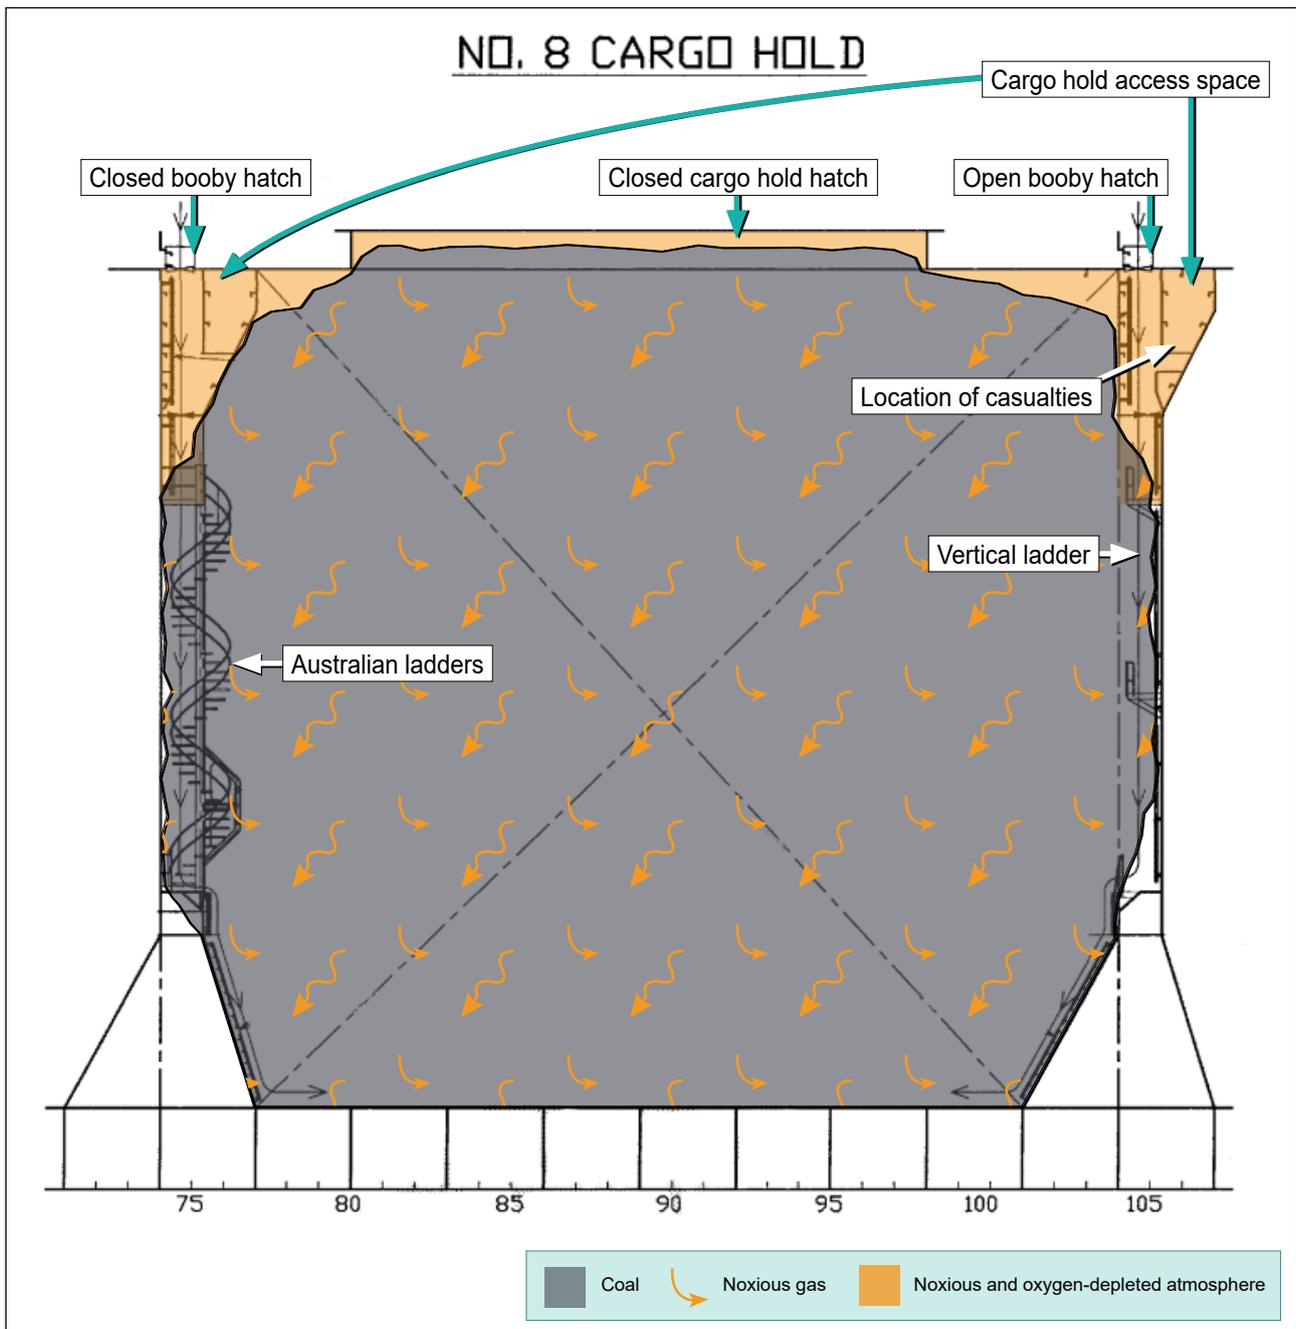
Cargo hold No.8 was loaded with coal and its hatches had been closed for about 2 days before bulldozer operator 2 made a mistaken entry into the cargo hold access space. Before this the hatch covers had been opened and closed due to rain. Although not measured or recorded, it is possible that CO<sub>2</sub> build-up caused oxygen to be displaced while the hatches were open. When the hold was full and loaded up to almost the top of the hatch coaming, the atmosphere beneath the cargo hatch and in the cargo hold access spaces was in direct contact with the surface of the coal (**Figure 9**). Given that the spaces had been closed and unventilated for nearly 48 hours, it was almost inevitable that they would become oxygen deficient and that noxious gases from the cargo would be present in high levels. The levels of methane (8% LEL), CO (225 ppm) and oxygen (5.8%) recorded during the last atmosphere test of cargo hold No.8 at 0830 on the day of the accident showed that the coal cargo had already depleted the air quality. The post-accident readings taken by the C/O 40 minutes after the discovery of the three stevedores showed that the cargo hold access space atmosphere had not yet been refreshed; CO was still present; and the low oxygen level and high H<sub>2</sub>S level could

not sustain life. It is evident that ventilation of the cargo hold access space had not been achieved by the opening of the booby hatch lid and that it would have taken a considerable amount of time before the enclosed atmosphere did not present a risk to life.

**Figure 9:** Representation of the level of coal in cargo hold No.8
