Report on the investigation of the  
engine room fire and subsequent fatality on board  
the liquefied petroleum gas/ethylene carrier

***Moritz Schulte***

in Antwerp, Belgium

on 4 August 2020

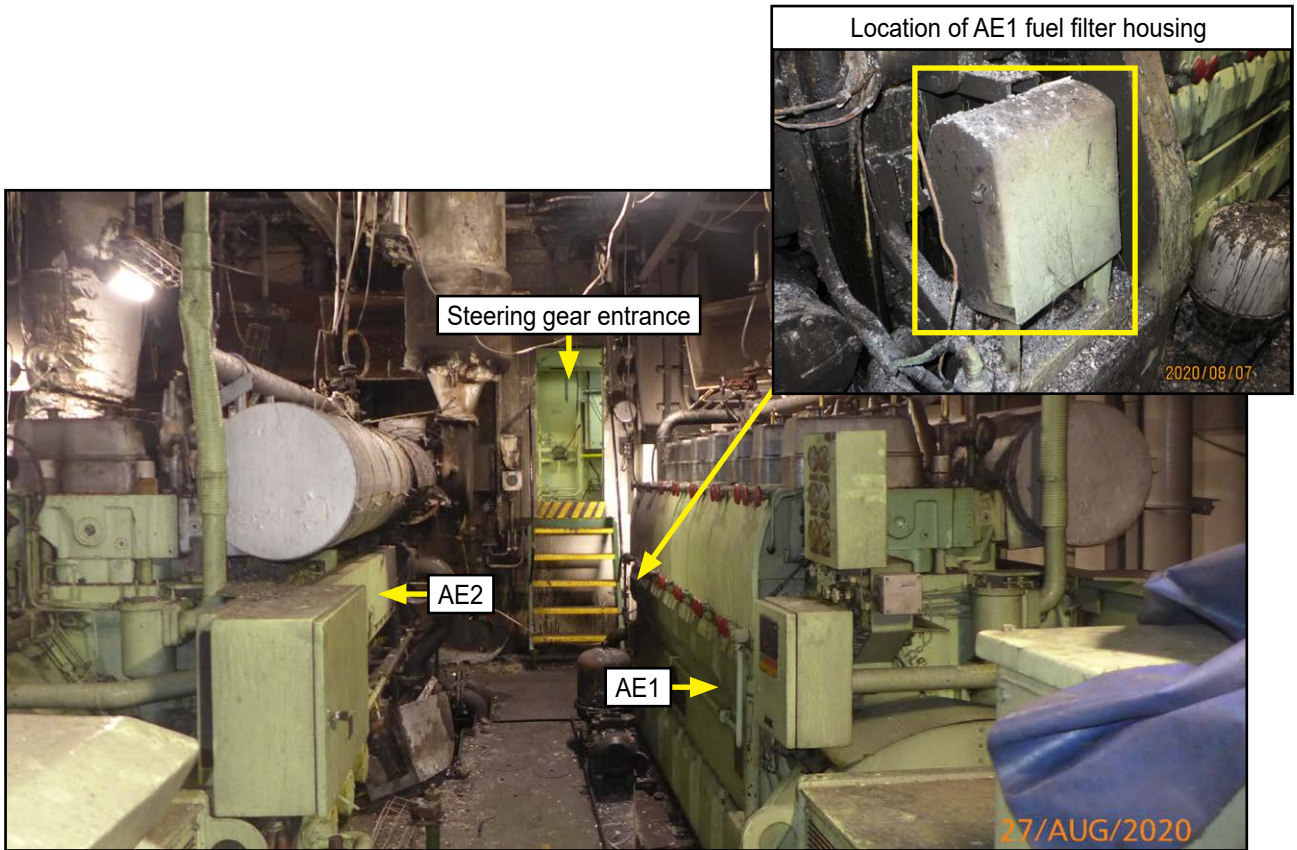
door. The AE1 fuel filter housing was under the turbocharger at the aft end of the engine (**Figure 2**), about 1m from AE2's turbocharger (**Figure 3**). The 3/E undid the two locking screws on the splash shield and removed it from the housing to access the duplex fuel filters, placing the cover on the deck (**Figure 4**).

**Figure 2:** View aft between AE1 and AE2 and (inset) the post-fire AE2 fuel filter housing, representing how AE1 would have looked with its splash shield cover in place

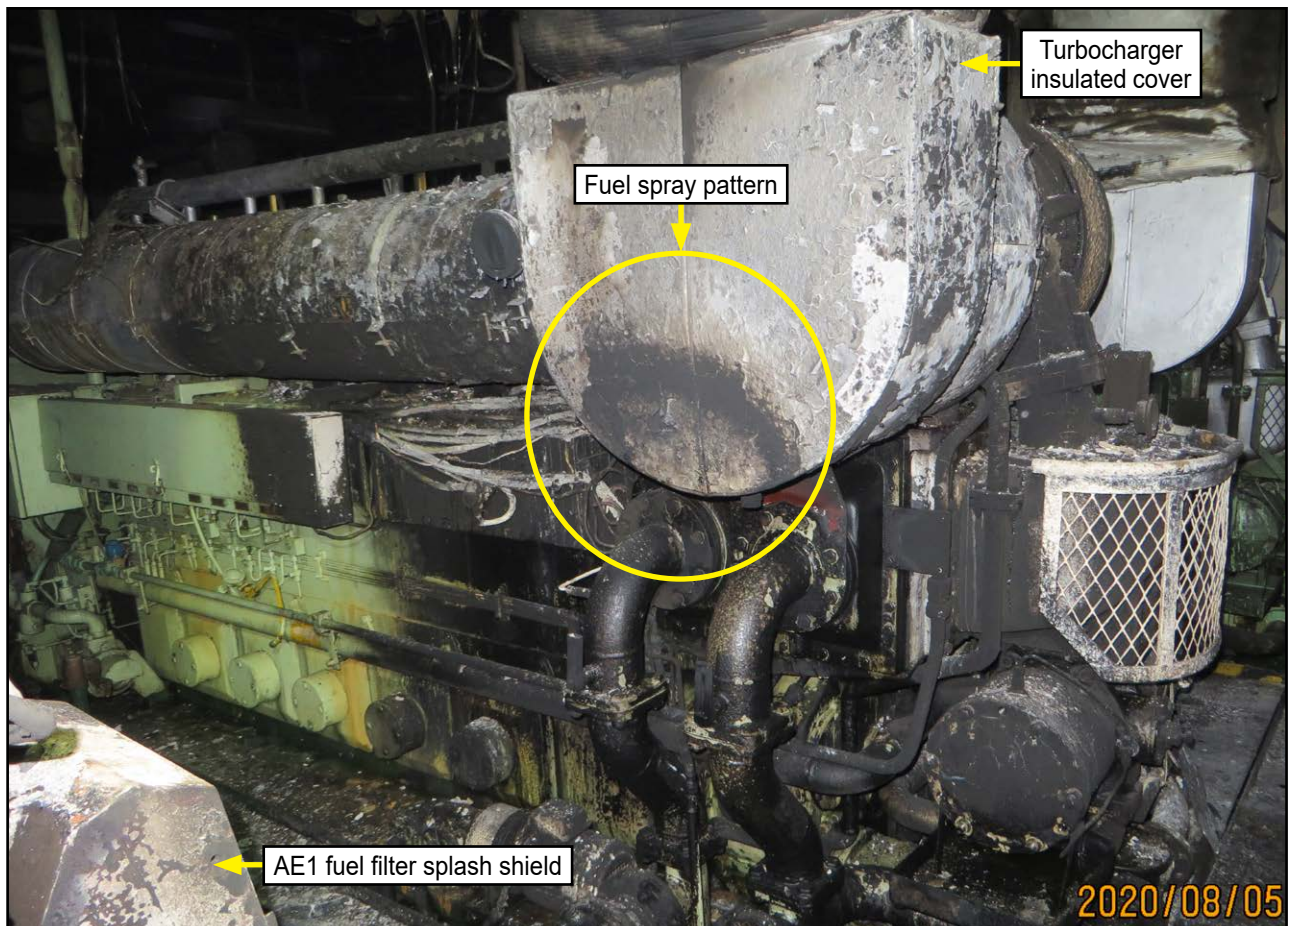
**Figure 3:** Post-fire AE1 fuel filter splash shield and AE2 turbocharger insulated cover

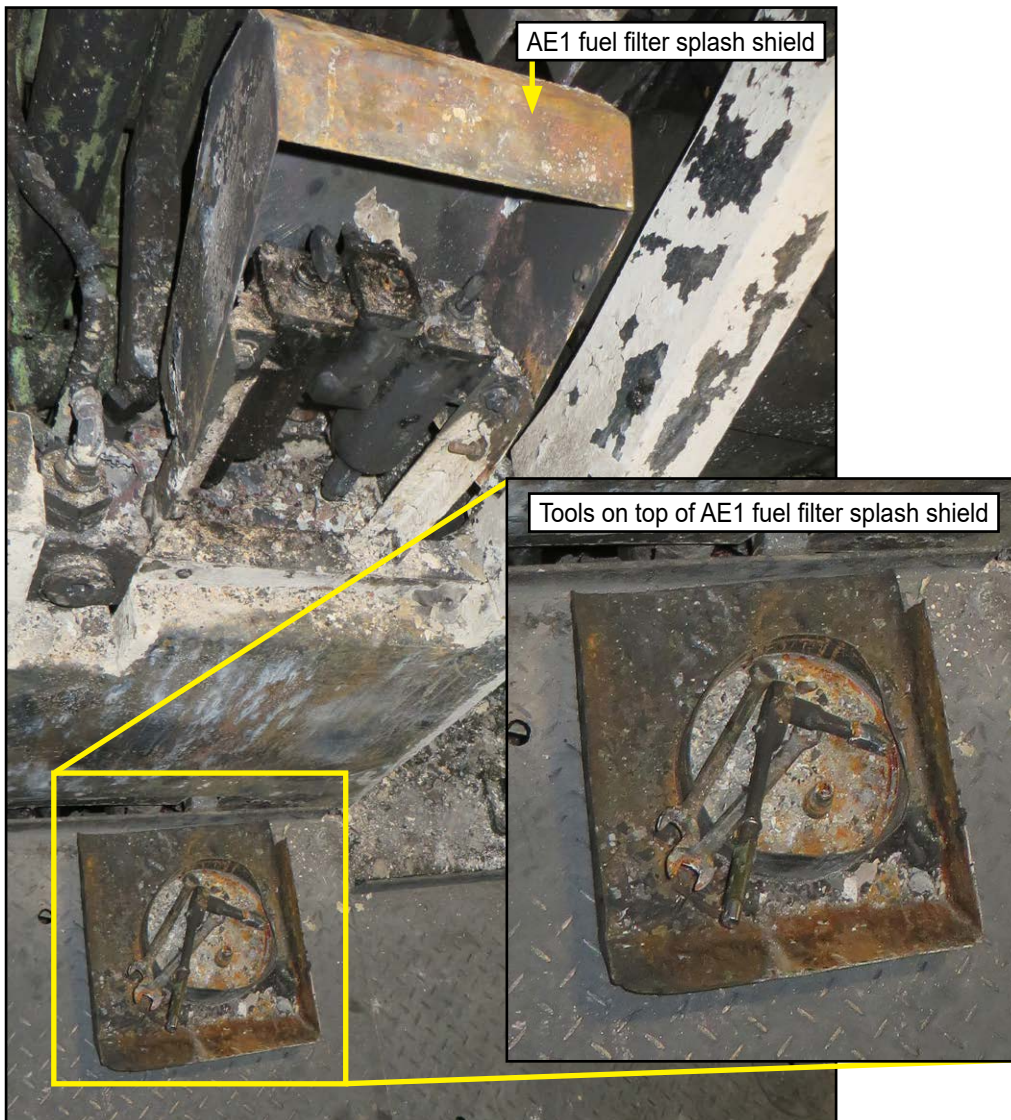
**Figure 4:** Post-fire AE1 fuel filter splash shield removed with tools on top

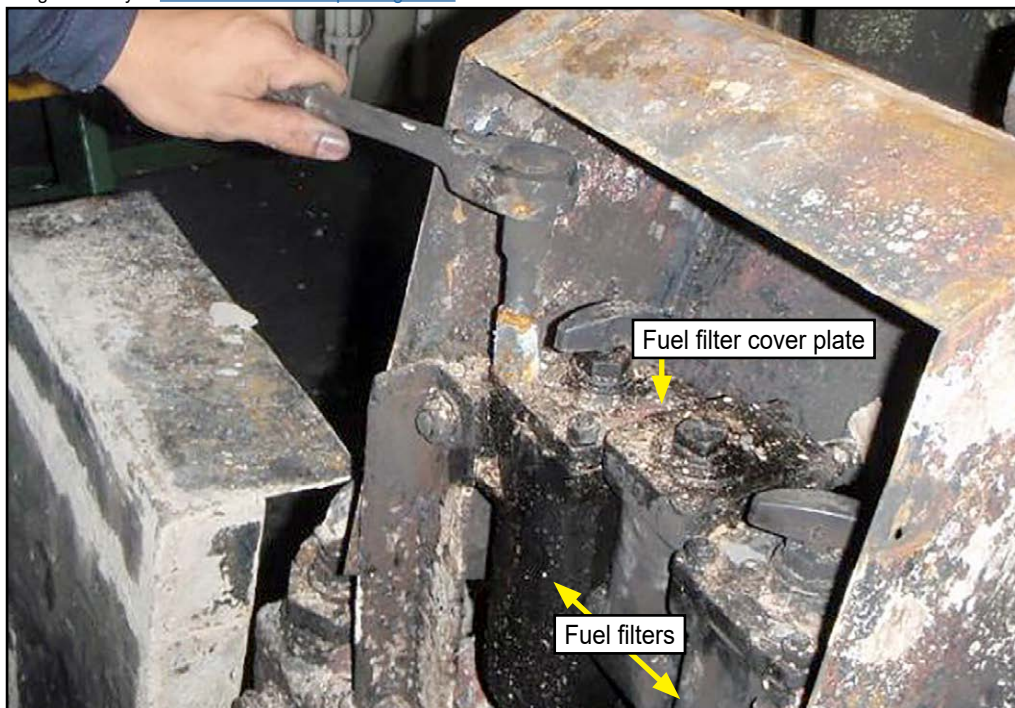
- The 3/E slackened the rear two nuts and removed the front left-hand nut securing the fuel filter cover plate. As he was undoing the front right-hand nut, the 5.5 bar fuel system pressure lifted the cover and forced the O-ring seal out of its recess, causing it to split (**Figure 6**).
- The marine gas oil (MGO) sprayed out over a large area, covering the 3/E and reaching the running AE2's turbocharger and exhaust pipework insulated cover (**Figure 3**). Soon after, the fuel ignited and thick black smoke began to emanate from the AE2 exhaust insulation.

**Figure 5:** Post-fire reconstruction of fuel filter cover plate removal

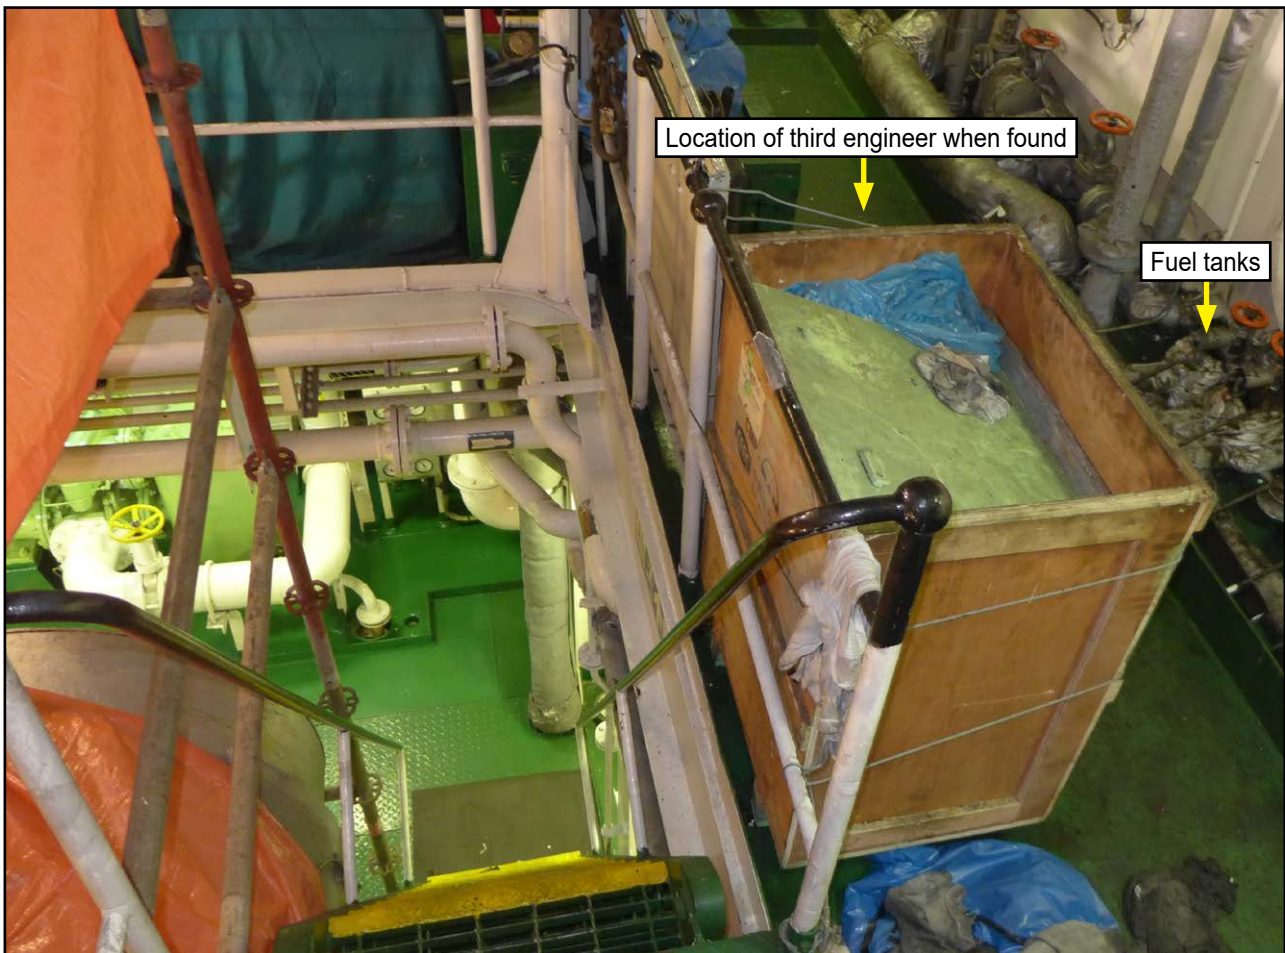
**Figure 11:** Location of third engineer on A Platform starboard mezzanine walkway when found by shore fire and rescue team

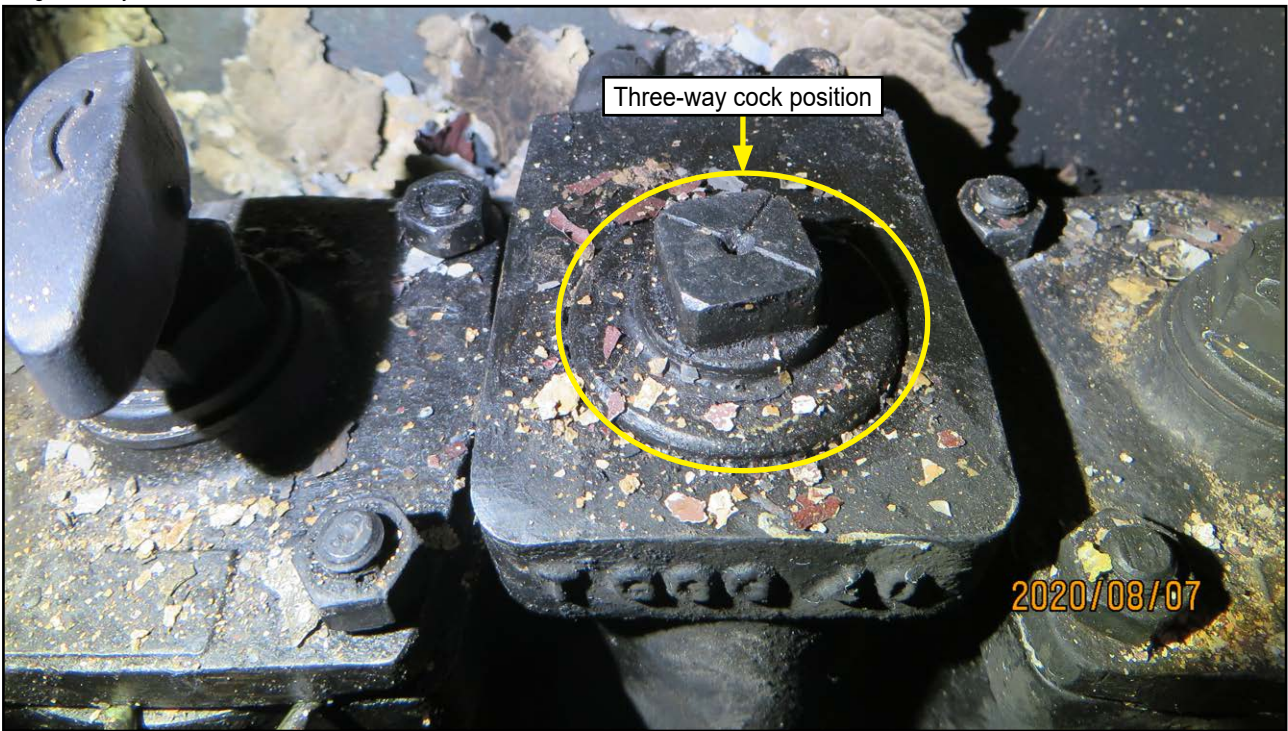
The front section of the splash shield, which enabled access to the filters, had been removed and the three-way cock between the filters was found partially closed (**Figure 14**).

**Figure 14:** AE1 fuel filters, showing three-way cock position as found post-fire

The three-way cock may have been moved to the partially closed position before work started on the filter in an attempt to both complete the intended task and comply with the 2/E's instruction not to isolate the engine. Alternatively, the 3/E may have tried to close it once the fuel spray started. In either event, post-accident testing found that its partially closed position made little difference to the amount of fuel released. However, the three-way cock was designed so each filter could be isolated in turn and, correctly operated, it would have prevented the unintended release of fuel.

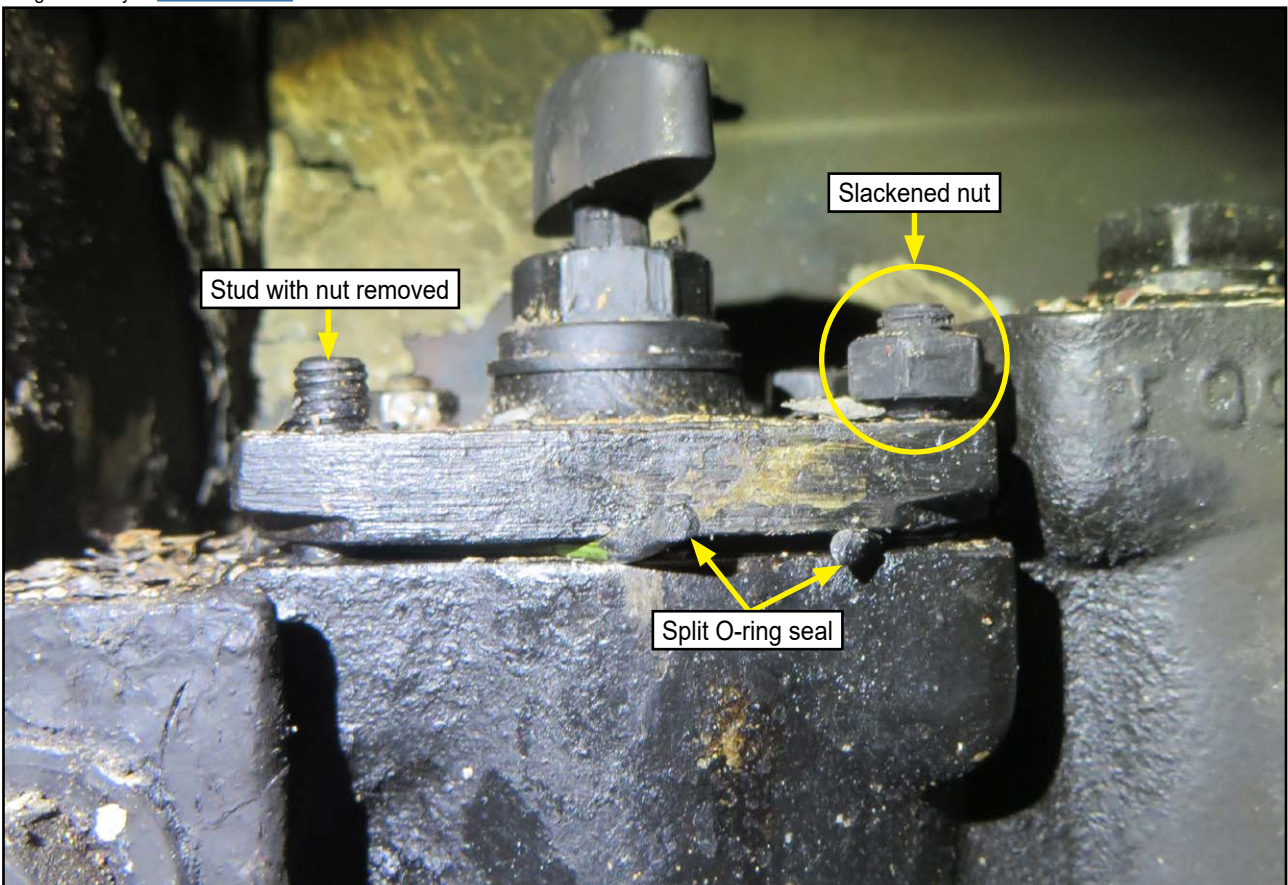
The gap between the left-hand filter cover and the filter housing was measured and found to be a maximum of 2.66mm at the front and 1.26mm at the rear. The front right-hand stud was found to be loose.

**Figure 15:** AE1 left-hand fuel filter cover and split O-ring seal

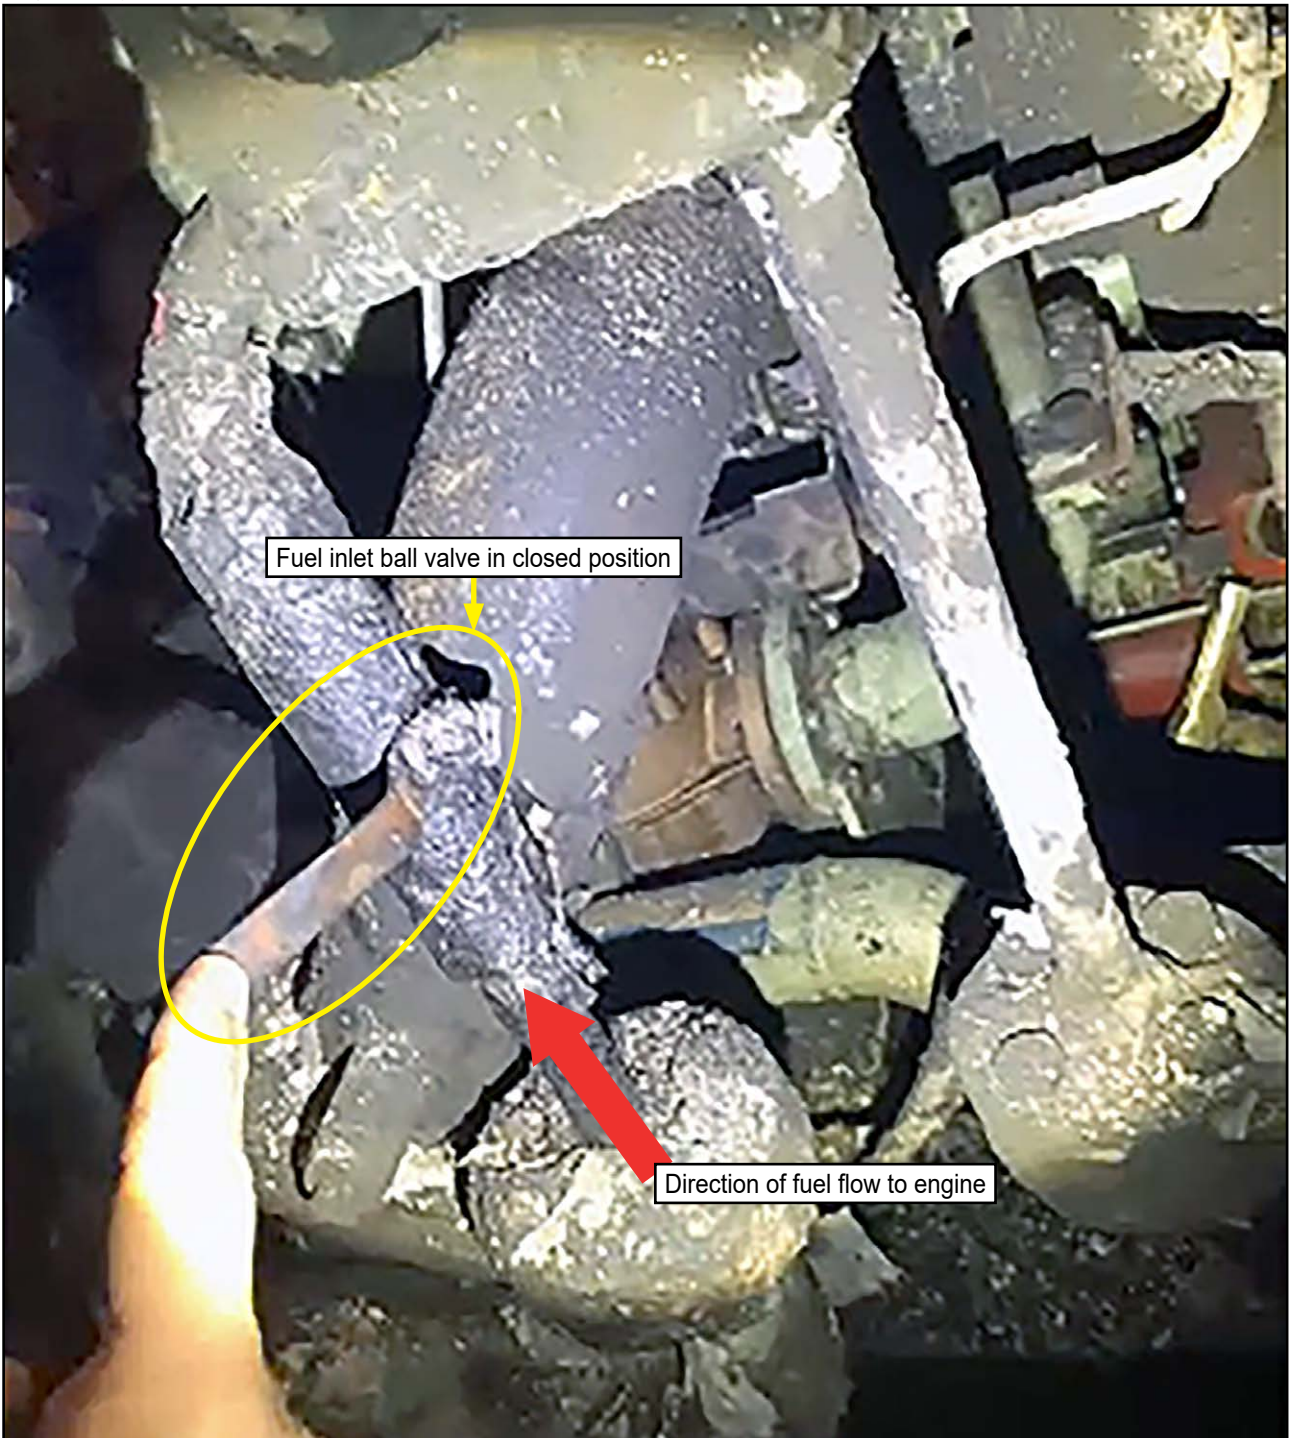
The fuel supply isolating ball valve was found in the closed position (**Figure 16**). The fuel return isolating ball valve was found in the open position.

The fuel supply isolating ball valve and the non-return valve on the fuel return side of the pipework were pressure tested to 5.5 bar and found to hold pressure without leakage. The return line isolating ball valve was similarly tested and found to not close fully, resulting in a leak. Further examination of this valve identified ball seal damage.

**Figure 16:** AE1 fuel supply isolating ball valve

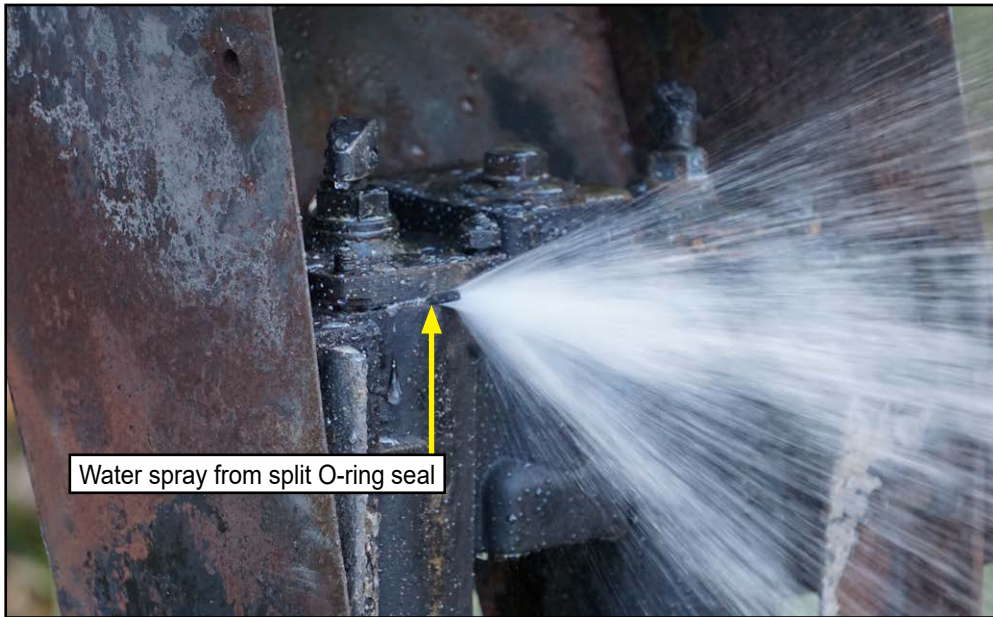
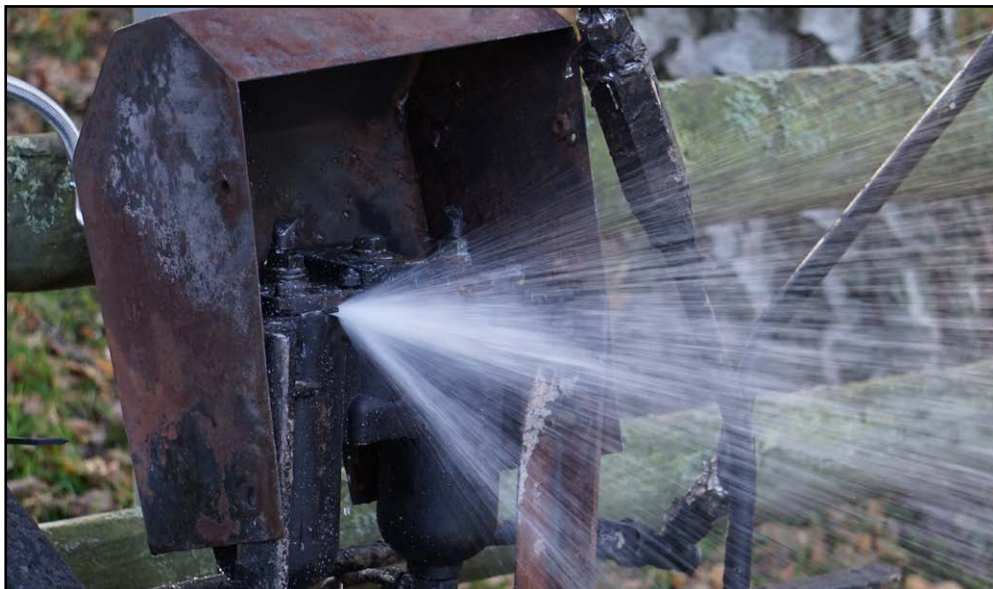
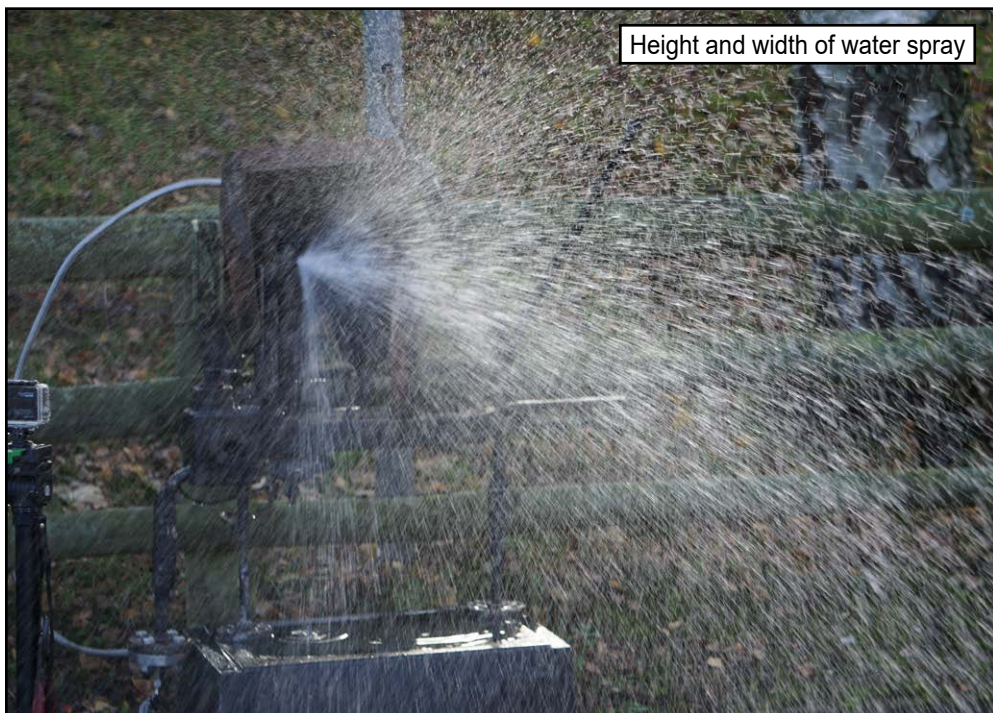
To understand the extent of fuel leakage through the partially removed left-hand filter cover, a 107 litres/minute 20 bar water pump was connected to the supply side pipework. The fuel filter and pipework testing ranged from 2 bar to 7 bar and at 5 bar the water spray reached up to 4m with a height of about 1.6m (**Figure 17**).

Figure 17: AE1 left-hand fuel filter leakage test

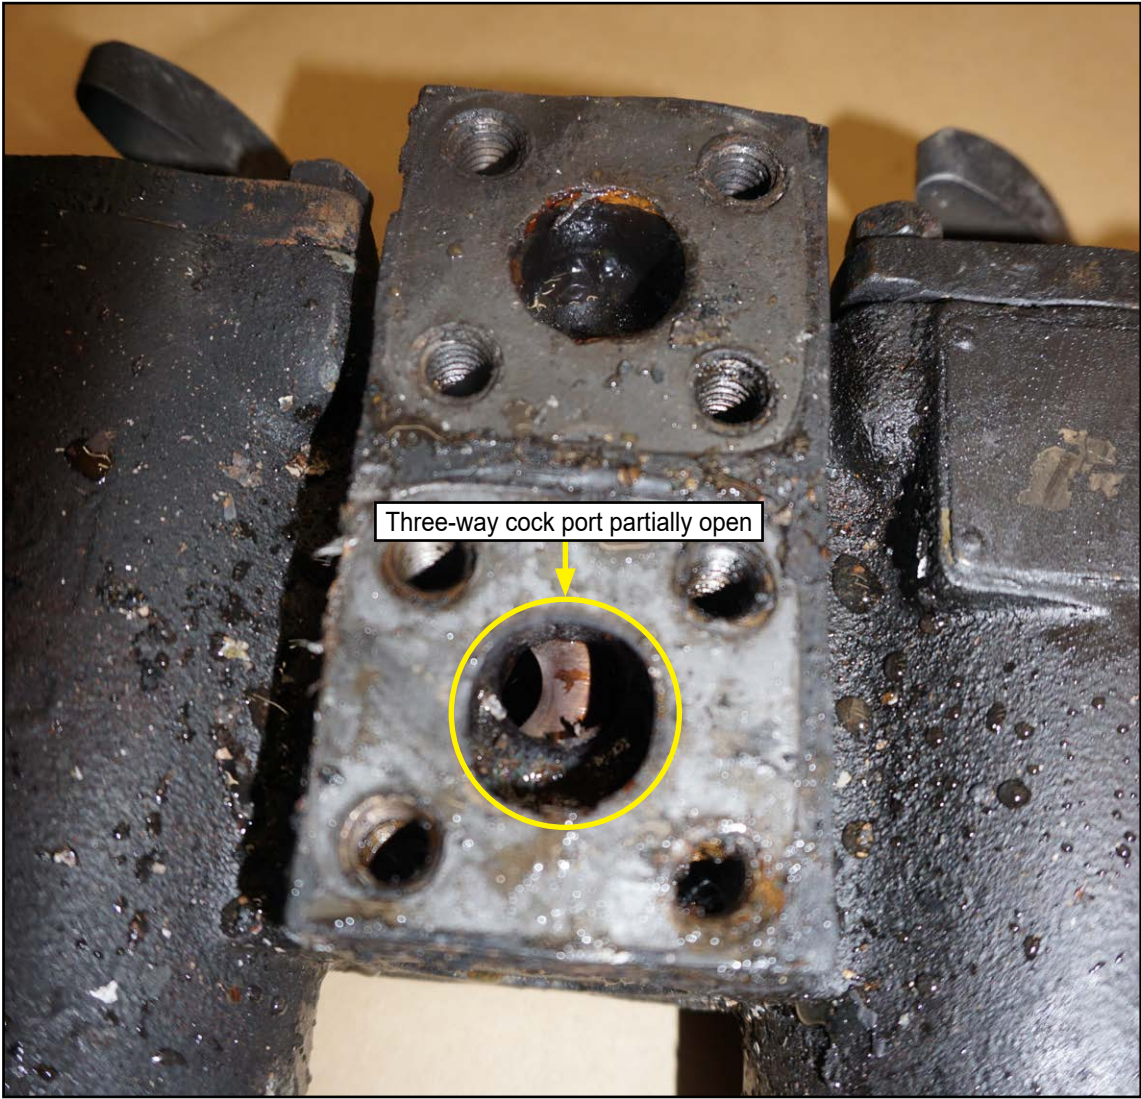
Both duplex filters were removed from their housings and found to be clean. The inlet and outlet ports within the housing were partially open (**Figure 18**) due to the as found three-way cock position; when tested, the cock could be rotated and the ports closed. The failed O-ring seal was in good condition and, apart from where it had split, was still in position (**Figure 19**).

**Figure 18:** AE1 fuel filters three-way cock ports partially open

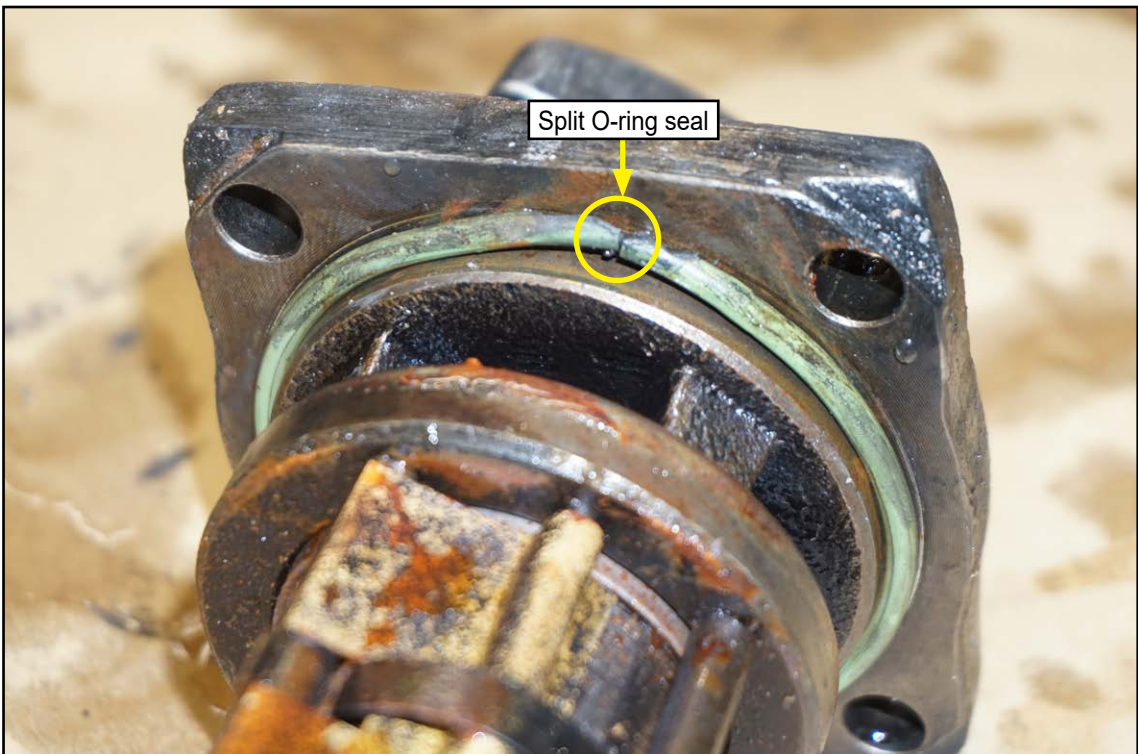
**Figure 19:** AE1 left-hand fuel filter cover plate O-ring seal

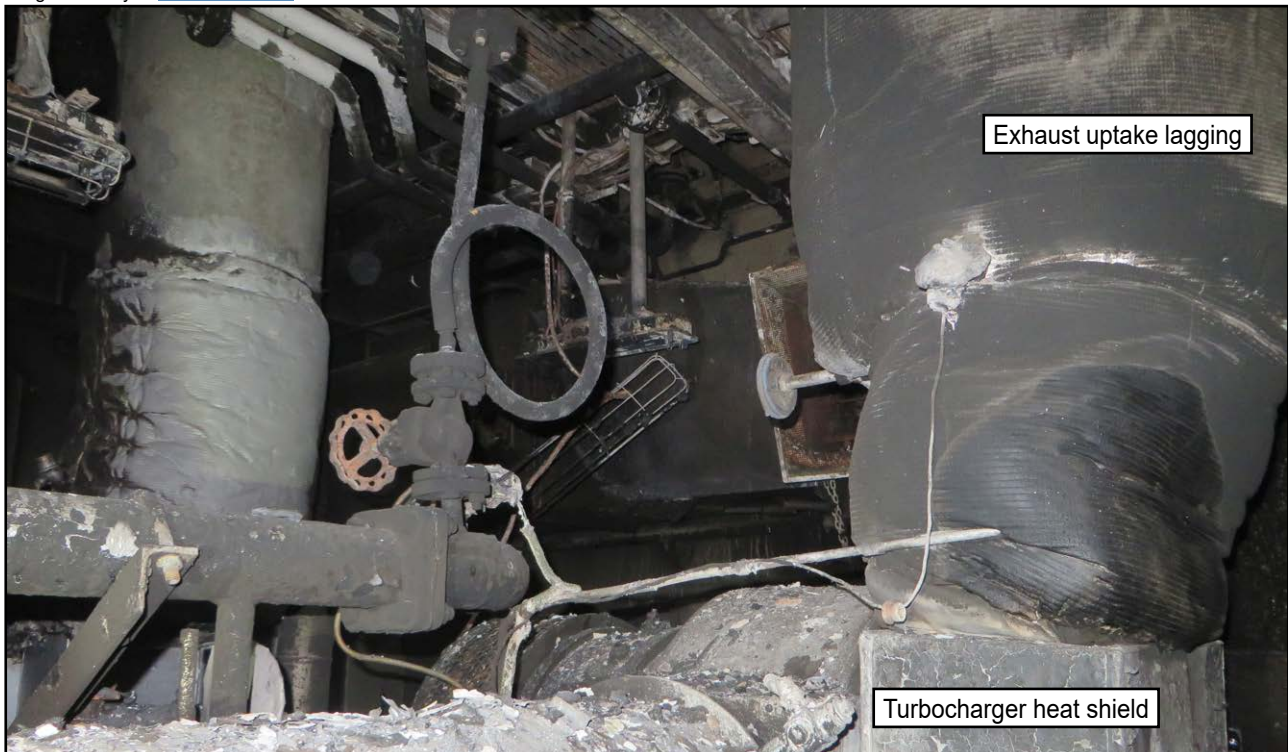
The exhaust pipework and turbochargers of the three AEs were protected by lagging insulation, which was covered by a thin galvanised sheet steel heat shield riveted together to form a homogenous barrier. The exhaust uptake pipework above the turbocharger heat shield was lagged (**Figure 20**).

**Figure 20:** AE2 exhaust insulation

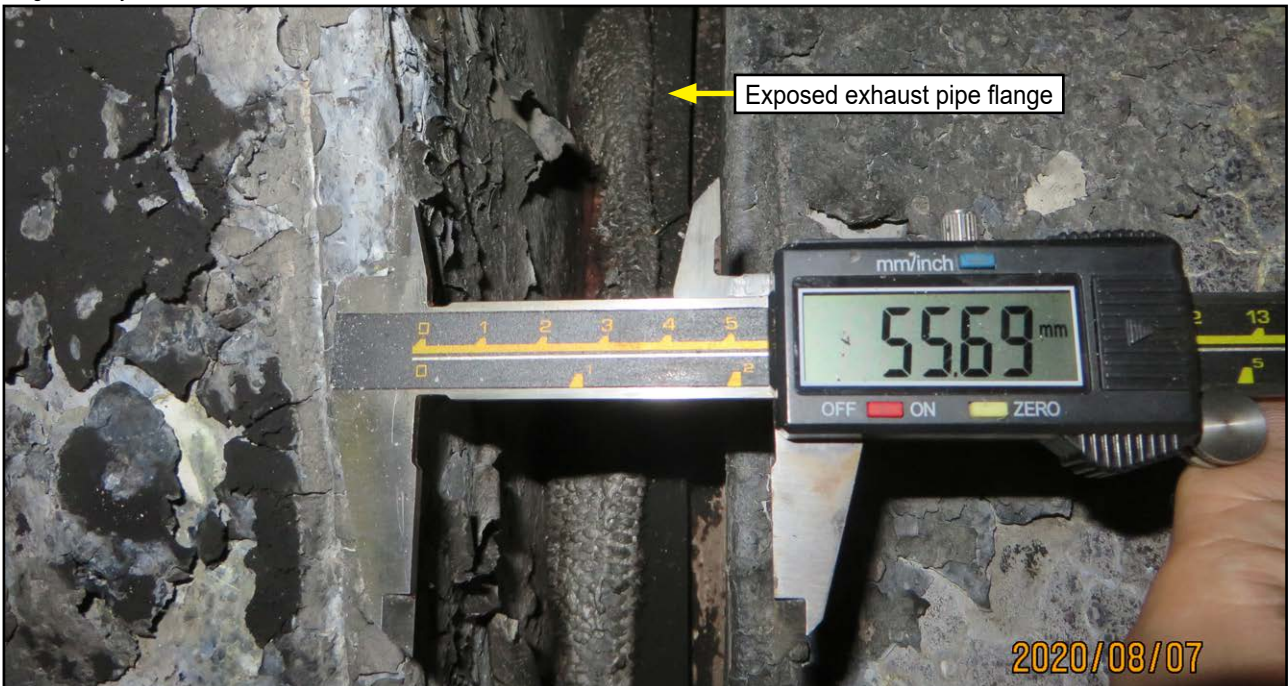
**Figure 21:** AE2 gaps in heat shields and exposed exhaust flange

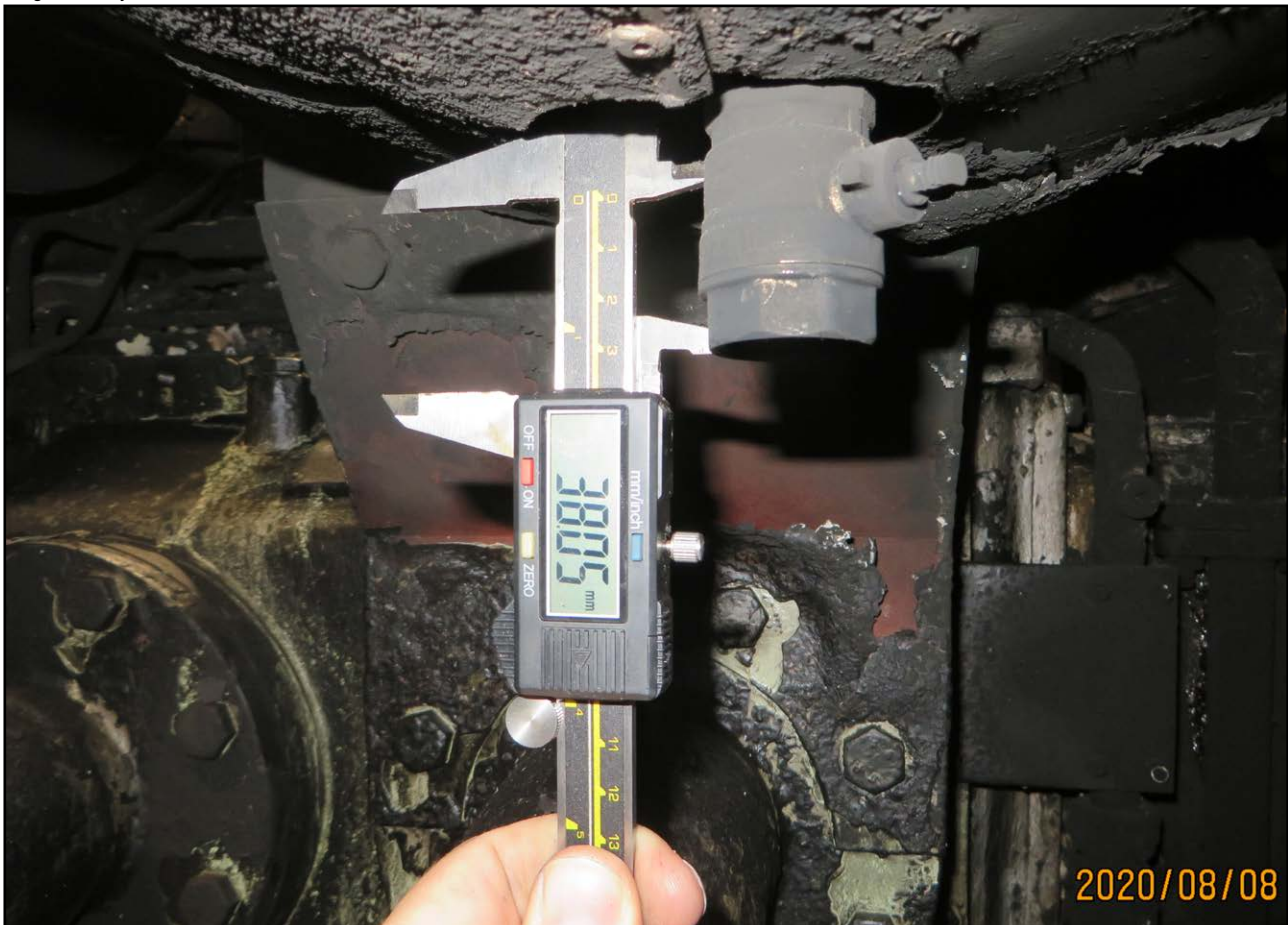
Additional exposed exhaust components included an unlagged valve on the turbocharger water-washing drain connection at the base of the turbocharger, which protruded almost 40mm beyond the heat shield (**Figure 22**).

**Figure 22:** AE2 exposed turbocharger water washing drain connection

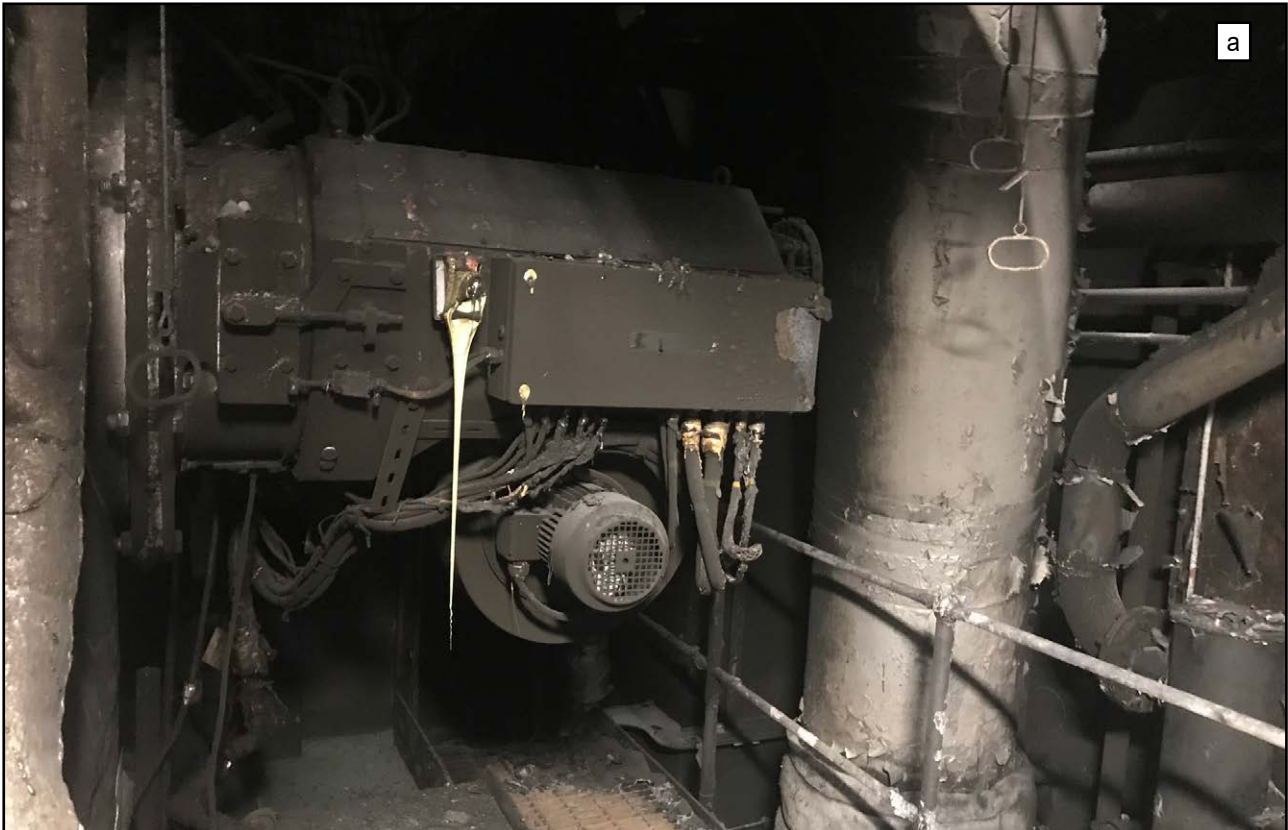
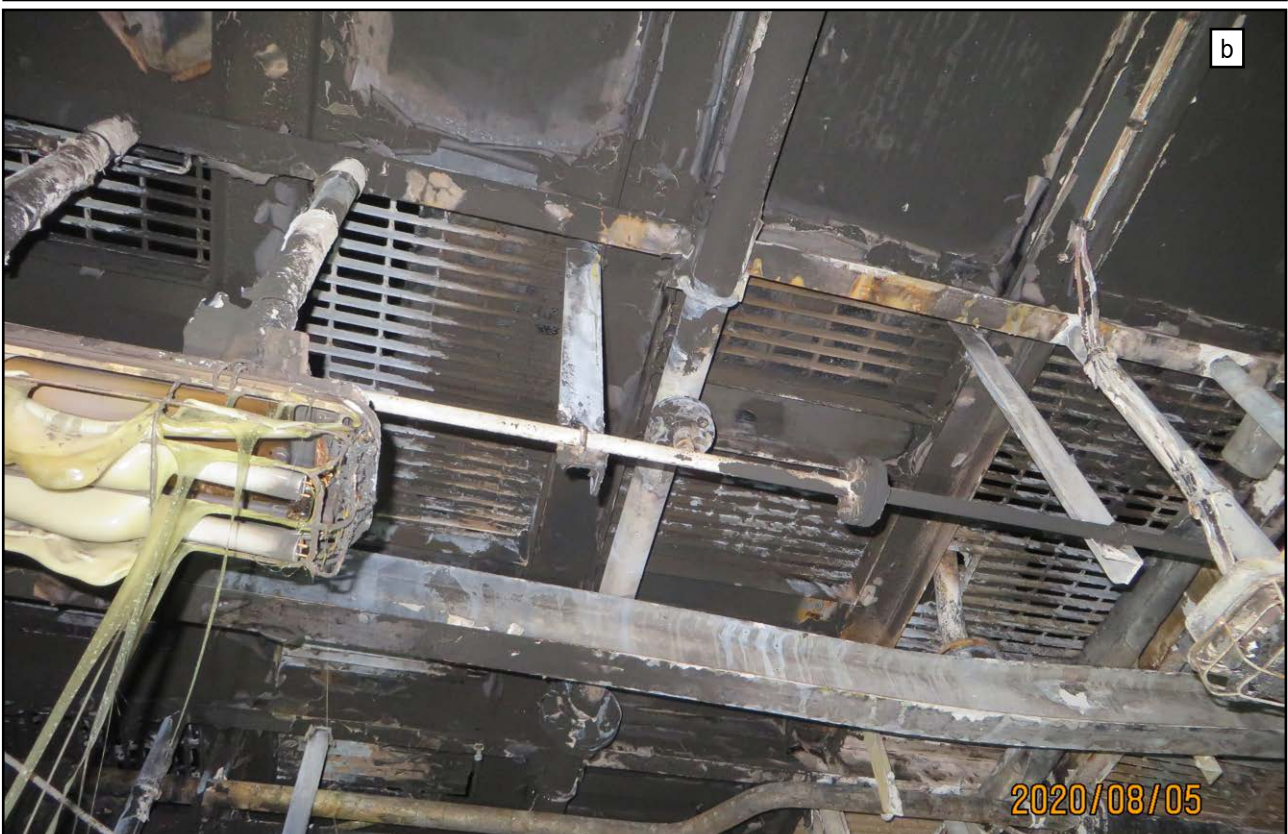
The fire was relatively short in its duration, but intense. It was localised at the aft end of the ER, around the aft end of AE1 and AE2 on A Platform and the entrance to the SG room. The fire had spread upwards, causing heat-related damage to the equipment on the boiler platform above the AEs (**Figures 23a** and **23b**). Heavy smoke damage was prevalent elsewhere.

**Figure 23:** Boiler platform fire damage (a) and view up to boiler platform from auxiliary engines (b)
