Isle of Man Ship Registry

Casualty Investigation

Report No. CA124

Isle of Man Registered “Hanjin Green Earth”

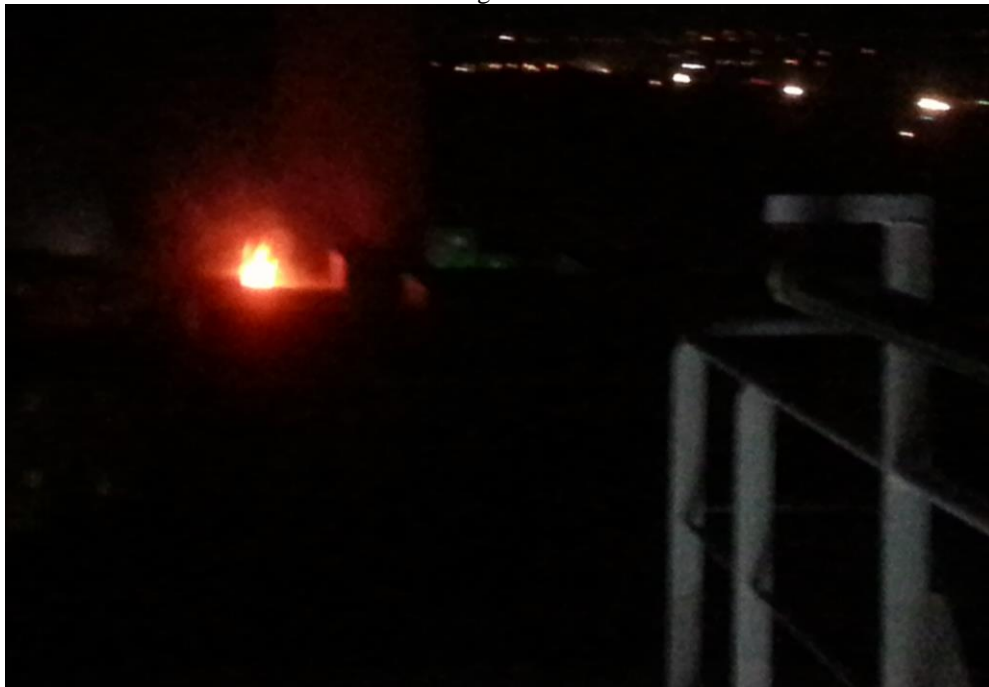
Figure 4

View of fire following CO₂ release taken from outside Navigation Bridge

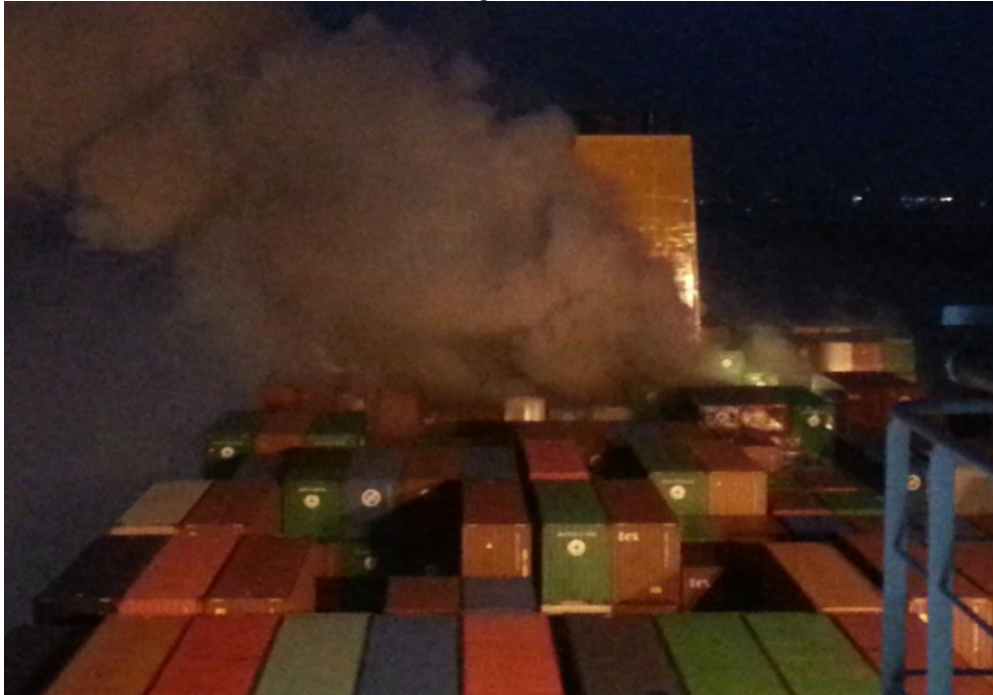
Figure 5

It was reported that the water jet from “Mosad 3” made little difference to the fire.

View of fire at the time of arrival of first tug “Mosad 3”

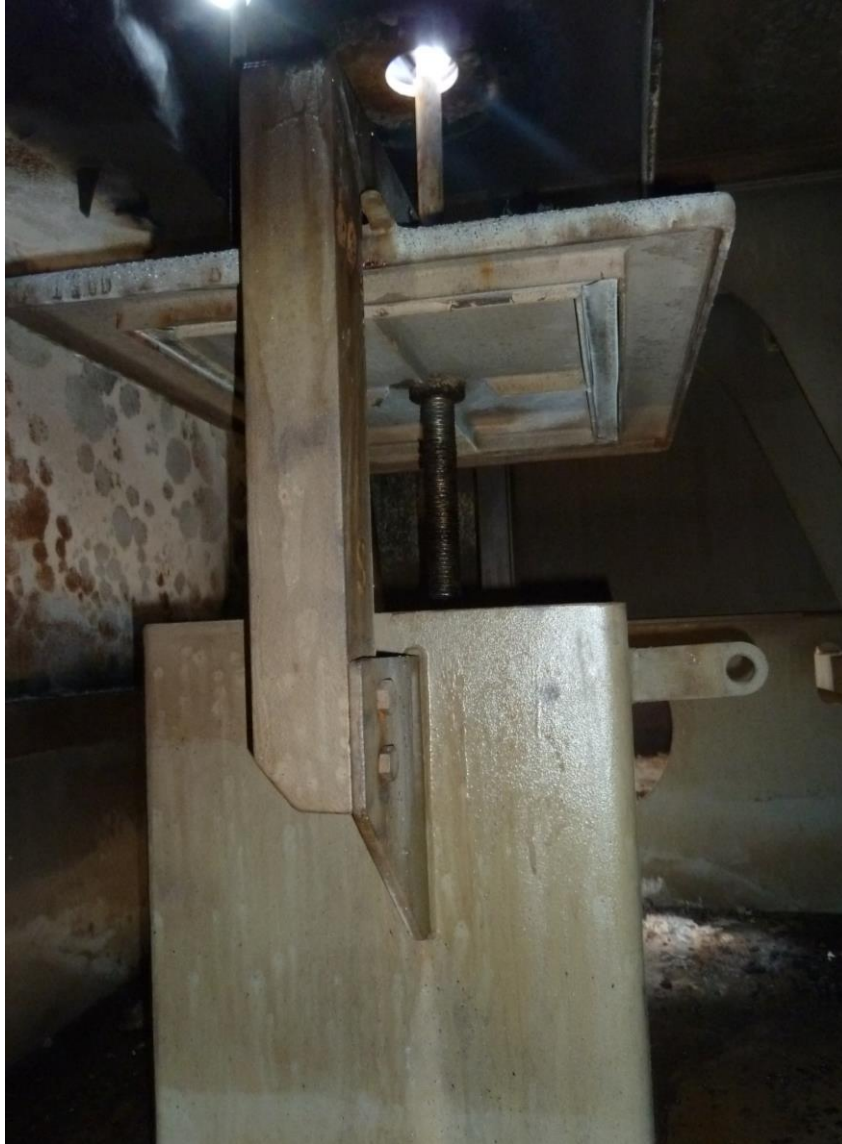
Figure 23

Example of the screw down ventilation trunking lid arrangement situated directly below X deck walkway

It could not be established if the screw down lids for the 2 hold ventilation supply trunkings were fully shut by the firefighting crew tasked with the job.

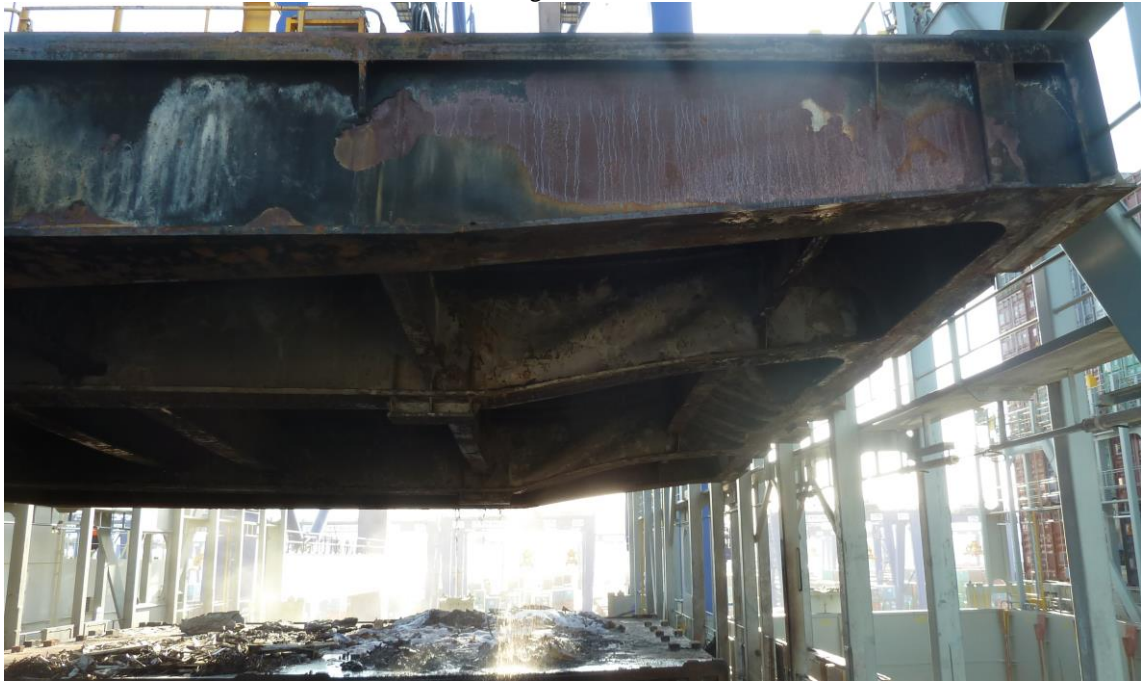
Figure 30

Once the containers on top of the 4 hatch covers had been removed it could be seen that there was significant damage to the 2 inner hatch covers. The deformation of some of the large structural members of the hatch covers could easily be seen as could the deformation of the steel plating on top of the hatches.

Bay 70 stbd inner hatch cover being removed in Algeciras

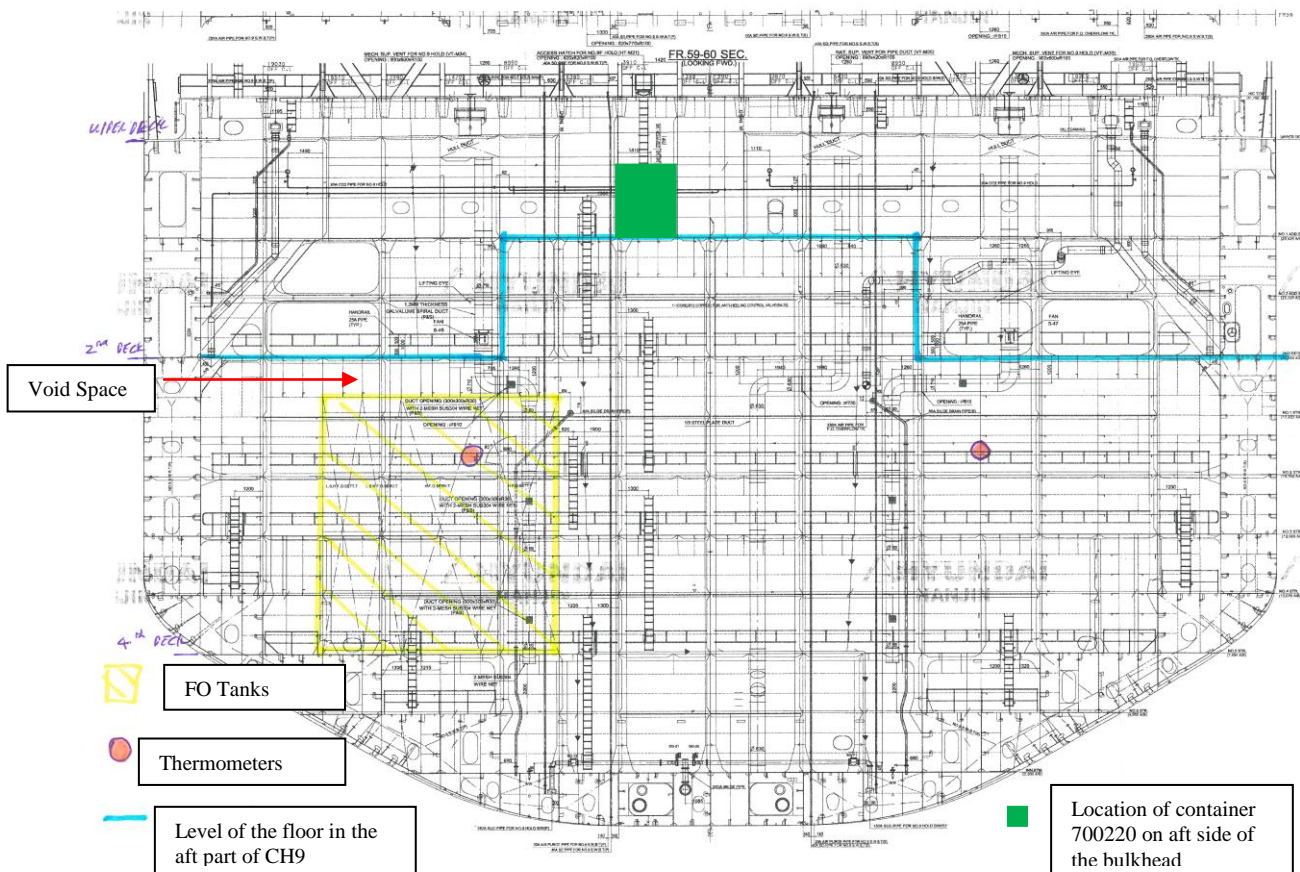
Figure 42

Two hold temperature readings are taken daily by local thermometers placed in the X deck though not positioned directly against the bulkhead. The local thermometer on the port side is located in the area of the X deck adjacent to the fuel oil settling and service tanks on the port side of the mid hold X deck bulkhead (see figure 42).

HFO has a mandatory min flash point of 60°C though typically the actual flash point of 380cst HFO can vary between 65-90°C. It is common practice to store fuel in the settling tanks approx. 5°C below the flash point. HFO storage tank temperatures would typically be around 95°C. There would have been scope to reduce the fuel tanks temperatures a little, however, these storage temperatures would not be considered excessive.

Section of X deck CH9 (looking fwd) showing the position of the port local thermometer in relation to the fuel oil tanks which are on the aft side of this bulkhead. The aft half of CH9 is relatively shallow, the base of which is at deck 2 level.

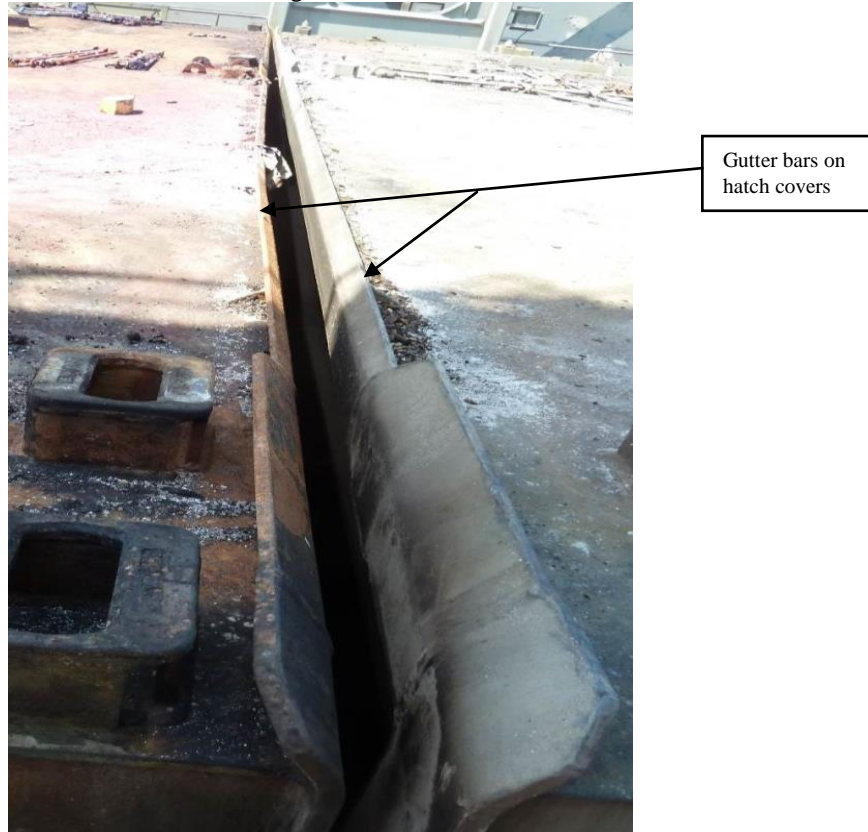
Figure 46

This longitudinal gap running between each hatch cover can have a max width of 50mm with the longitudinal length of each hatch in this case being 12.95m. There is also a 17mm air gap between the bottom of the hatch covers and hatch coaming as no rubbers are fitted on this design of vessel with the hatch resting on bearing pads.

In consequence this inability to seal the hatch covers would seem contrary to what would normally be expected to be found on a more conventional vessel. Typically once all vents and dampers have been closed it would be assumed that the space would be relatively air tight in order to prevent air entering the space and CO₂ from escaping from it once released. As indicated above this is not the case on Hanjin Green Earth.

Longitudinal gaps between hatch covers. Gutter bars shown are for preventing water entering between the gaps in the hatch covers so it instead runs fwd or aft and off the hatch covers

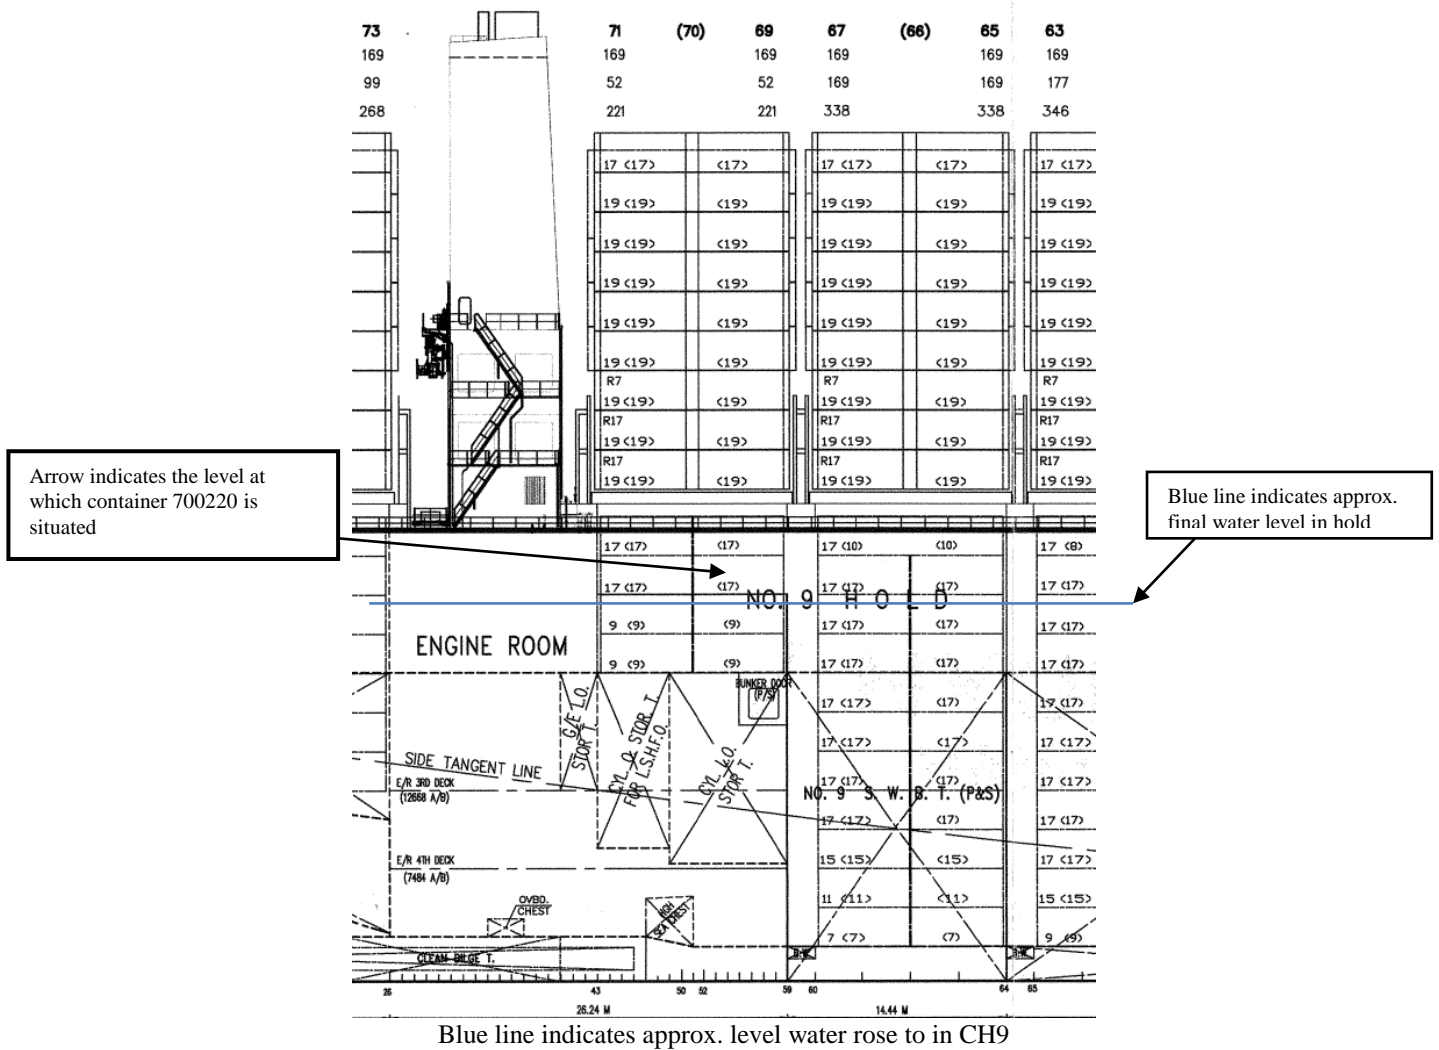
Tide mark clearly seen above ladder on deck 2.

The water in the hold was a result of the firefighting water used to fight the fire on deck which entered the hold through the longitudinal gaps in the hatch covers and gaps between the hatch coaming and the bottom of the hatch covers. As it could not be ascertained if the rectangular screw down lids for the 2 hold supply trunkings were fully shut it is also possible that some water flooded into the hold via his route. It would seem odd that such a large volume of water could enter the hold via the hatch covers as it may be assumed that a hatch cover should be weathertight. However, as discussed in 3.5 above MSC/Circ.1087 allows longitudinal gaps between individual hatch covers and also between the bottom of the hatch covers and the top of the hatch coamings.

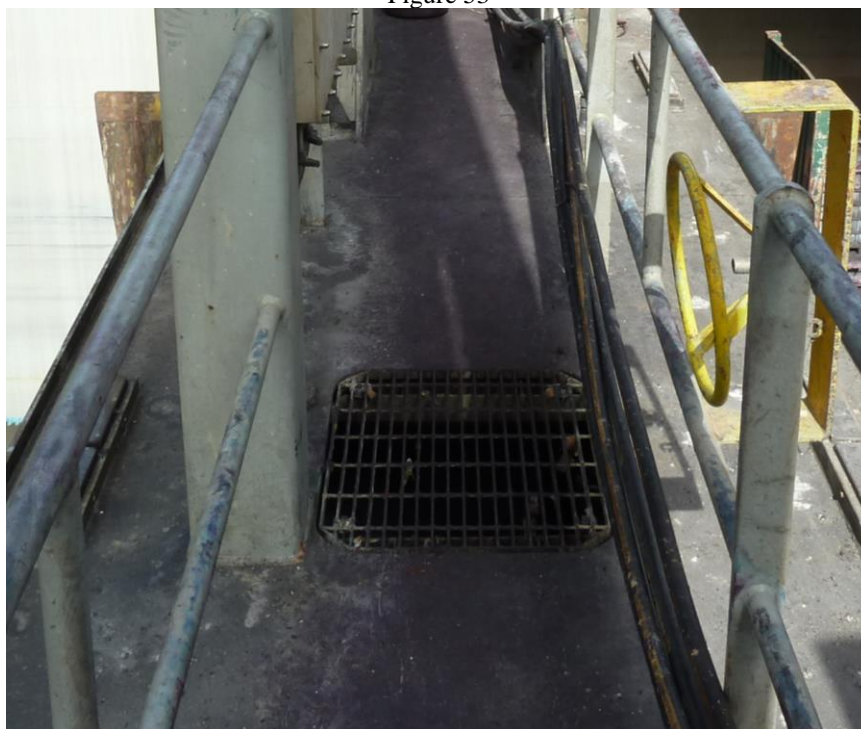
Figure 53

As previously mentioned it could not be ascertained as to whether the rectangular screw down lids for the 2 x supply fan ventilation trunkings had been fully shut. On the top of the X deck there are large grids on the deck (figure 53) to allow air to be drawn into the ventilation trunkings that sit directly below the X deck. If the above was the case then the firefighting water could have poured down into these spaces. Normal drainage for these spaces is through small drainage holes in the corners as shown in figure 55. Larger quantities of water as could have been experienced would rise up until level with the larger lightening holes then travel outboard. Both spaces would eventually drain out onto the main deck walkway via 2 elliptical holes at the end of the spaces on both port and stbd sides (fig 56-57). These elliptical drainage holes would only normally have to deal with rainwater run-off. Due to the amounts of water entering the space it is likely that these 2 elliptical holes would not be large enough to disperse the quantities of water entering these spaces, thus the level inside the space would continue to rise. Once the level reached 760mm i.e. the top of the ventilation trunking opening (if the cover was not fully screwed down) then the water could run down the trunking and into the hold.

One of the grids flush in X deck walkway leading to X deck supply fan inlet trunking situated directly below the X deck.

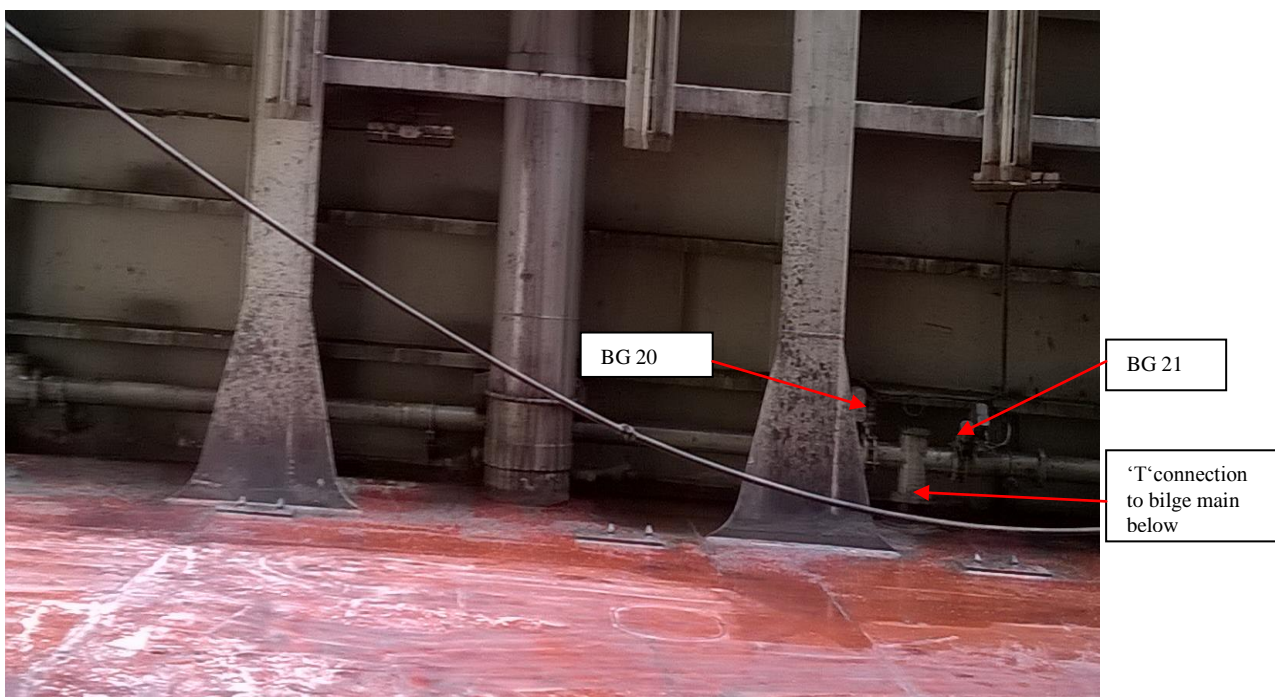
Figure 59

The ER event log shows numerous attempts to operate the CH 9 bilge suction valves BG020 and BG021 between 17:17hrs and 17:36hrs. The valves were found to be inoperative and thus they were unable to start pumping out the accumulation of the fire water from the hold.

Shows stbd bilge valve and actuator BG21 in the foreground and port bilge valve actuator BG20 can be seen in the background. Both lead into bilge main below via T connection (orange pipe).

Port and stbd bilge lines arrangement dropping down to bilge main in duct keel below tank top.

If the bilge pumping system in CH 9 had been effective it would have allowed the hold to be pumped out and ensured the vessels' longitudinal strength and stability were not put at risk. The concern with the amount of fire extinguishing water being used on the fire by the FiFi tugs would also have been unnecessary. In such scenarios it is critical that these valves and actuators and cabling remain operable and intact so the option to pump out the hold is always available.

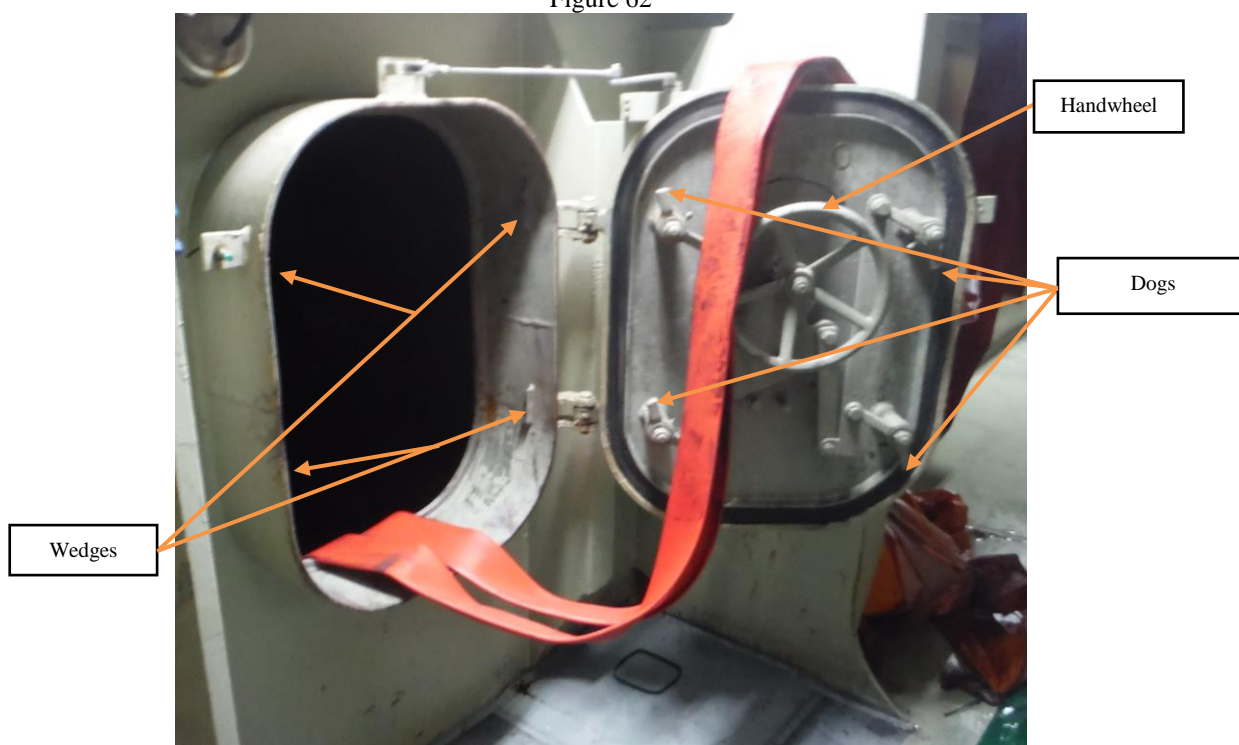
Figure 62

Just after 18:45hrs ship's crew entered the hold via the stbd underdeck passageway WT door on deck 2 (figure 62) and the water level was found to be level with the floor of deck 2. This level is 18.14 m above the inner bottom and 20.55 m above the base line¹

WT hatch to CH9 from 2nd deck underdeck passageway, with closing arrangements indicated

The design of this WT hatch door consists of a gear toothed central wheel operating a geared rack that in turn via link arms close and open the 4 dogging levers (figure 62). The dogging levers locate onto tapered wedges welded within the circumference of the hatch frame and pull the hatch door inwards until it seals tight against the frame. The design means that from the fully closed position the hatch cannot be opened more than a few millimetres before the dogging levers will disengage completely from the tapered wedges. As soon as they disengage from the wedges the door is free to open.

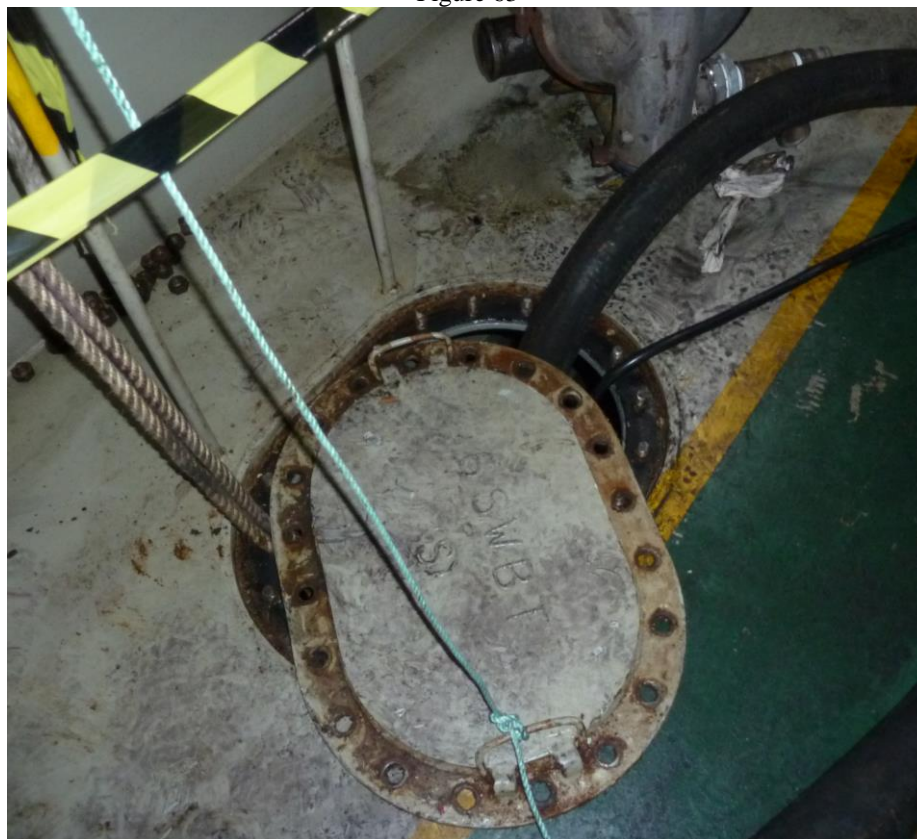
Figure 63

In the time between the last inspection inside CH 9 through the WT hatch (20:35hrs) and time taken by the crew to prepare for the draining operation, (which would include removal of ballast tank covers in the underdeck passageway (figure 63), preparing a portable air driven salvage pump and rigging a tarpaulin at the bottom of the WT hatch to direct any leakage into the closest ballast tank), the water level rose past the bottom of the WT hatch.

Ballast tank lids removed for drainage

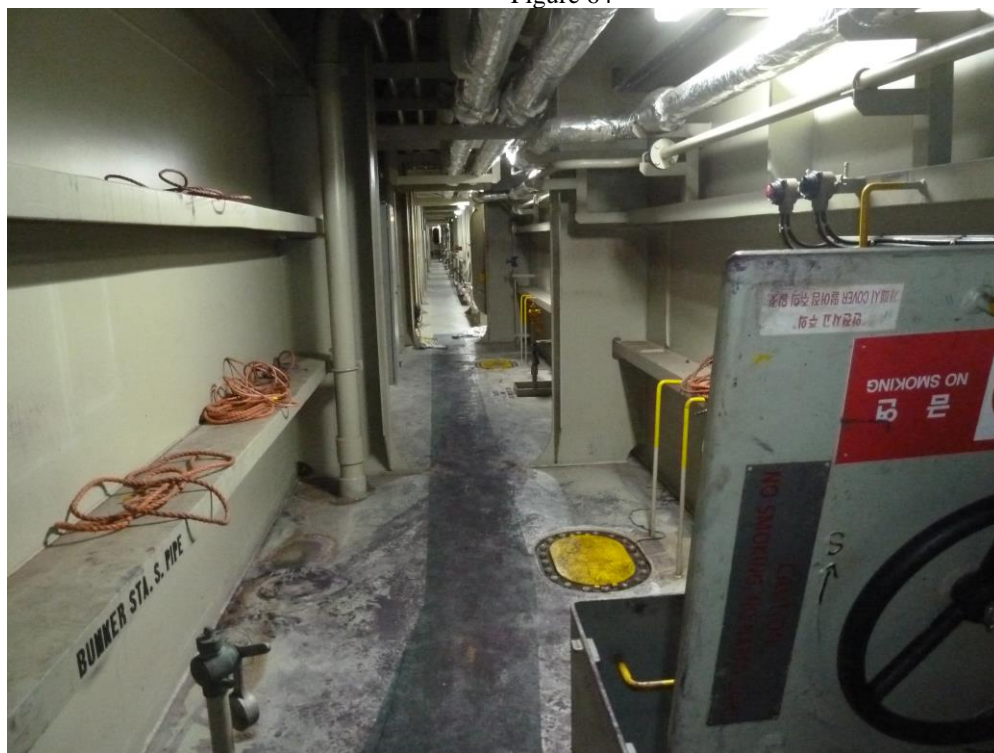
Figure 64

Bunker station WT hatch foreground – ER WT door opening is 2 frames aft out of sight behind framing
–Aft WT door found at the very end of the passageway. Pipe hangers can be seen above

There seemed to have been little consideration given to the implications of what would happen if the WT door opened fully i.e. the consequences and risks to those in the immediate vicinity of a sudden release of a huge amount of water into the narrow underdeck passageway which runs the length of the stbd side of the vessel on deck 2. Those involved should have realised that due to its design that this type of door could only be opened very slightly before the dogging levers would become disengaged from the tapered wedges. It was obvious that the water level was some way above the top of the door and as a result there would be substantial flooding to the space if the door inadvertently opened.

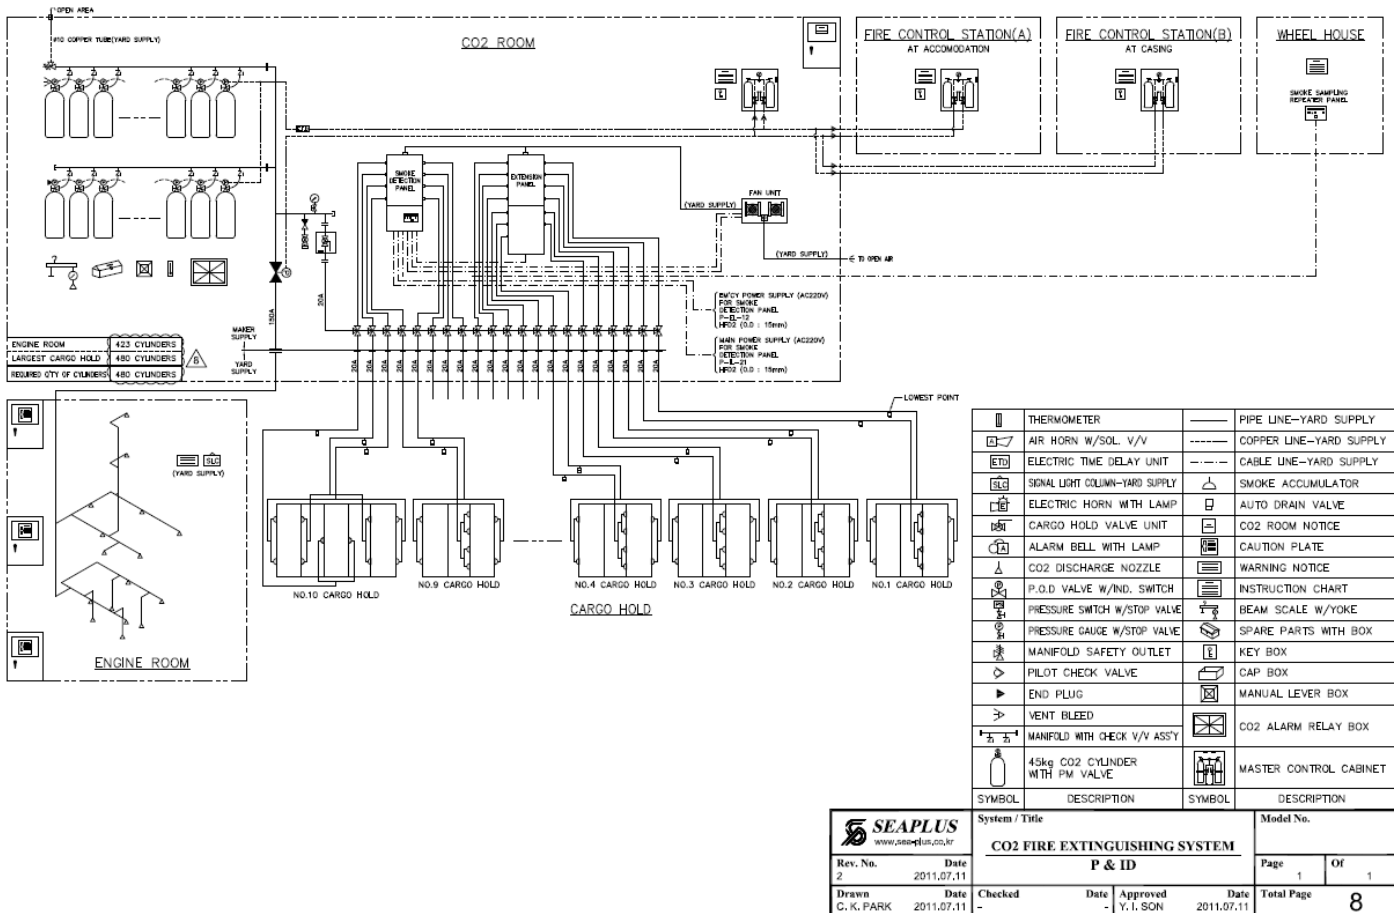
Figure 1

Overview of CO2 System

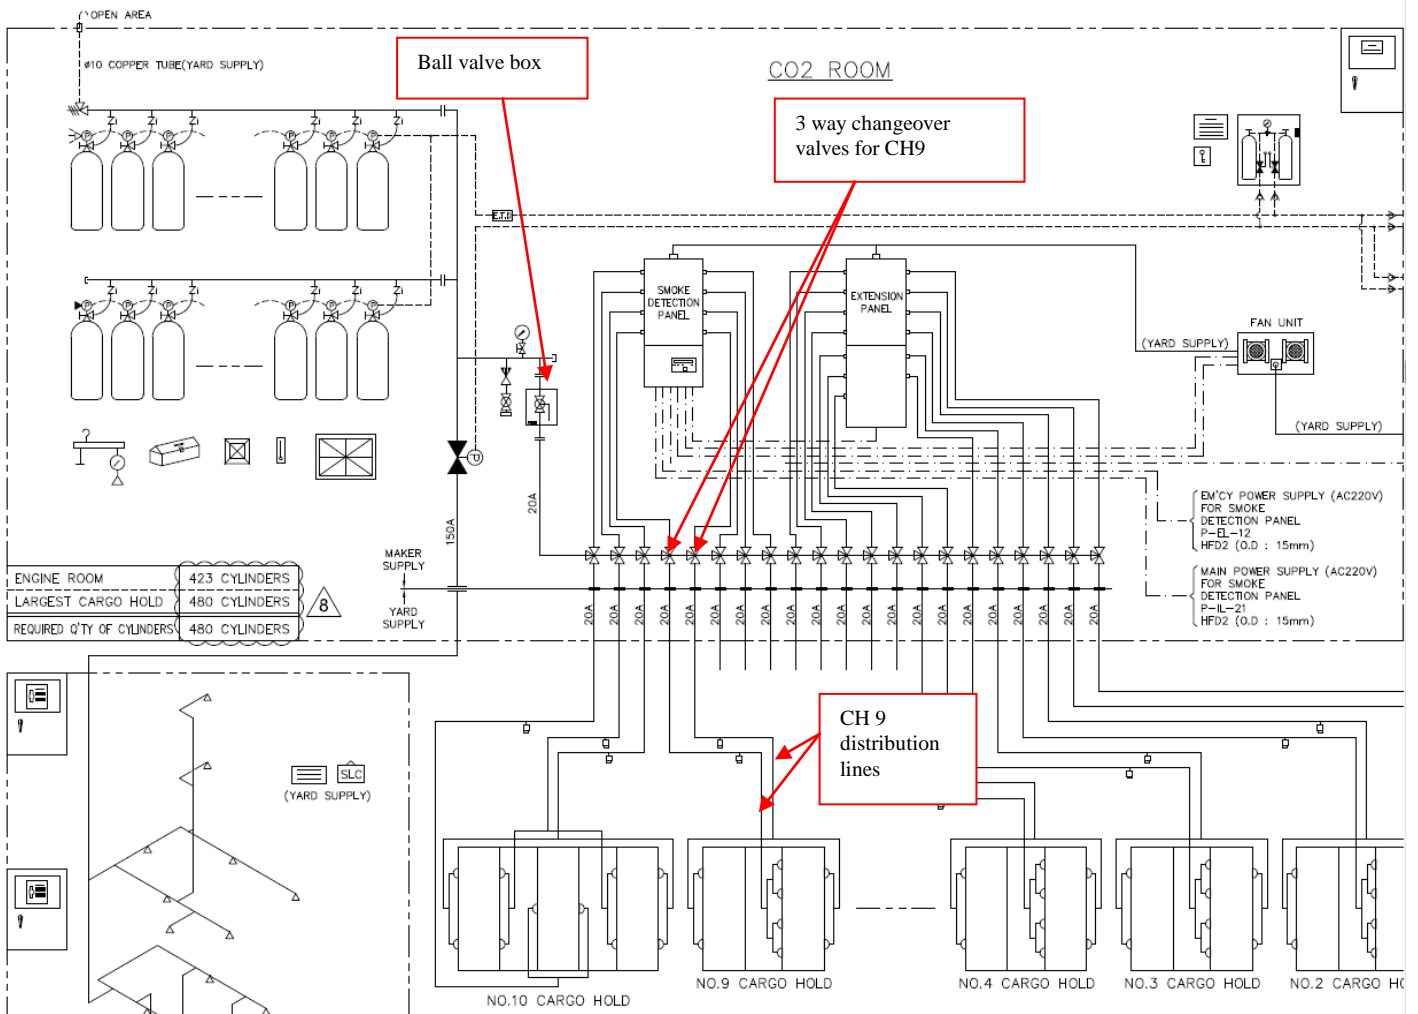
Figure 2

Enlargement to show; ball valve cabinet, 3 way changeover valves (smoke/CO2) and CH9 distribution lines.

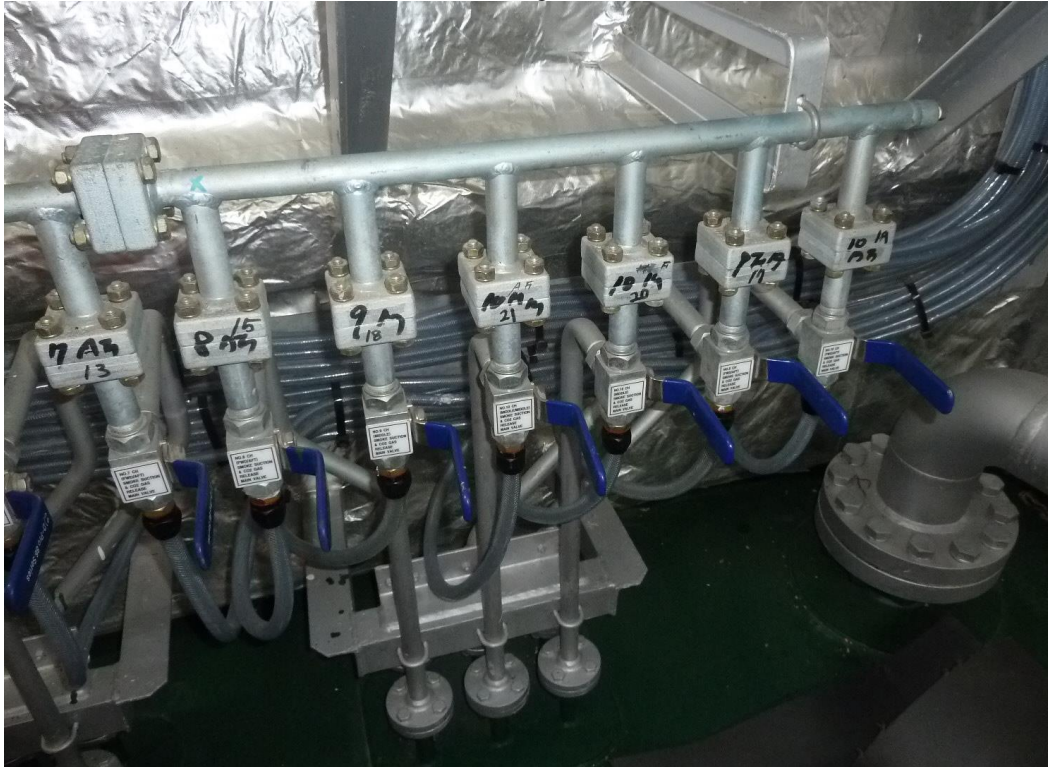
Figure 3

Section of CO₂ distribution manifold showing blue handled levers used to change over from smoke sampling to CO₂ delivery

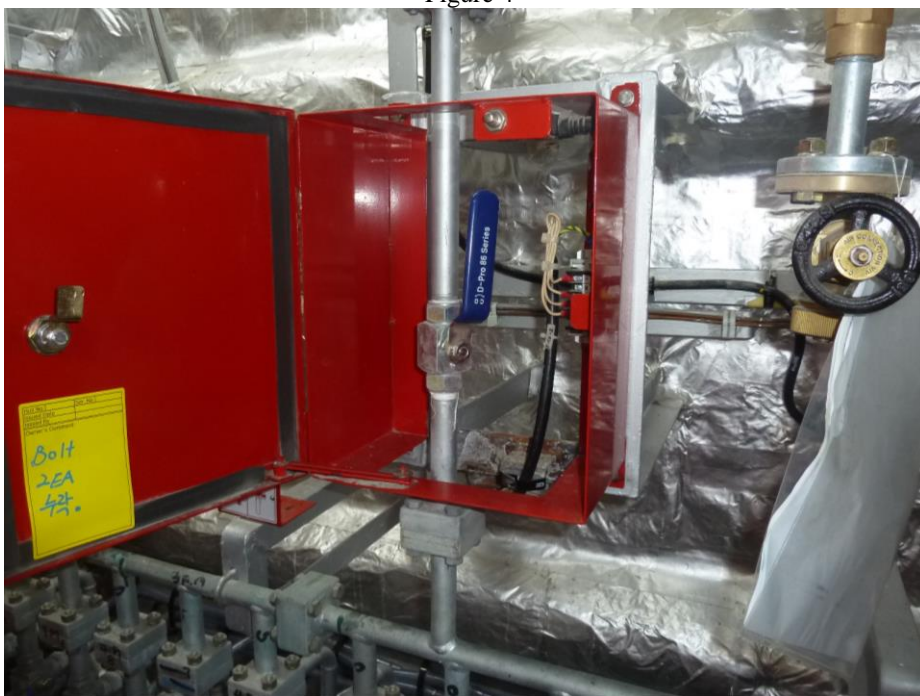
Figure 4

Ball Valve Box for cargo hold open shows operating lever and micro-switch for alarm

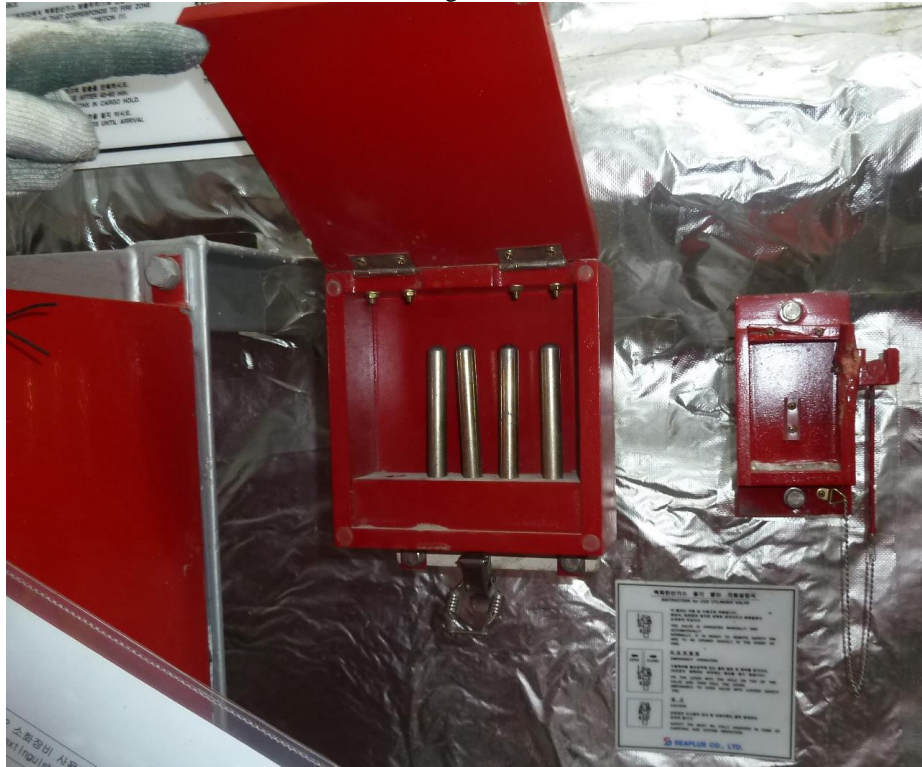
Figure 5

Manual lever box showing CO₂ bottle manual actuating levers
