Isle of Man Ship Registry

Casualty Investigation Report No. CA 119

Nordic Visby

Fatality

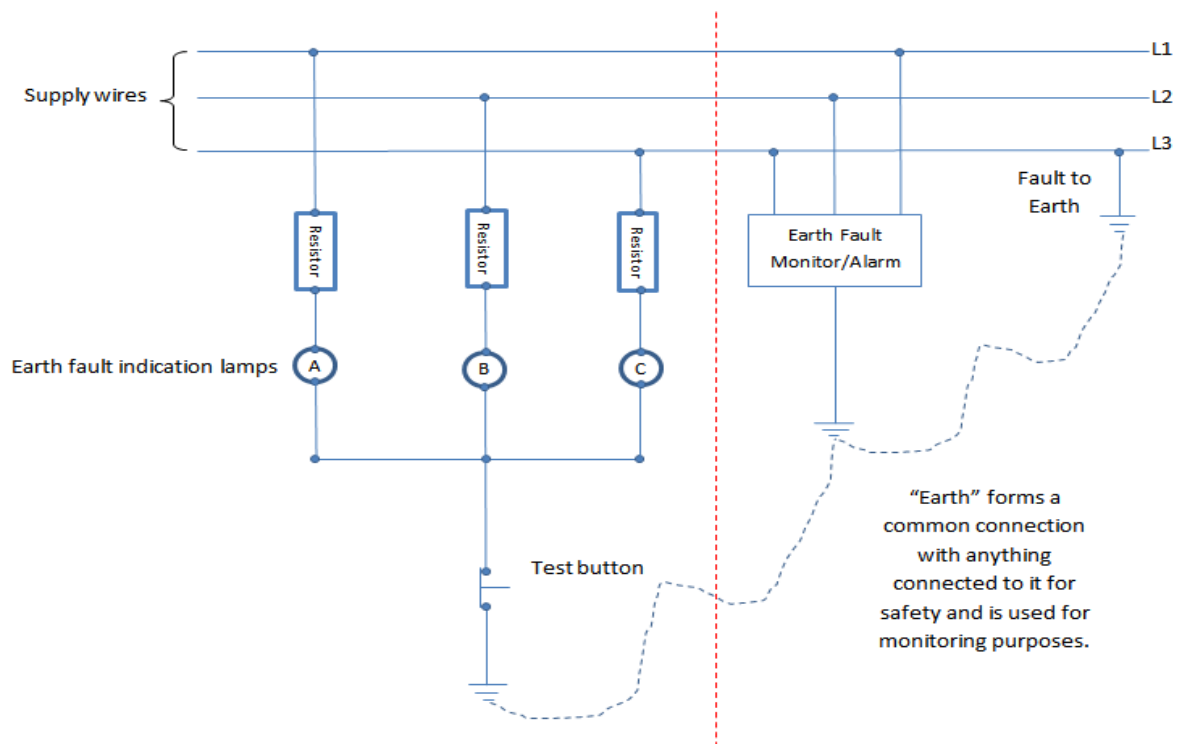
The left side under no fault conditions has all three indicator lamps normally burning with equal brightness. If a fault develops on one supply line, depending on the resistance to current flow to earth, one lamp dims compared to the others. The test button temporarily removes any indicated fault to restore the lamps to their comparison brightness to check the fault has been fully removed (small differences can be perceived by the naked eye). On the right side, continuous comparison monitoring occurs and when a falling insulation resistance threshold is reached (0.5~0.2 MΩ on this vessel) a switchboard alarm is initiated in order that the cause of the fault can be investigated.

The Nordic Visby has continuous monitoring and the alarm printer history shows that no earth faults sufficient to exceed the threshold and initiate an alarm occurred on the night of the incident (or indeed the days leading up to it). Subsequent testing under investigation proved the system to be functioning normally and the alarm sounded soon after a test fault condition occurred. However it was then determined from the alarm history log that the emergency switchboard 220v alarm (ch 673) was set to “offsc” at the time of the incident.

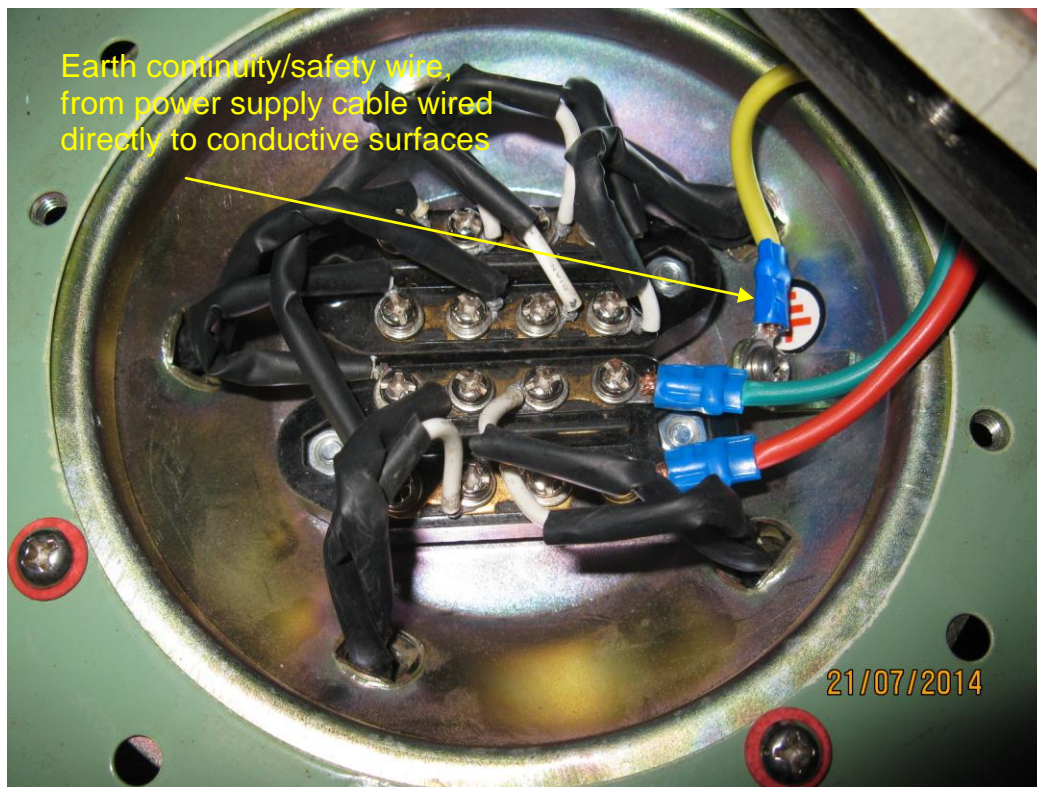
A correctly wired cluster light fitting having earth continuity/safety wire properly attached to a dedicated attachment point.
