Isle of Man
Marine Administration

Report CA 95

Crane Failure / Fatality

Sallie Knutsen

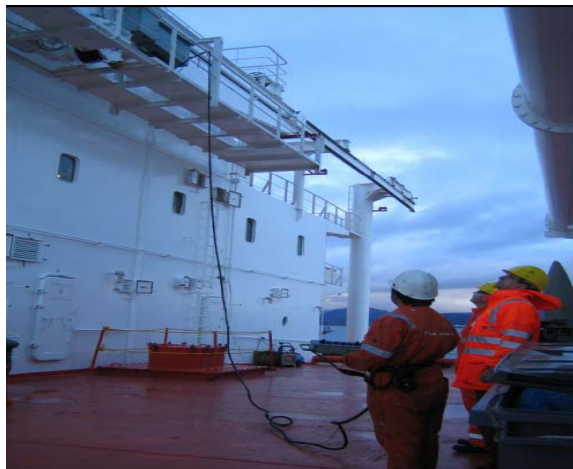
Figure 1

The ship's traverse crane (monorail gantry crane) was prepared for the stores and provisions operation.

Gantry crane looking from port aft

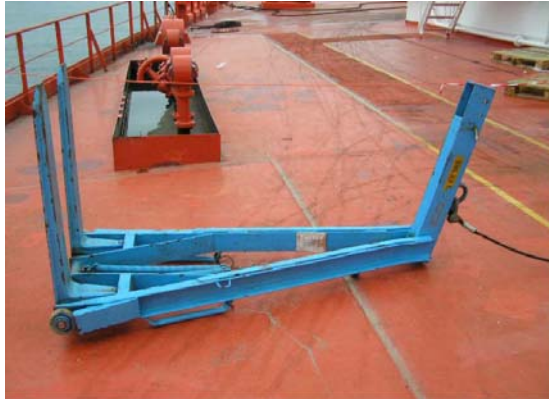
Figure 2

“Bulldog” had thirty five pallets of stores and provisions for the Sallie Knutsen. To facilitate their transfer, Statoil had provided the tug boat with a purpose designed lifting device known as a pallet fork (see figure 2).

Pallet fork lying in horizontal position

When the crane wire failed, the only thing suspended from the hook was the pallet fork which weighed 240kg and its attachment wire.

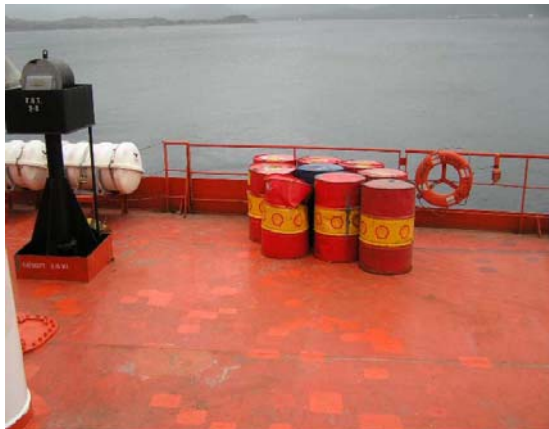
Figure 3

There were also nine, two hundred litre drums of waste oil to back load from the Sallie Knutsen to the “Bulldog”.

Figure of nine two hundred litre drums placed against starboard side rail
