Isle of Man
Ship Registry

Casualty Investigation Report No. CA99

**Isle of Man Registered "SCOTTISH BARD" and Panamanian
Registered "O PRINCESS"**

Collision

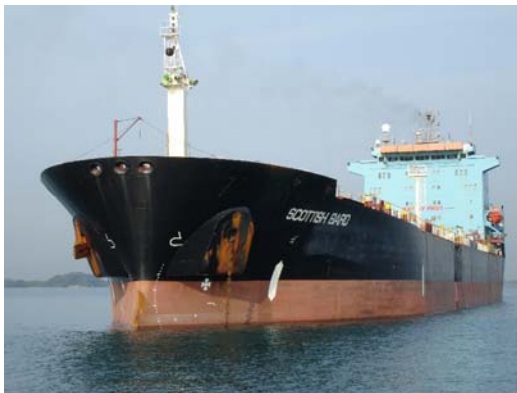
Scottish Bard (pictured at anchor following the collision)

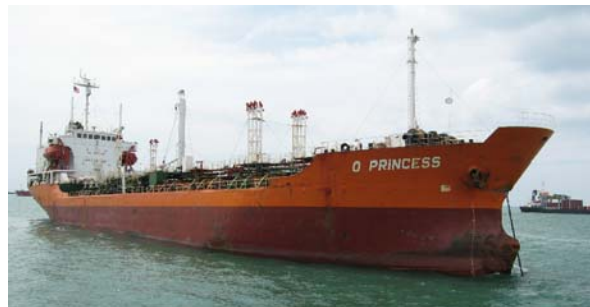
O Princess (pictured at anchor following the collision)

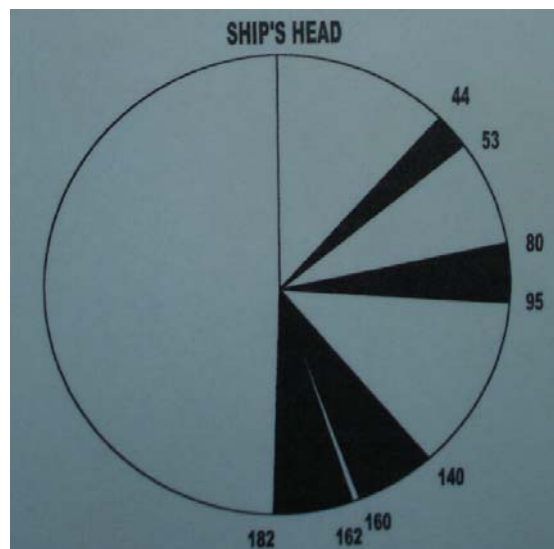
3cm X Band Radar Shadow Sectors

The notice shown below is placed on the 3cm X band Radar informing the Officer of the Watch of shadow sectors that may affect the detection and subsequently the display and plotting of targets.

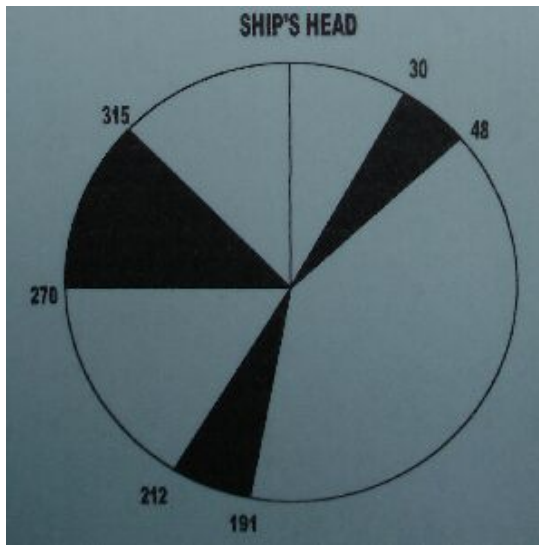
10cm S Band Radar Shadow Sectors

The notice shown below is placed on the 10cm S Band Radar informing the Officer of the Watch of shadow sectors that may affect the detection and subsequently the display and plotting of targets.

12nm Range - Shadow sectors between 270° and 315° from ships head. (Nb picture taken after collision for illustration only.)
