Isle of Man Ship Registry

Casualty Investigation
Report No. CA118

**Isle of Man Registered “Sharp Lady”
Enclosed Space Fatality and Near Fatality**

23rd August 2013

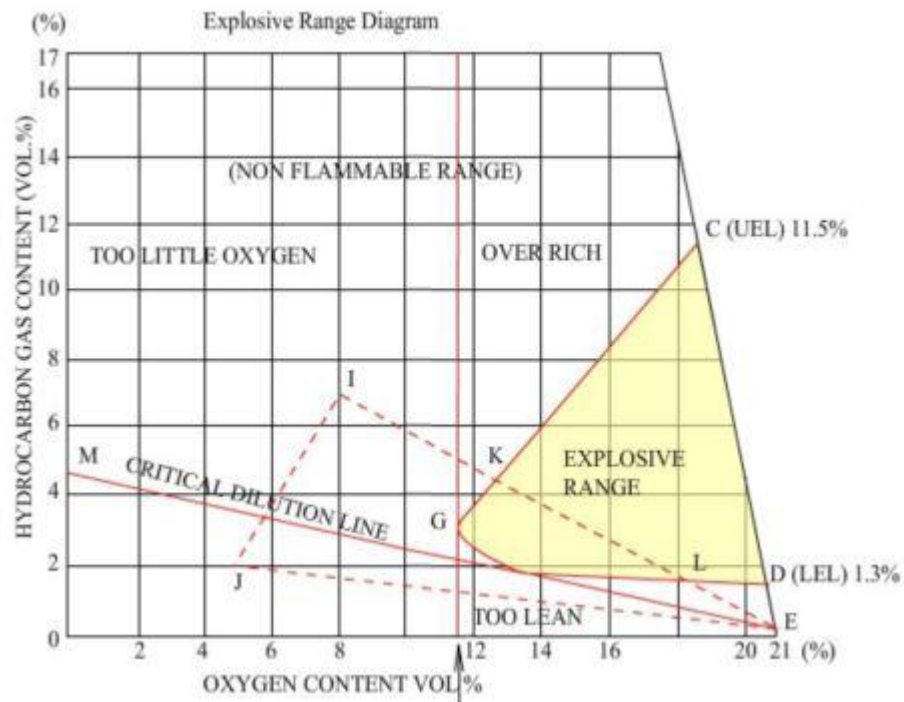
There are various references within risk assessments and work permits relating to ensuring the HC level is less than 1% but no description within the Cargo Handling procedures describing the process of purging and gas freeing.

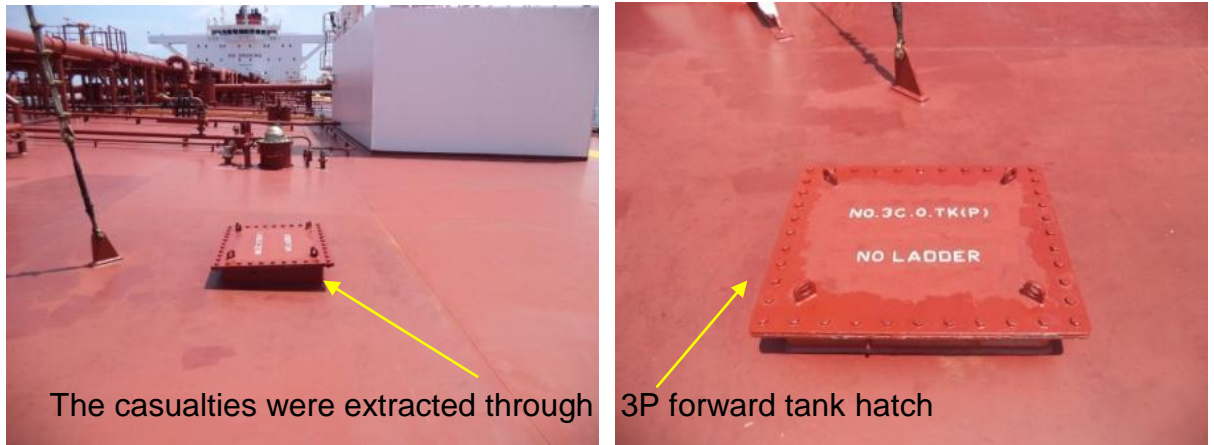
The vessel was equipped with adequate medical oxygen for the resuscitators in accordance with the Medical Stores Regulations² applicable to the type of ship. All of the medical oxygen was exhausted on board whilst giving first aid and medical treatment to the Cadet and Master.

Hoisting equipment was not used during the rescue as it had not been placed at the tank access hatch during the preparations. The casualties were raised from the tank bottom in a Neil Robertson stretcher attached to gantline with all available crew on the main deck heaving on the gantline. The same gantline was used to raise both casualties without problems. It should be noted that the gantline was rubbing against the lip of that tank access hatch during heaving. Potentially if the gantline had parted the casualty would have fallen in the stretcher to the tank bottom causing significant additional injury. Use of the lifting hoist would have made the lift easier but in this case the casualties were raised to the main deck without additional delay.
