Report on the investigation of
explosion and fire
on
Border Heather
in Grangemouth
Firth of Forth, Scotland
31 October 2004

**Report No 5/2006
February 2006**

At about 1823 UTC on 31 October 2004, the 2159gt Isle of Man registered tanker *Border Heather* suffered an explosion and fire in her forecastle while in Grangemouth. Significant damage was caused to the vessel's structure and systems but no-one was injured and there was no pollution.

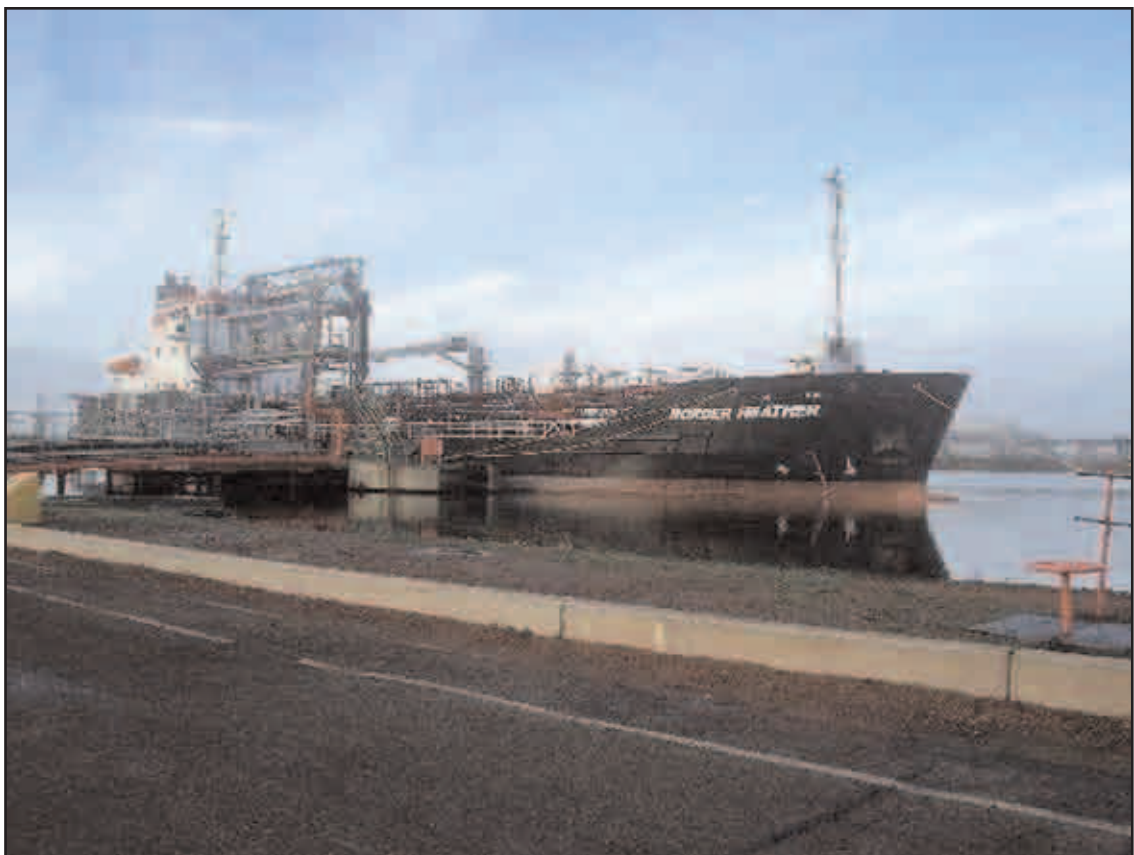
Figure 3

Border Heather alongside

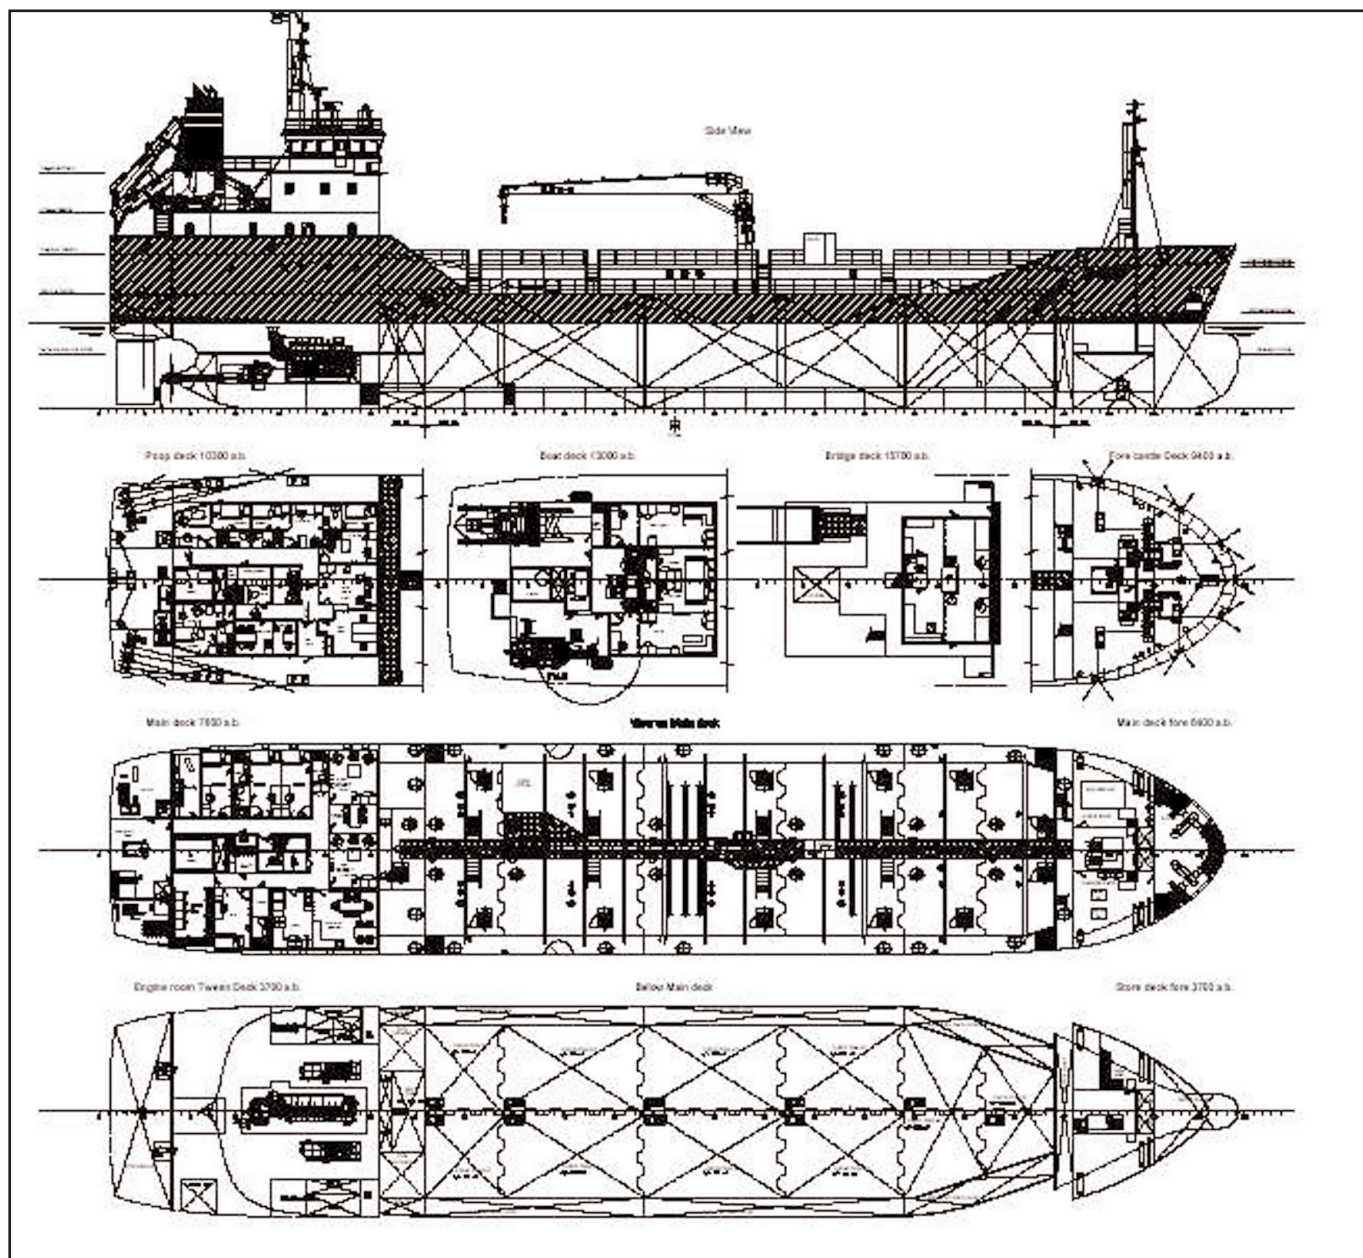
General arrangement

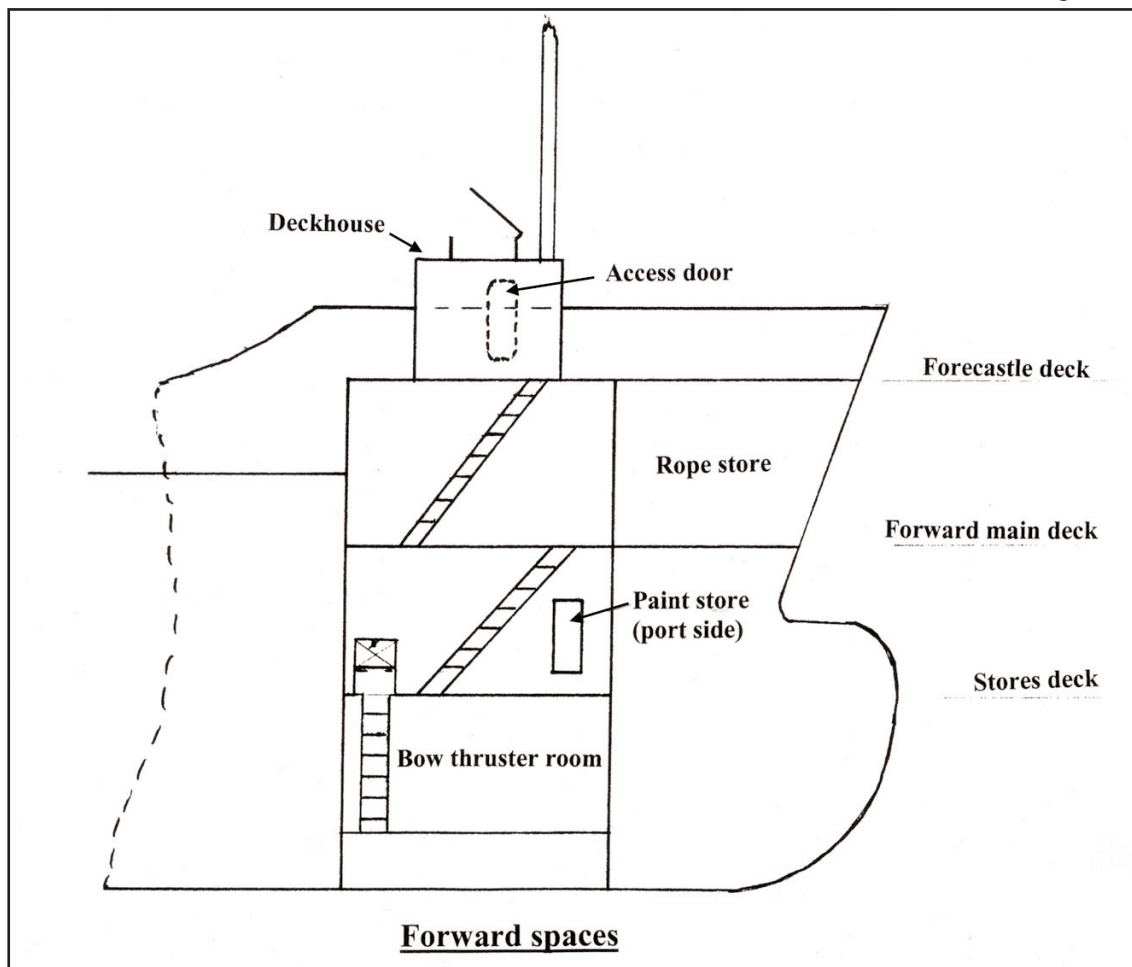
Figure 6

The forecastle deck is one deck above the main or working deck level. On it is mounted a deckhouse containing an access door, and ventilation ducts serving the spaces below. On the roof of this deckhouse are the foremast and a stores access hatch down to the stairwell (**Figure 6**).

A stairway leads down from the access door to main deck level. Here, through a watertight door on the port side, is the purge air compressor room housing an air compressor that supplies the cargo tanks' stripping pumps and line purging system. Through a similar door on the starboard side is the gas freeing room, housing the gas freeing fans. A watertight door at the forward end of this space leads to a rope store.

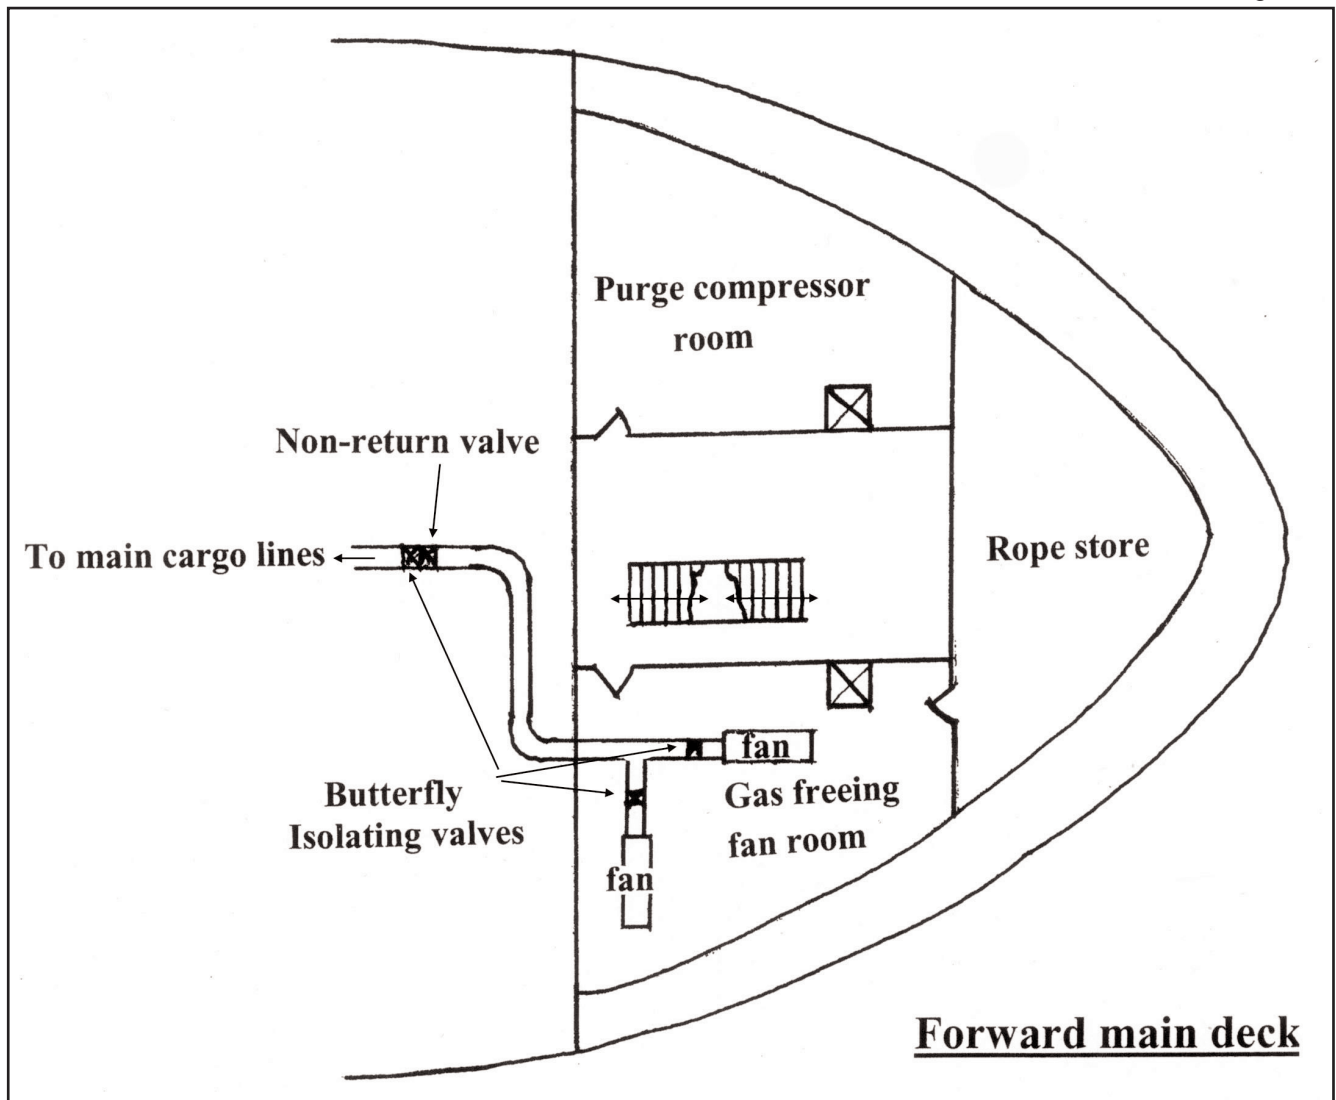
Figure 18

Aft of the bulkhead, this line is connected to the cargo filling and discharge piping system. Two further valves separate the fans from the cargo system, one non-return and one butterfly. These valves are outside the gas freeing room. The butterfly valve is locally operated (**Figure 18**).

Drawings approved by the vessel's classification society, Lloyd's Register of Shipping (LRS), show the butterfly valve and the non-return valve, but no spectacle plate is shown.
