## **Isle of Man Ship Registry**

Casualty Investigation Report No. CA127

**Collision between the BW MAPLE and DAWN KANCHIPURAM**

on the 28<sup>th</sup> January 2017

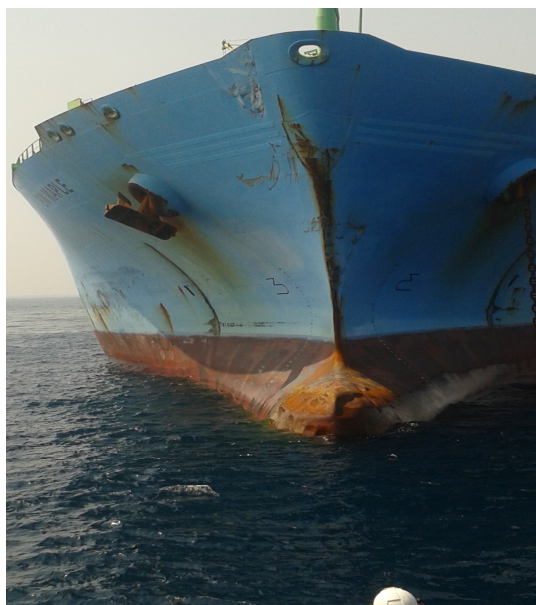
**BW Maple**

3.93 A hull damage occasional survey was completed by the attending Classification Society on 31/01/17. Damage occurred to the bulbous bow, forepeak ballast tank, bulwark plating, bulwark railing, and shell plating. The structural capacity and the watertight integrity of the cargo area including the collision bulkhead are not impaired by the damages in present condition.

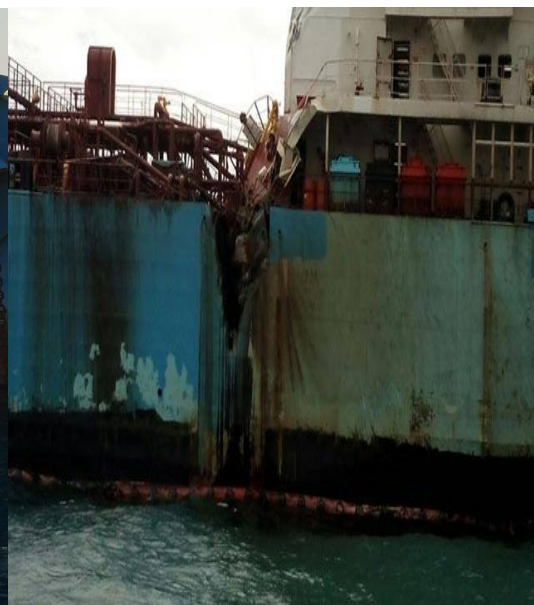
**Dawn Kanchipuram**

3.91 It is unknown as to the full extent of the damage that occurred. However substantial damage is known to have been sustained to the vessels accommodation, deck and hull on the port side. The resultant damage caused tanks containing oil to be ruptured and pollution to occur.

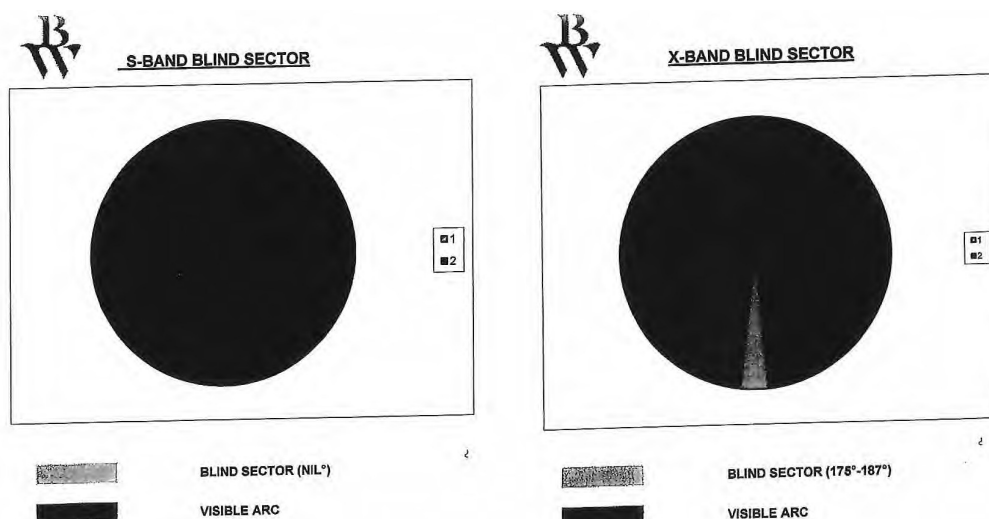
- 3.80 VDR recording of bridge conversations confirm the Master is aware that there is an inbound vessel At 03:32hrs The Master says "one vessel is inbound vessel... I see it". Shortly after this the Dawn Kanchipuram is acquired on radar by the Cadet.
- 3.81 The notice shown below is placed on the radars of the BW Maple informing the Officer of the Watch of blind sectors that may affect the detection and subsequently the display and plotting of targets. The Dawn Kanchipuram was not in the blind sector of the radar.

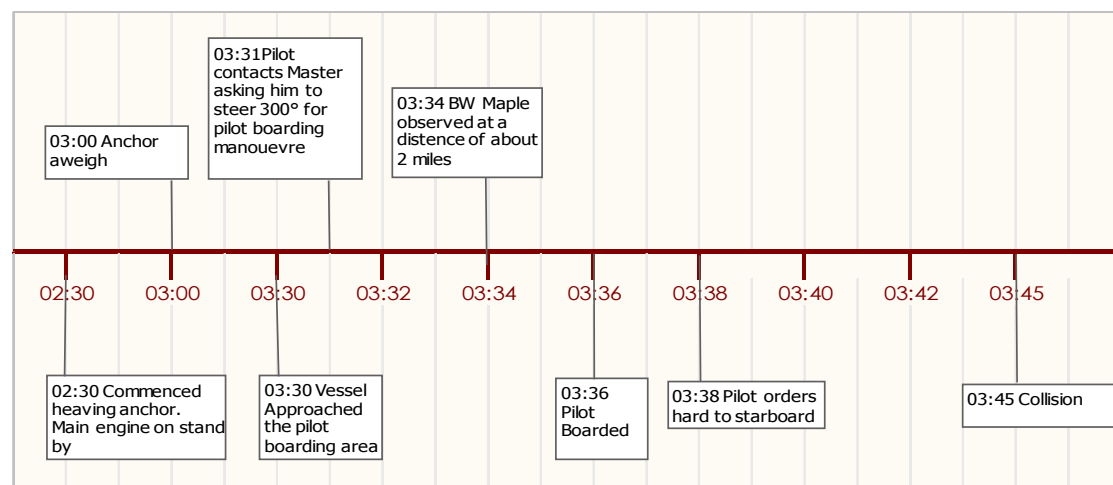
### 3.85 Dawn Kanchipuram Timeline 28<sup>th</sup> January

- 3.84 The management company of the Dawn Kanchipuram have made public the timeline of events that occurred on board the vessel. On the time line below, the time of collision is 03:45 hrs which is approximately two minutes later than the time recorded on the VDR on the BW Maple.
