Isle of Man Ship Registry

Casualty Investigation Report No. CA 128

M/V Cheshire

Ammonium nitrate fertiliser cargo decomposition

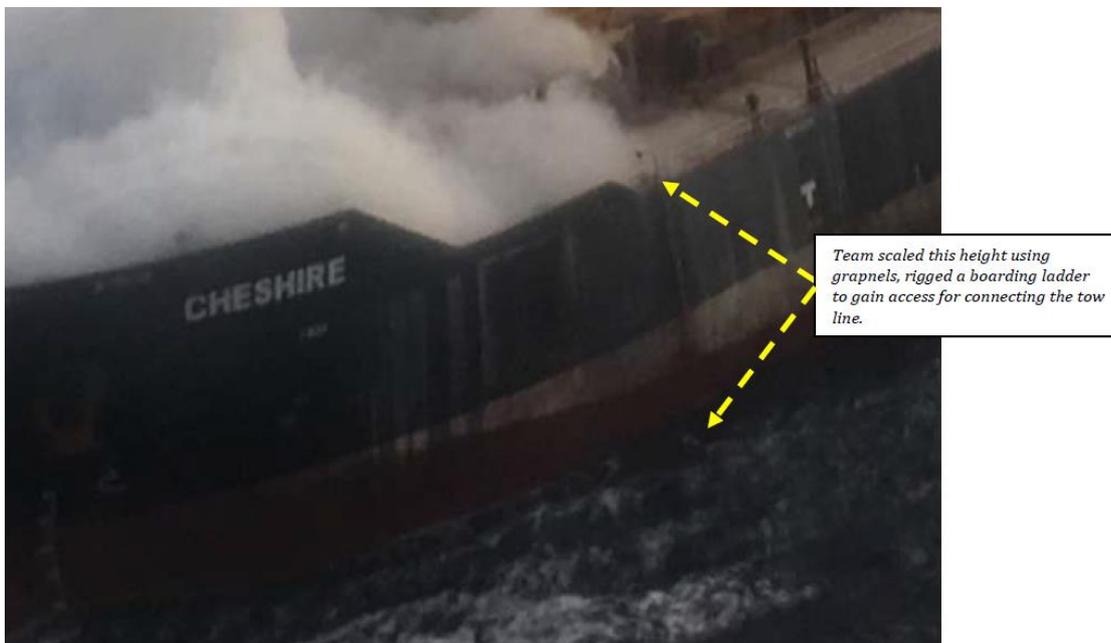
Initial salvage access to vessel, by gas colour CH#2 is seen to be at a more advanced stage of decomposition than CH#1^[1]

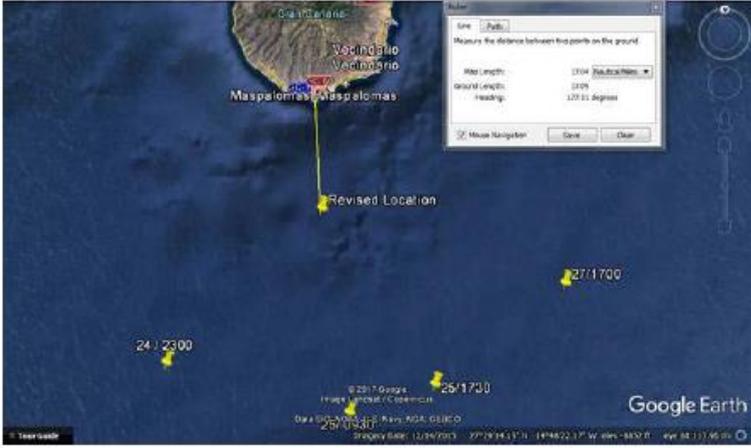
27th / 1700 hrs - Vessel Position 27°15.426'N 014°53.081'W
 The vessel remains under tow by the tug 'RED SEA FOS', proceeding at around 3.5 knots. The convoy will steam around 27°26.8'N, 015° 34.7'W maintain 12 miles south of Gran Canaria. This location was advised by SASEMAR Miguel De Cervantes.

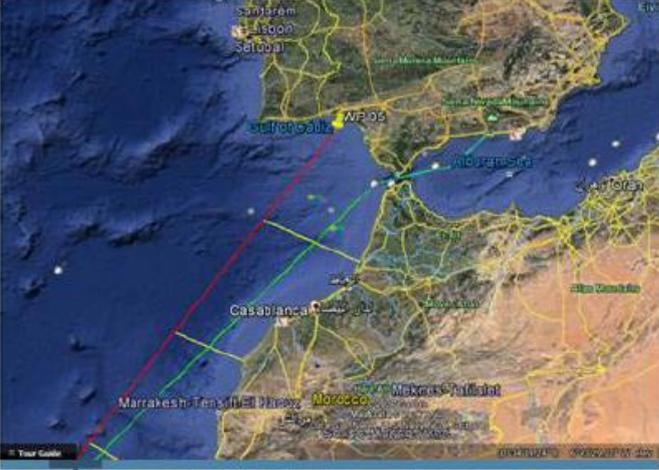
Sitrep extracts when vessel was under tow^[1]

- Overnight Casualty continues under tow by Red Sea FOS proceeding towards Bay of Cadiz. Vessels were facing gale force winds BF 8, significant wave heights of 3.5m. The tow is doing about 2.2 knots, expect to improve once she clears the local disturbance.
- Demobilization of Helicopter & equipment at air base
- Cargo owner’s Yara advised that Puerto Motril Spain (Near Malaga) as a possible port for discharge, Approx distance to go is around 750 miles, at present tow continues towards Bay of Cadiz.

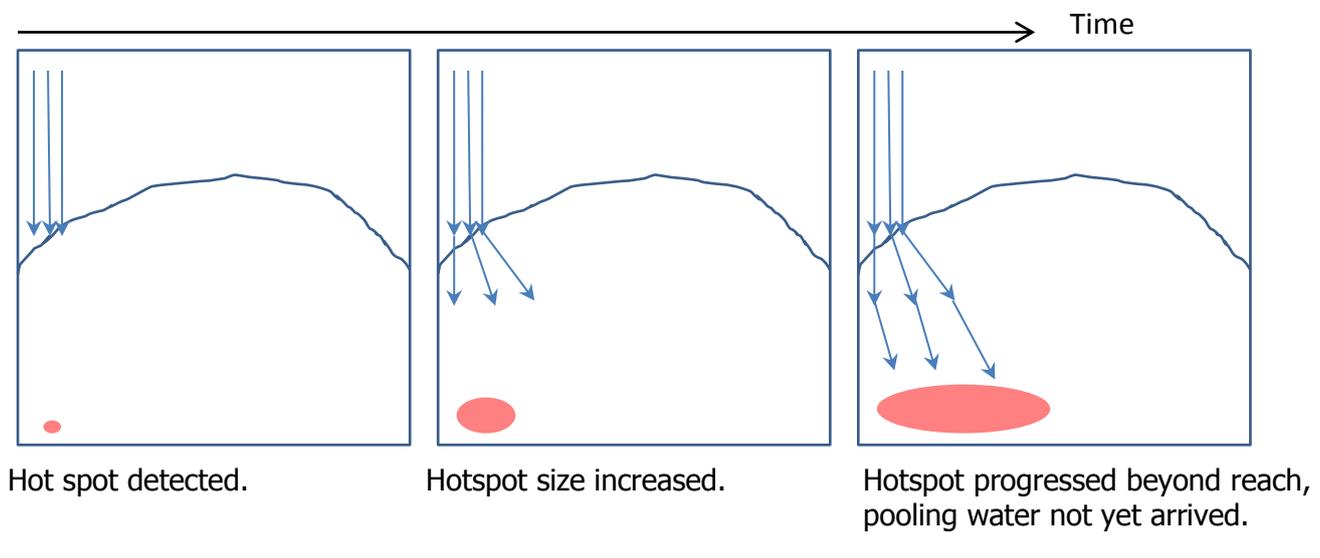
Figure one - Hose cooling from the cargo surface, time is taken for the water to fall through the bulk pile - large quantities of water are required for cooling effect to be observed (can cause stability issues for the vessel and significant cargo water damage!)

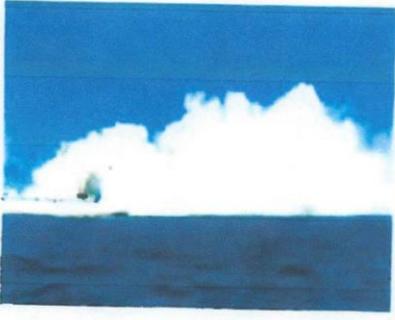
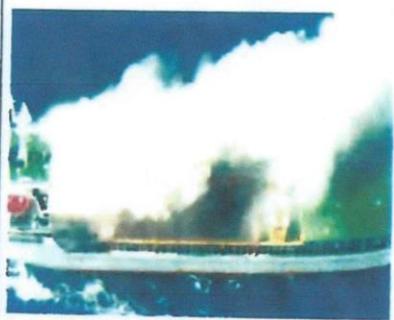
Serious consequences of heat sources not being switched off !!!
