Isle of Man Ship Registry

Casualty Investigation Report No. CA 133

“Heather Maid”

Fire

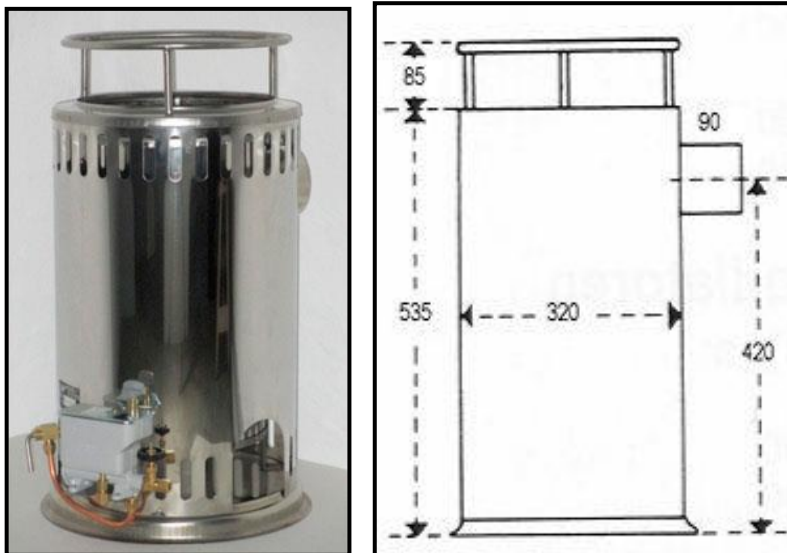
The stove, model 60M, manufactured by "Refleks" in Denmark, was purchased new and installed on board in January 2015. The stove burns diesel oil which is delivered through a pipe by gravity from a diesel oil tank in the Engine room. The stove's output is adjusted manually by the regulator which controls the flow of diesel oil to the burner. According to manufacturer's instructions the chimney's temperature, when set at maximum, can reach up to **250°C**.

The stove is fitted with a "heat safety fuel valve" which is designed to close automatically when the surrounding area temperature reaches 70°C. When the safety valve closes, fuel is not supplied to the burner and the stove stops. However this safeguard was not relevant to this fire as the fuel system was not the cause or contributing factor.
