Isle of Man Ship Registry

Casualty Investigation Report No. CA 135

"POLARIS"

Sinking

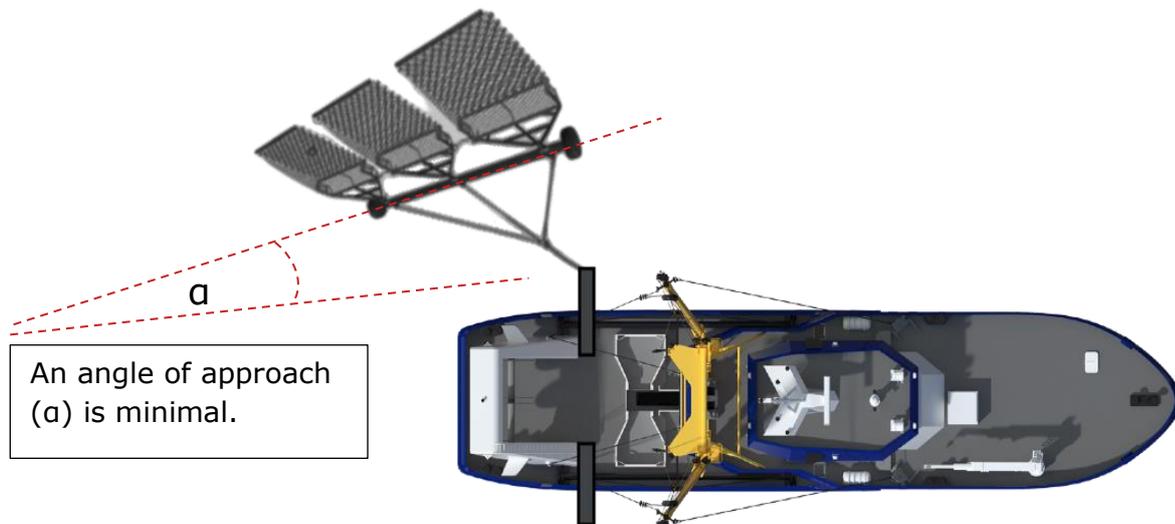
Figure 4, angle of approach. Models' source - Scottish Marine and Freshwater Science Vol 3 No 7, and www.pngbarn.com

The final stage of picking up the gear should ensure that the tow bar is approaching the vessel's side at the minimum angle and speed. The angle shall be as close to 0° (parallel) as possible and the pulling speed shall be minimal to avoid heavy contact with the ship's hull.

When bar approaches at right angles, it involves more risks due to inevitable contact with the vessel's hull. Situations like this shall be avoided, however due to sea conditions and rigging arrangements it may not always be possible.

3. Skippers and crew shall be mindful about gear's speed and direction during final stage of recovery and the potential damage the gear can make to the hull when approached at right angle.
