Isle of Man Ship Registry

Casualty Investigation
Report No. CA116

**Isle of Man Registered “Iron Queen”
Enclosed Space Fatality and Near Fatality**

25th November 2011

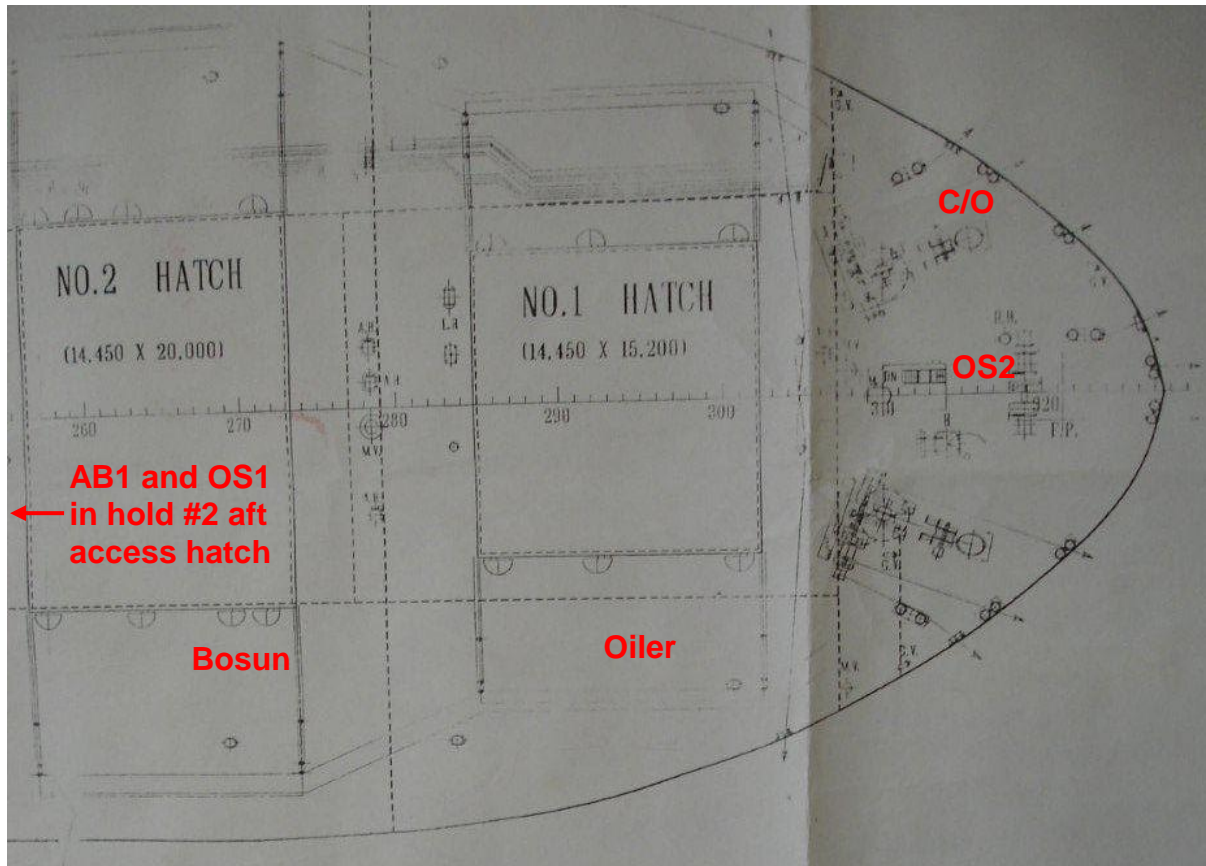
- 1134** Bosun proceeds forward. Bosun hears shouting from inside hold #2 aft access hatch space.
- The crew positions at fwd mooring is as per the following diagram.
