Report on the investigation of
the grounding of the ro-ro freight ferry

Arrow

in the approach channel of Aberdeen Harbour
on 25 June 2020

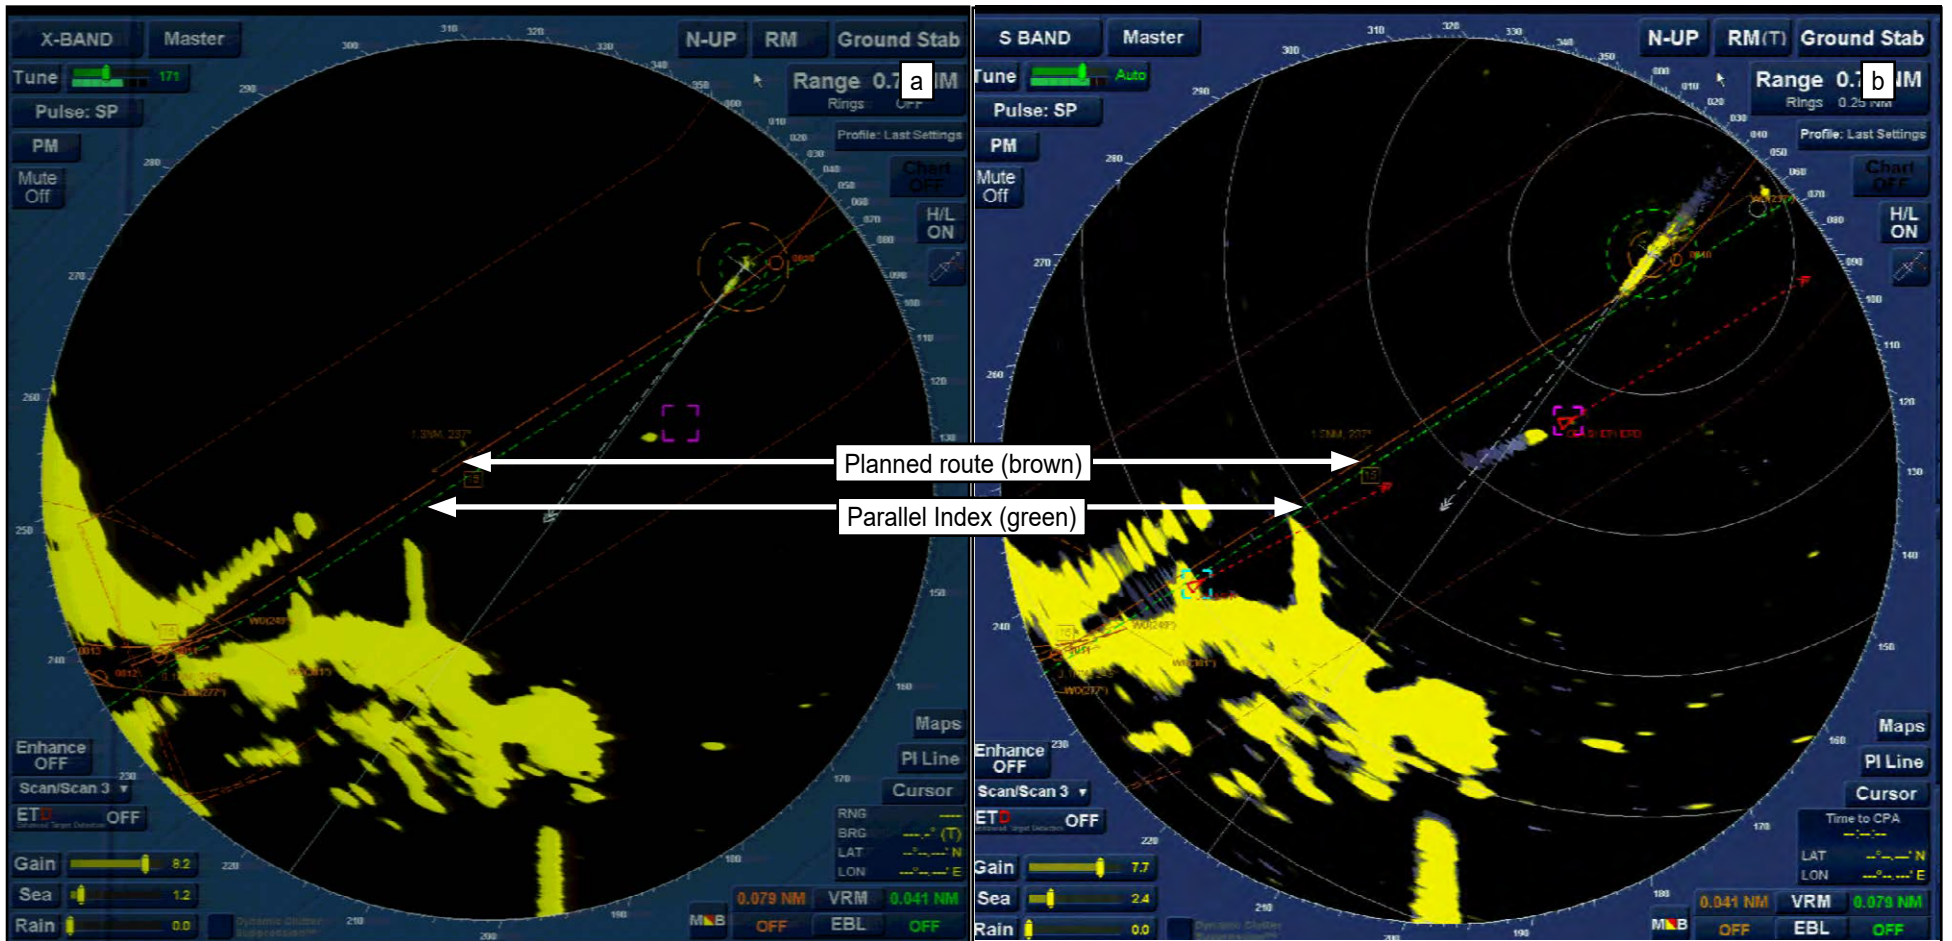
Figure 3: Radars set up for entry to Aberdeen. X-Band (a) and S-Band (b)
 (Note: both displays offset to give maximum look ahead)

Both of *Arrow*'s radar displays had been similarly set up by the PEC holder prior to commencing pilotage (**Figure 3**). Each was offset to the north-east to give a maximum look ahead as the ship entered the south-west-oriented Navigation Channel. Both displays were linked to either the GPS or DGPS receivers and had route waypoints input, shown as a red long-dashed line. A single PI, to run along the northern tip of the Old South Breakwater (**Figure 5**) was set up on each radar on a bearing of 237° and at a distance of 0.050nm to port. This PI was not noted on *Arrow*'s paper harbour approach chart although a PI was drawn on the chart, 0.025nm to starboard on Abercromby Jetty (**Figure 10**). *Arrow*'s radars also had two VRMs set up to assist in clearing shoal patches in the Turning Basin. Each display was capable of displaying up to four PIs.

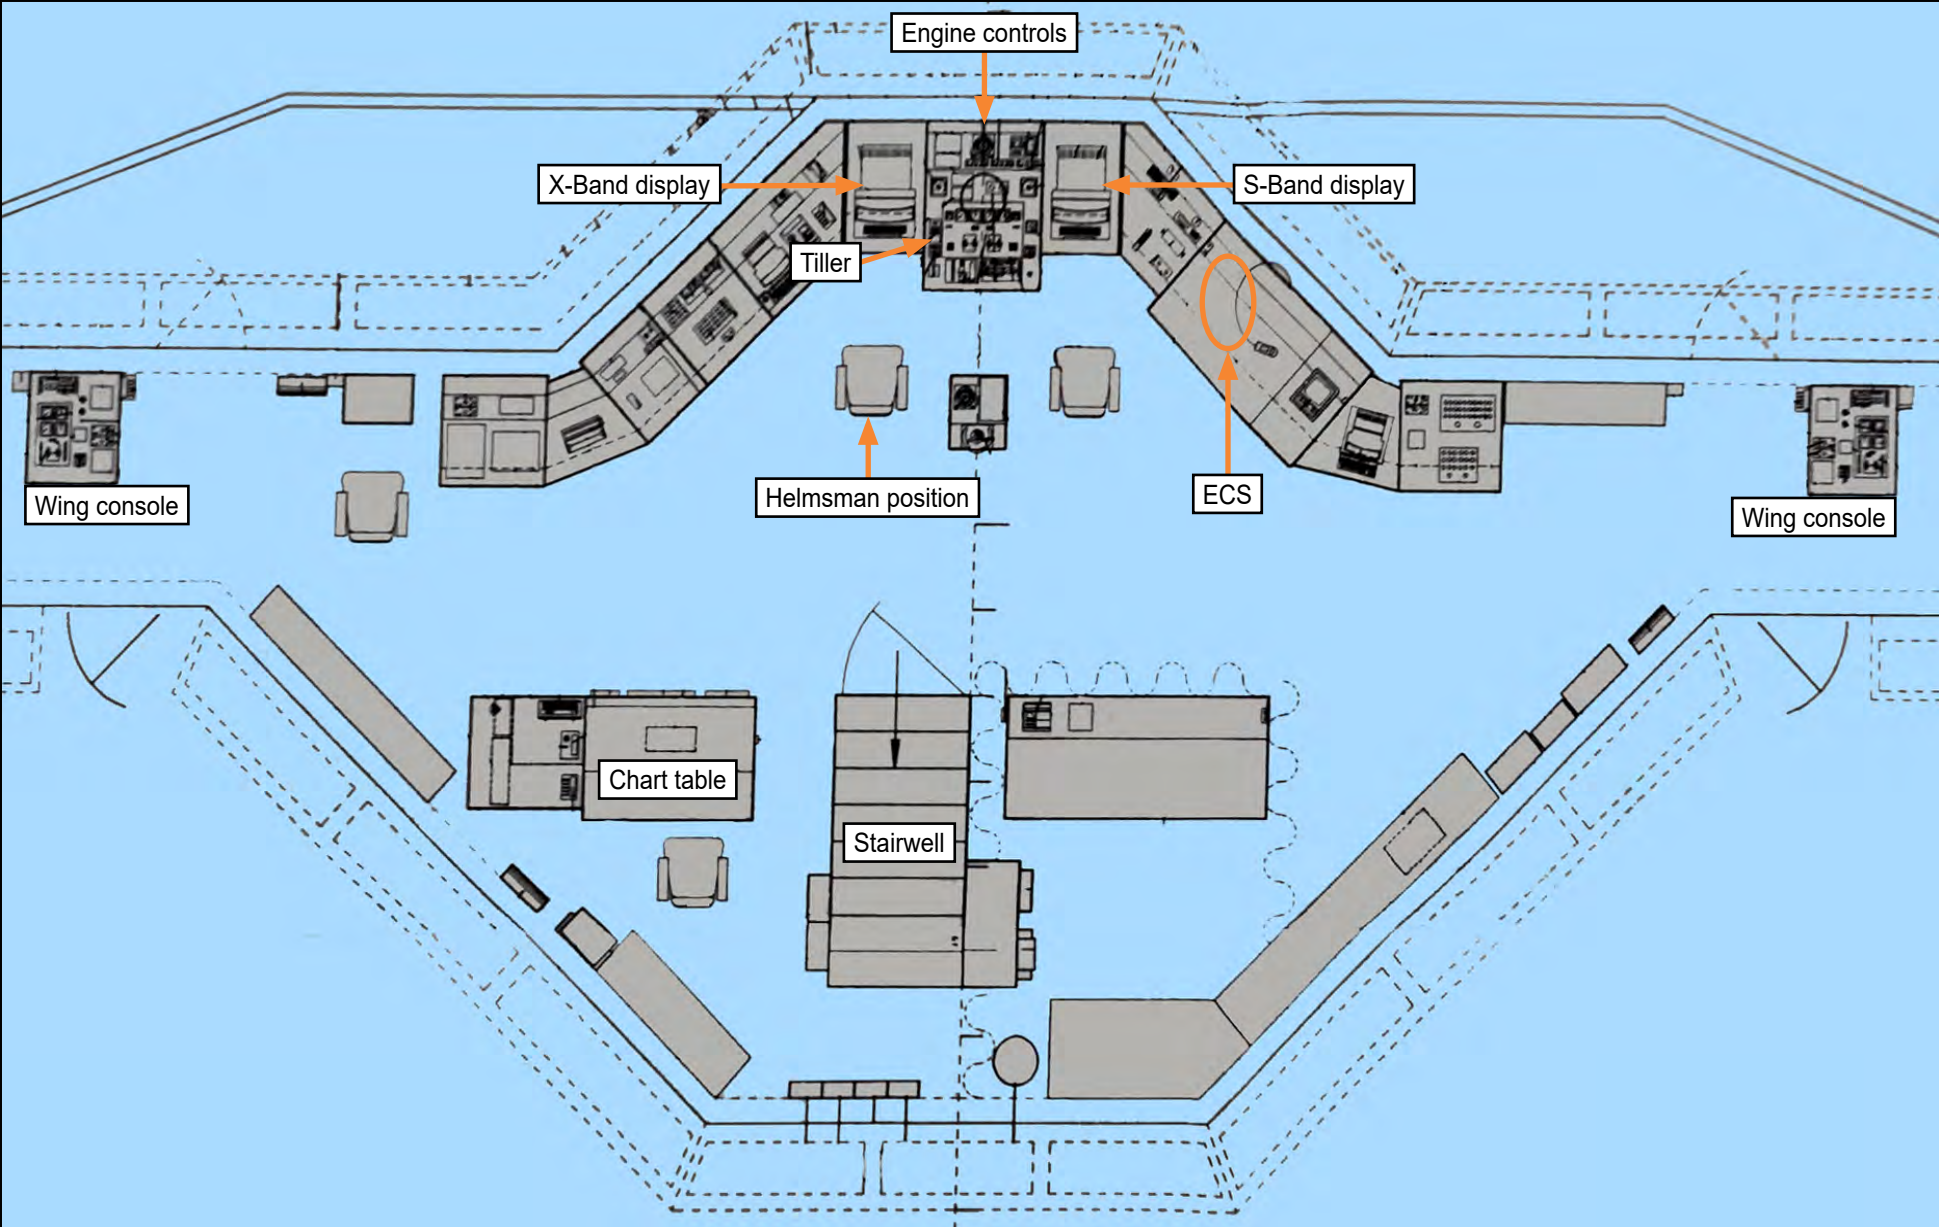
Figure 4: Arrow bridge layout

paper charts as the primary source of chart information, and the ECS was used to improve situational awareness. The ECS was well placed for the master to use but was 2.5m from the PEC holder's conning position (**Figures 4 and 7**) making the display of limited practical use to him.

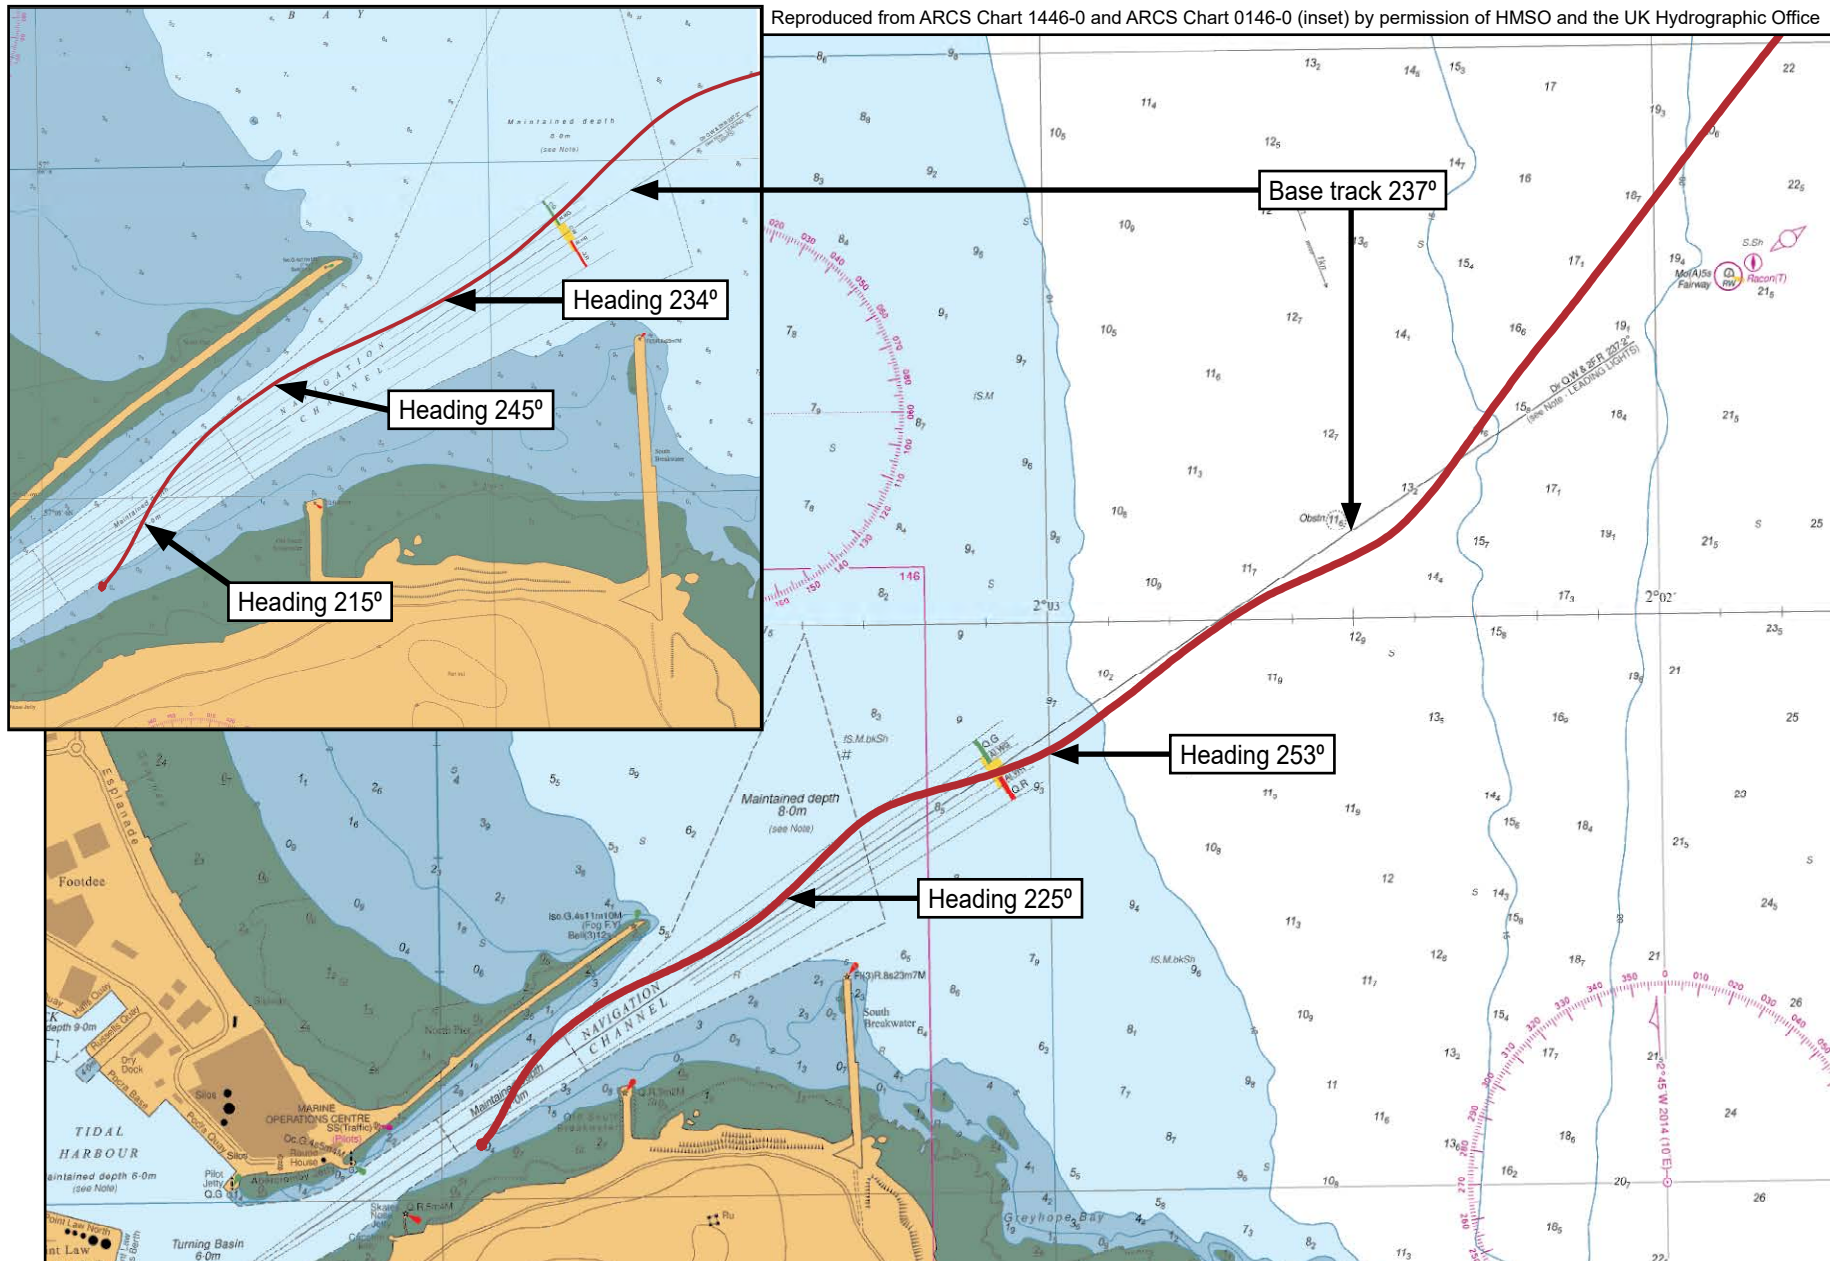
Figure 8: Plot of Arrow's entry track on 25 June 2020

As *Arrow* approached the harbour entrance, the PEC holder steered a heading of 250°, making good a course over the ground (COG) of 253° (**Figure 8**), tracking to the north of the planned course of 237° along the centre of Aberdeen Harbour's Navigation Channel. Prompted by the master, who was using the S-Band radar and looking at the ECS display, the PEC holder altered heading to 225°. At 0724:51, *Arrow* came within 10m of the planned track as it passed the fog-obscured South Breakwater, and the PEC holder altered the ferry's heading to 234°.

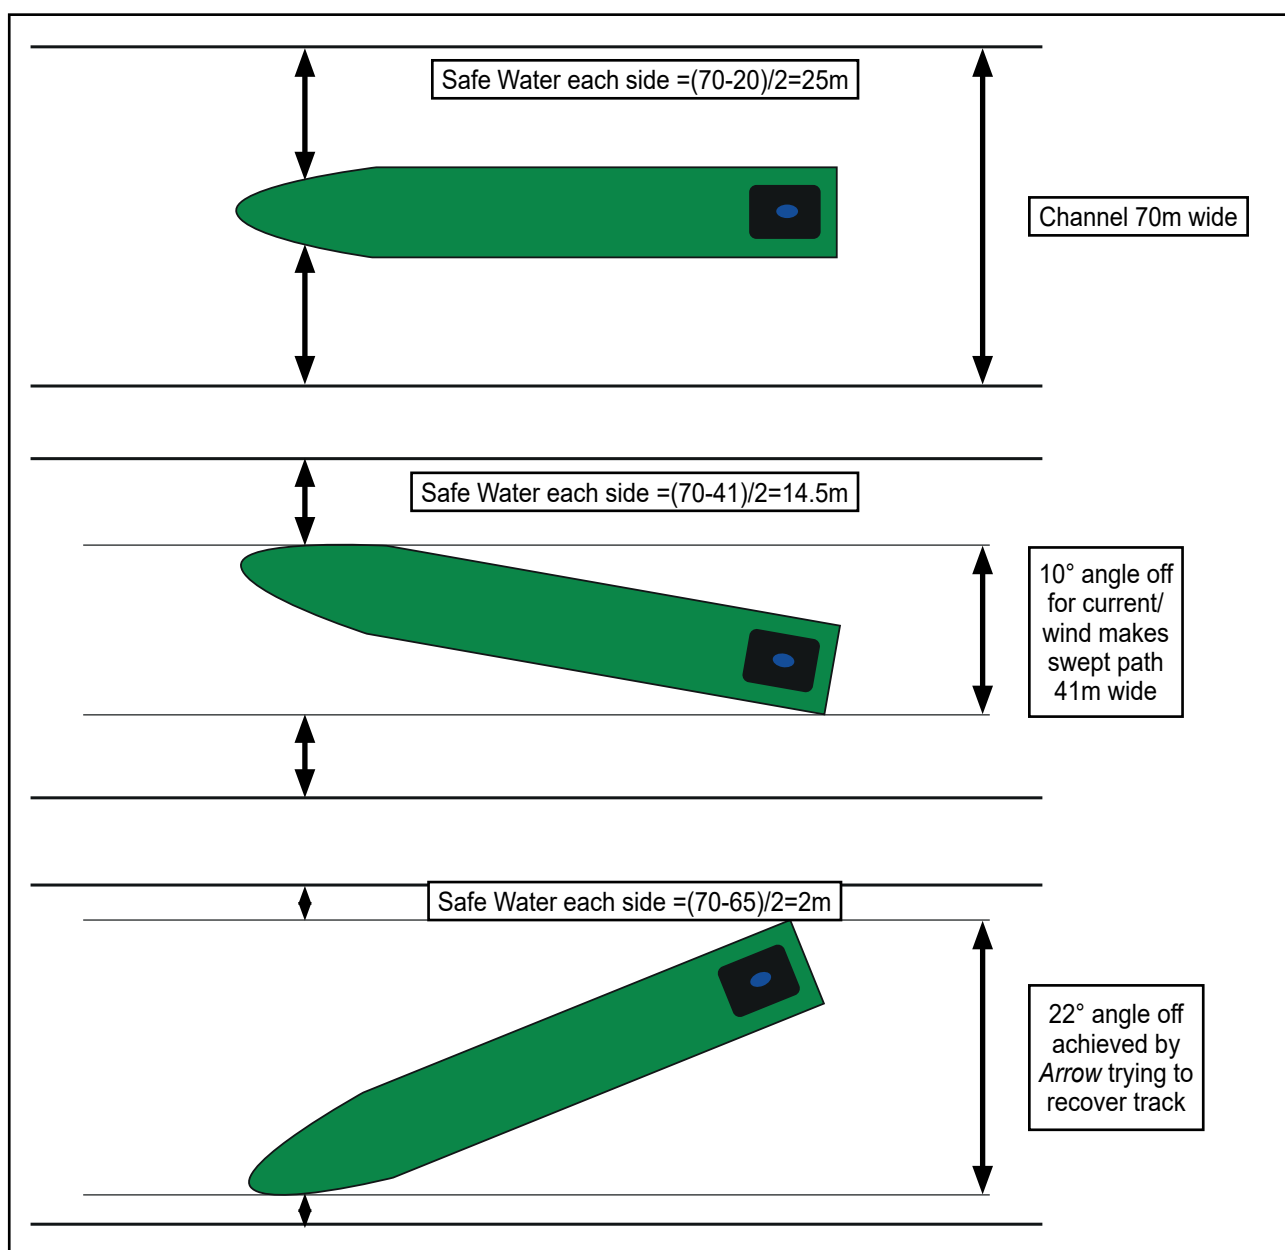
Figure 19: Diagrams showing effect on swept path of steering off the base track in a narrow channel

The passage from Lerwick to Aberdeen had been used several times by *Arrow* on this charter and took the vessel from berth to berth. The ship's paper British Admiralty charts 1446 and 146 (**Figure 10**) had been prepared for the entry, with 'no-go' areas clearly marked. The course marked for the route through the Navigation Channel was '237° – 057°' indicating that the chart was prepared for exits as well as entries. Beyond the 'no-go' areas, there were no clearing bearings or ranges or other safety calculations to indicate how close the vessel could get to danger, nor how far the vessel could be steered off base track and remain safe (**Figure 19**).

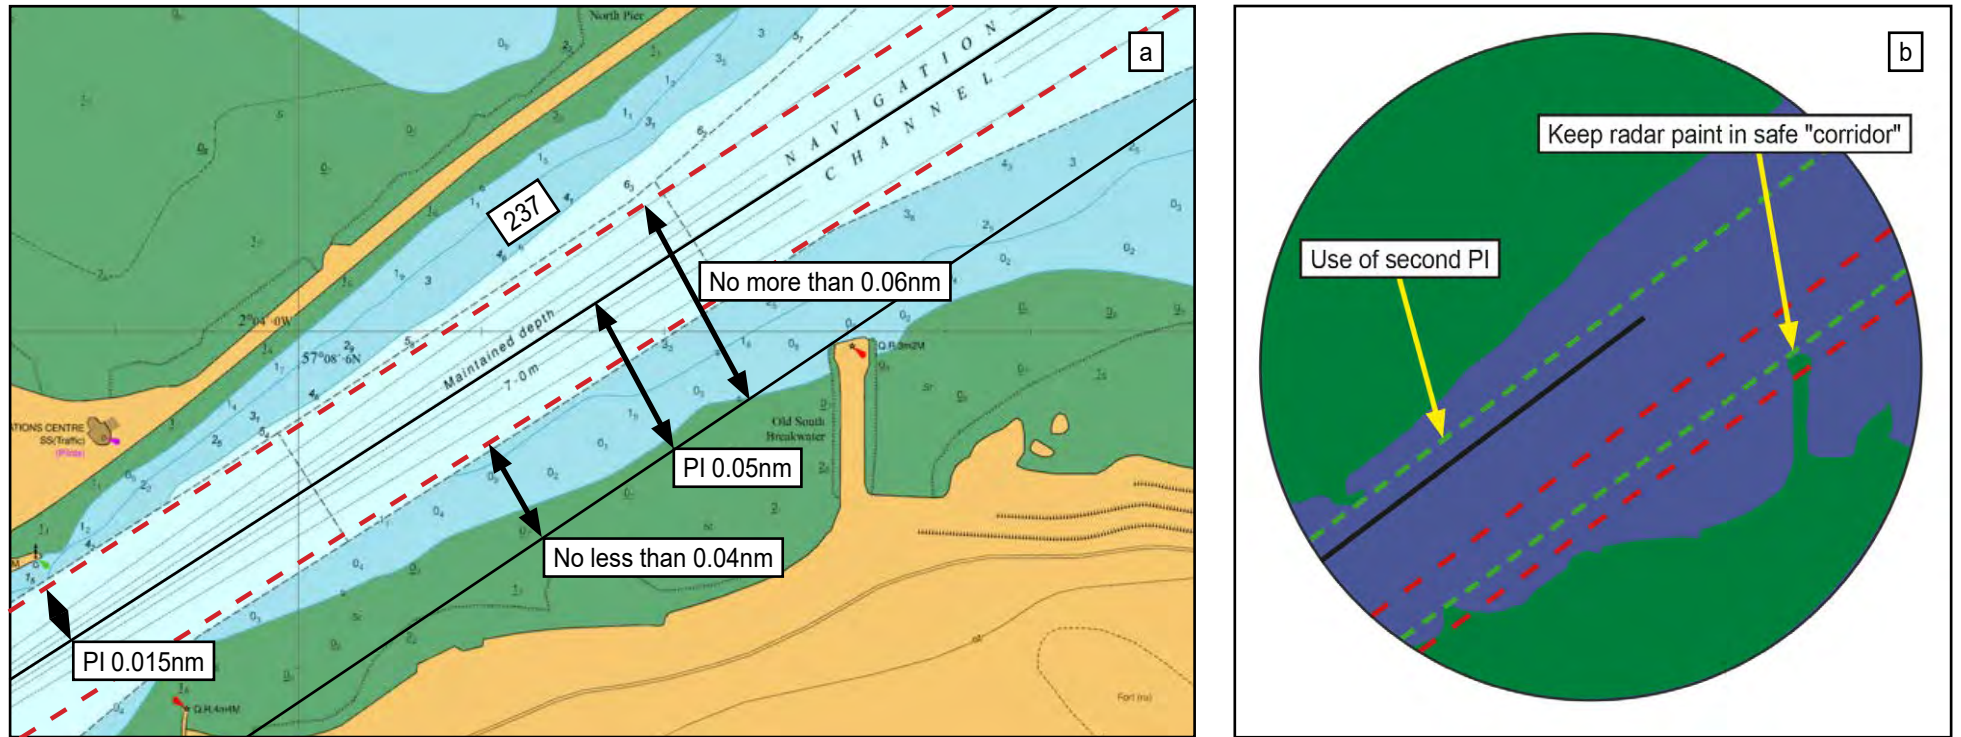
Figure 20: Parallel indexing techniques - showing use of two PIs and safe "corridor" (a) and radar display with additional PIs (b)

The use of one PI alone can only accurately give an indication of position if a measuring tool is used to determine distance off track. A more effective use of PIs would be to use multiple PIs to display safety limits, drawing a corridor down which the ship can be safely driven. The use of multiple PIs also allows more than one radar conspicuous mark to be used (**Figure 20**). In this case, Old South Breakwater had disappeared from *Arrow*'s offset radar display (**Figure 21**), which meant that immediately prior to the grounding the PEC holder had no real-time navigational information available. *Arrow*'s radar displays each had the capacity to store four PIs, and with only one track requiring precise navigation, two 'safety corridors' drawn on each display would have provided the bridge team with more information.

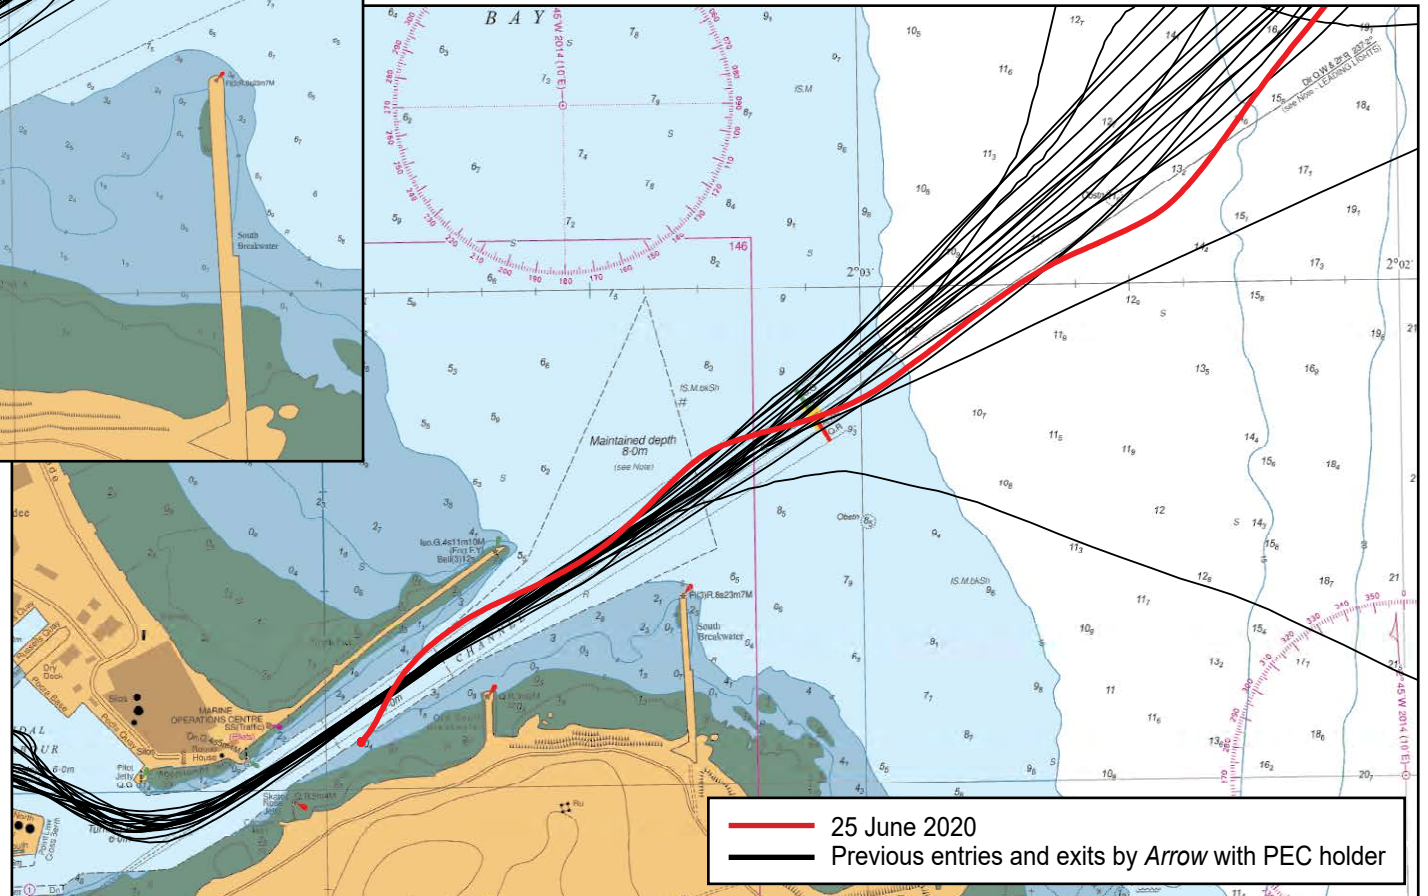
Figure 22: Plots of Arrow's tracks into and out of Aberdeen Harbour January to June 2020

Detecting movement trends is much more difficult on a radar display than watching the movement of visual transit marks. Accurate radar navigation requires extremely close attention from the conducting officer. **Figure 22** shows previous entries and exits in good weather, together with the track on 25 June in red. It is highly likely that the PEC holder's ability to simultaneously navigate and steer was degraded to an unsafe level compared to entries and exits conducted in good visibility.
