Isle of Man Ship Registry

Casualty Investigation

Report No. CA 138

Head injury to crew member from failed lifting equipment

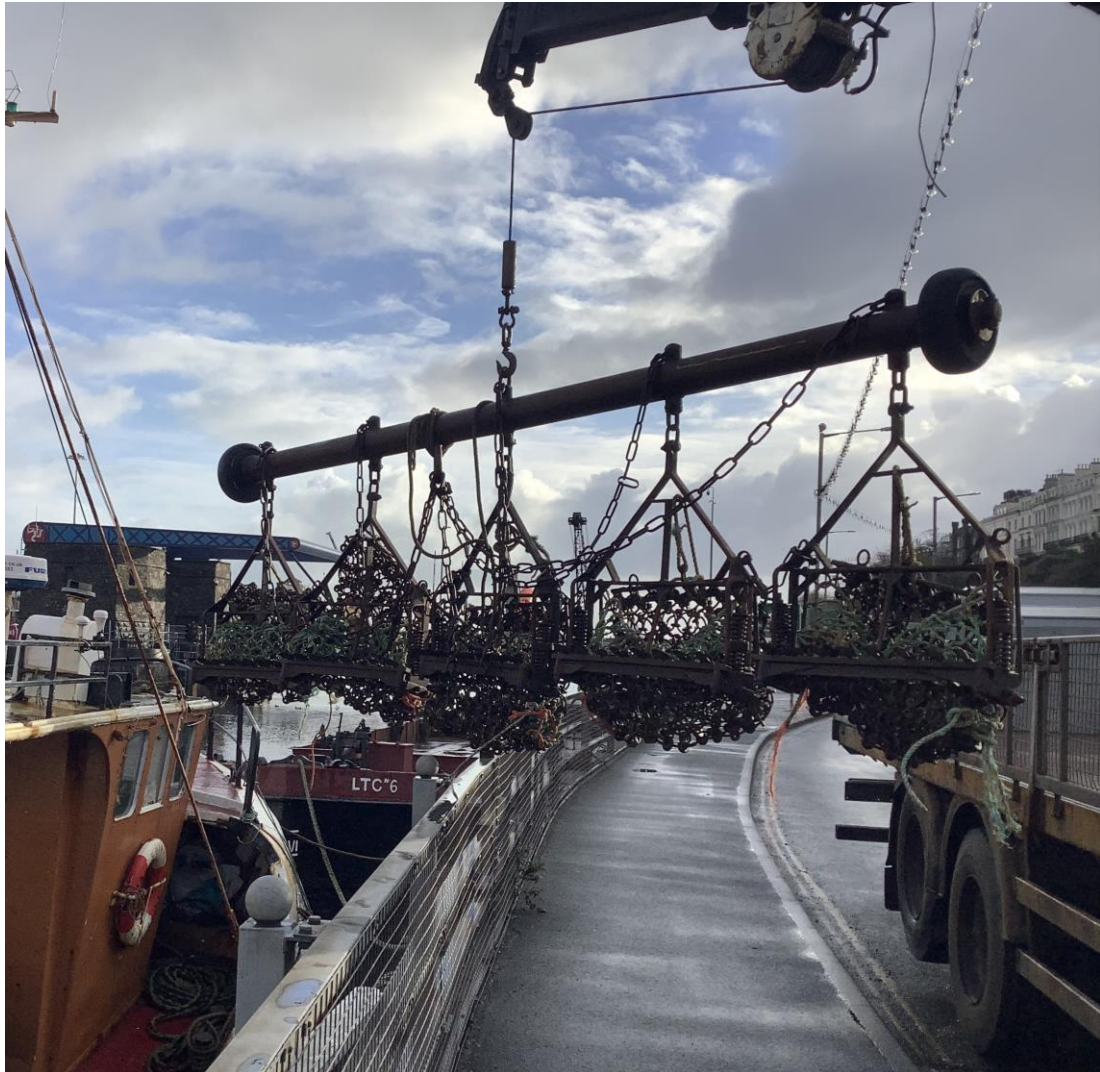
In order to ascertain if the load was within the block's safe working load, the fishing gear (including the dredge arm and dredge nets) were weighed.

Fig 06 - Empty Port side scallop dredge gear being removed from the Silver Viking to be weighed.

The safe working load of the block is 2 tonnes and as the total weight is estimated at 850-900kg, this is found to be well within the safe working load of the block.

It can be concluded that the dredge gear and the catch in the dredge nets were well within the safe working load of the lifting block. Overloading was therefore not found to be the cause of the failure of the block.

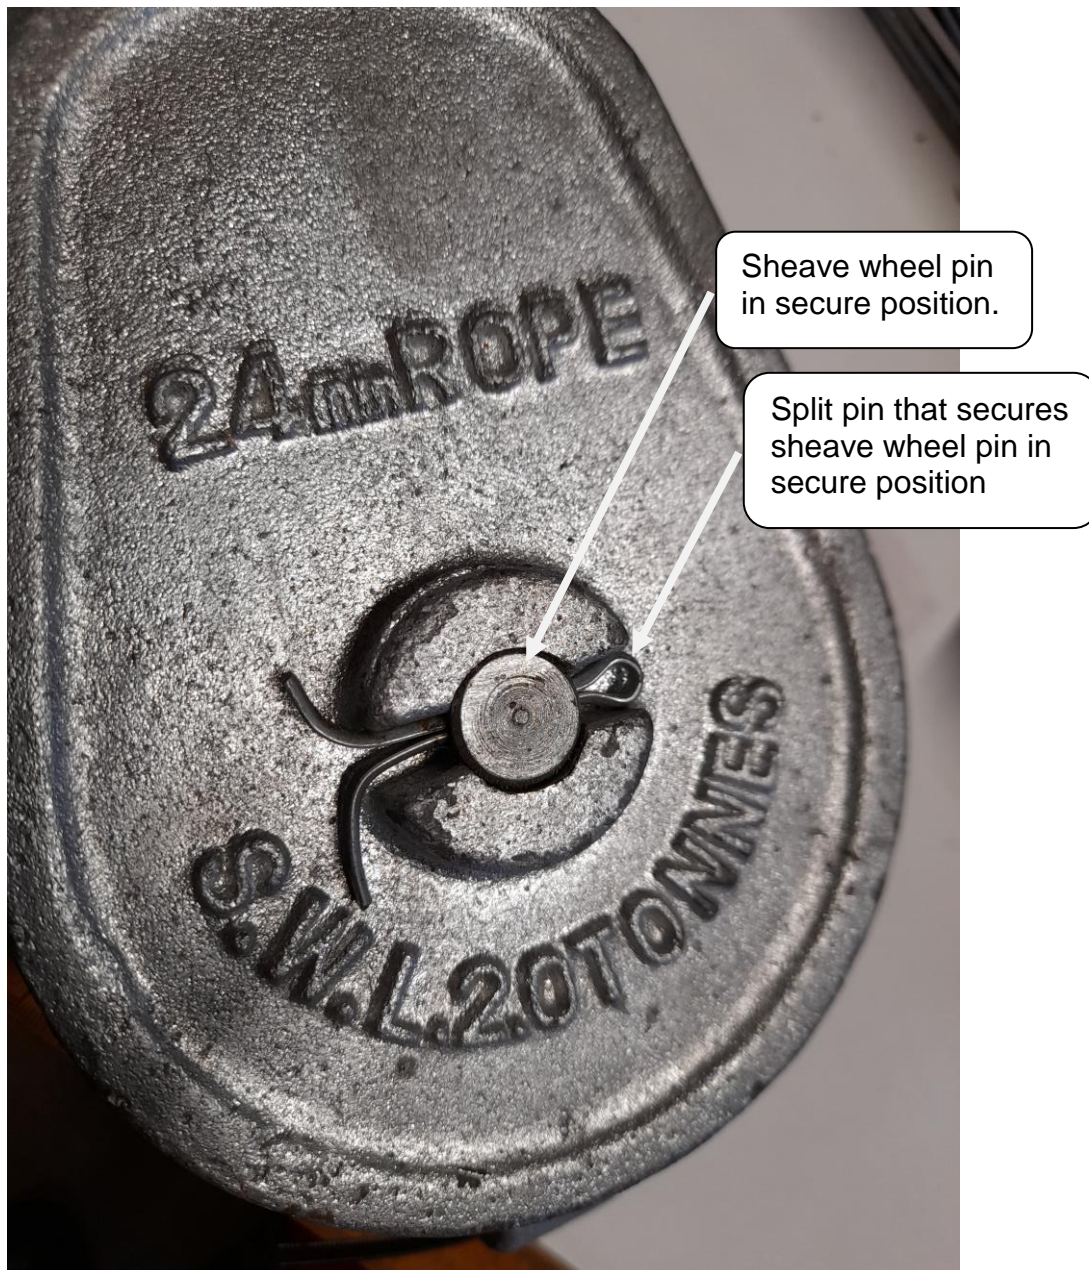
The block is a 6-inch double wheel pulley block with a swivel oval eye. Within the housing are 2 sheave wheels both with an external diameter of 90mm (see Fig 08 & Fig 09). The sheave wheels are located within the block housing on a sheave wheel pin acting as an axle for the 2 sheave wheels. The sheave wheel pin is secured in place by split pins on either side of the block housing (see Fig - 09).

On contacting the supplier it was stated that a test certificate could be obtained for a block if requested by a customer within 90 days of purchase. The block was beyond the 90 days. A new block of the same model from the same supplier was locally available (see Fig – 09).

Fig 09 - new version of block available locally from same UK supplier.

If the sheave wheel pin had been in its proper secured position with each end of the sheave wheel pin secured with split pins to the block housing (see Fig 09 above, showing secured split pin) then the estimated weight of approximately 850-900kg would be within the capacity of the single sheave wheel to manage.
