Report on the investigation of a
fatal accident during mooring operations
on board the bulk carrier
Mona Manx
at Puerto Ventanas, Chile
on 26 August 2021

VERY SERIOUS MARINE CASUALTY

REPORT NO 18/2024

NOVEMBER 2024

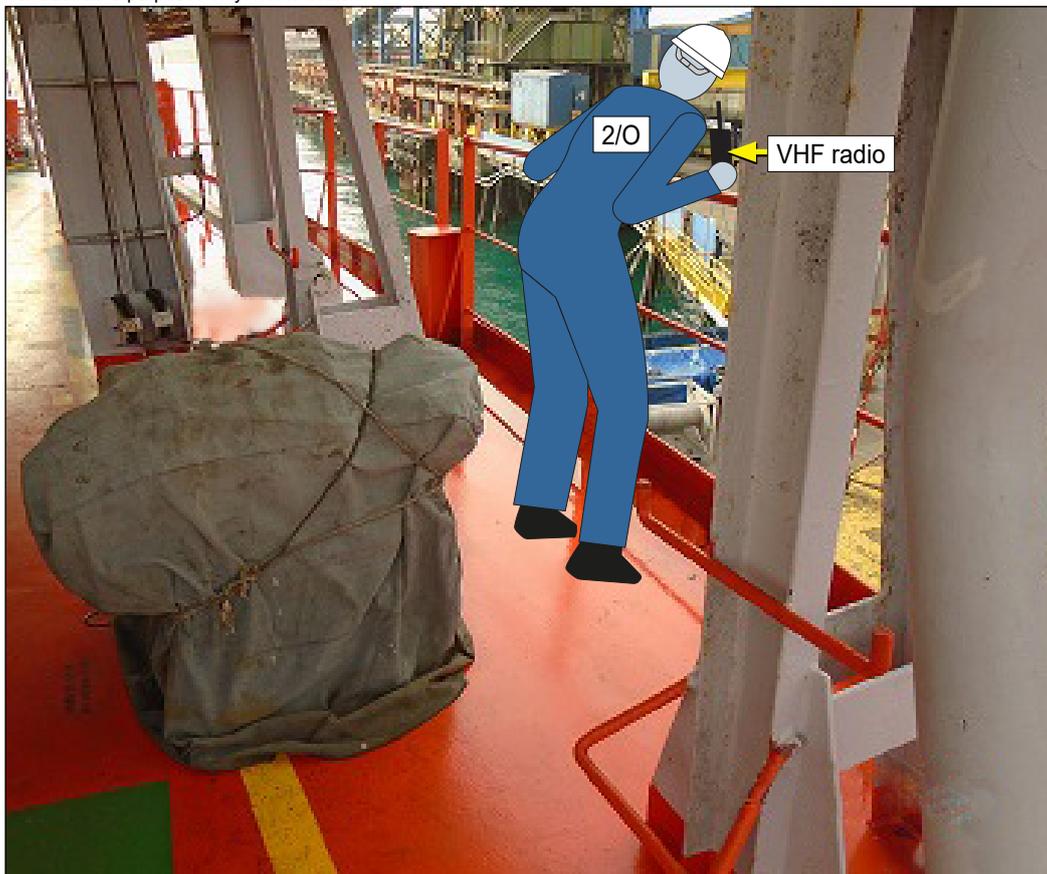
Figure 6: Representation, showing the position of the 2/O at the ship's rail

At 0836:11, the 2/O arrived near the forward end of the accommodation ladder (Figure 5) and looked over the side rail directly above the slack spring line while using a very high frequency (VHF) radio (Figure 6). A few seconds later, the spring line tightened and then slackened. At 0836:23, the 2/O appeared to use the VHF radio again as the spring line came under tension once more.

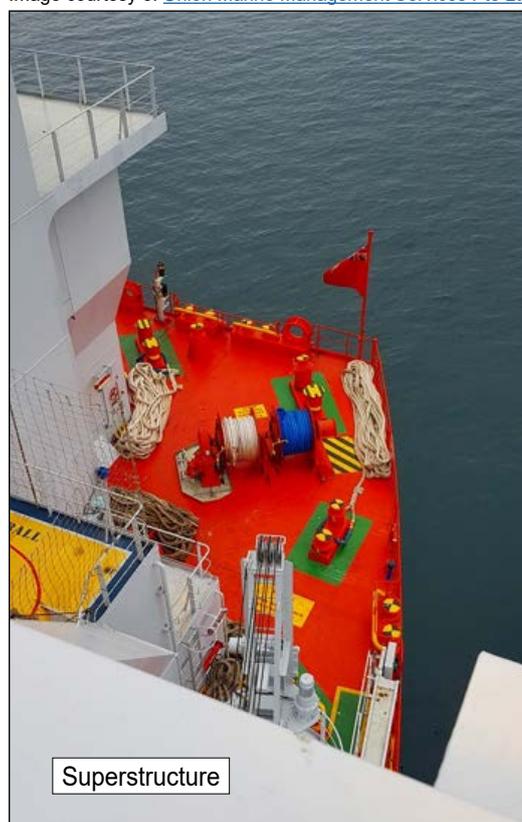
Figure 11: View of aft mooring deck from *Mona Manx*'s port bridge wing

A *birds eye view* was advised in the COSWP to monitor mooring operations. The master's position on the bridge wing afforded a view of the aft port quarter mooring deck, which provided the opportunity for the running of mooring lines to be seen (**Figure 11**). However, when the 2/O moved forward the master's view was restricted by the superstructure below so neither the 2/O's position nor the spring line could be adequately monitored.
