Report on the investigation of  
the deaths of three stevedores in a cargo hold  
access space on board the bulk carrier

***Berge Mawson***

at Bunyu Island anchorage, Indonesia

on 27 June 2022

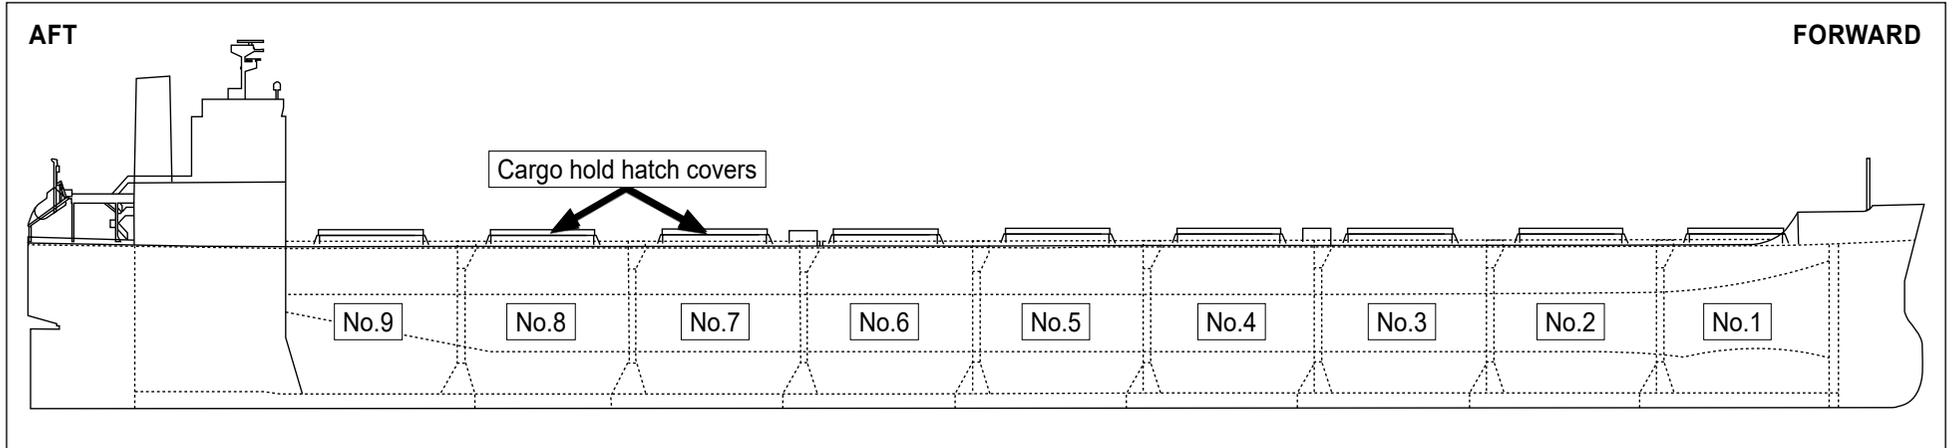
*Berge Mawson* had nine cargo holds (**Figure 4**), which were separated by corrugated transverse bulkheads. Cargo holds No.2 to No.8 each had a capacity of about 22,970 cubic metres (m<sup>3</sup>), while cargo holds No.1 and No.9 had a capacity of 19,862m<sup>3</sup> and 20,743m<sup>3</sup>, respectively.

**Figure 4:** General arrangement of *Berge Mawson's* cargo holds

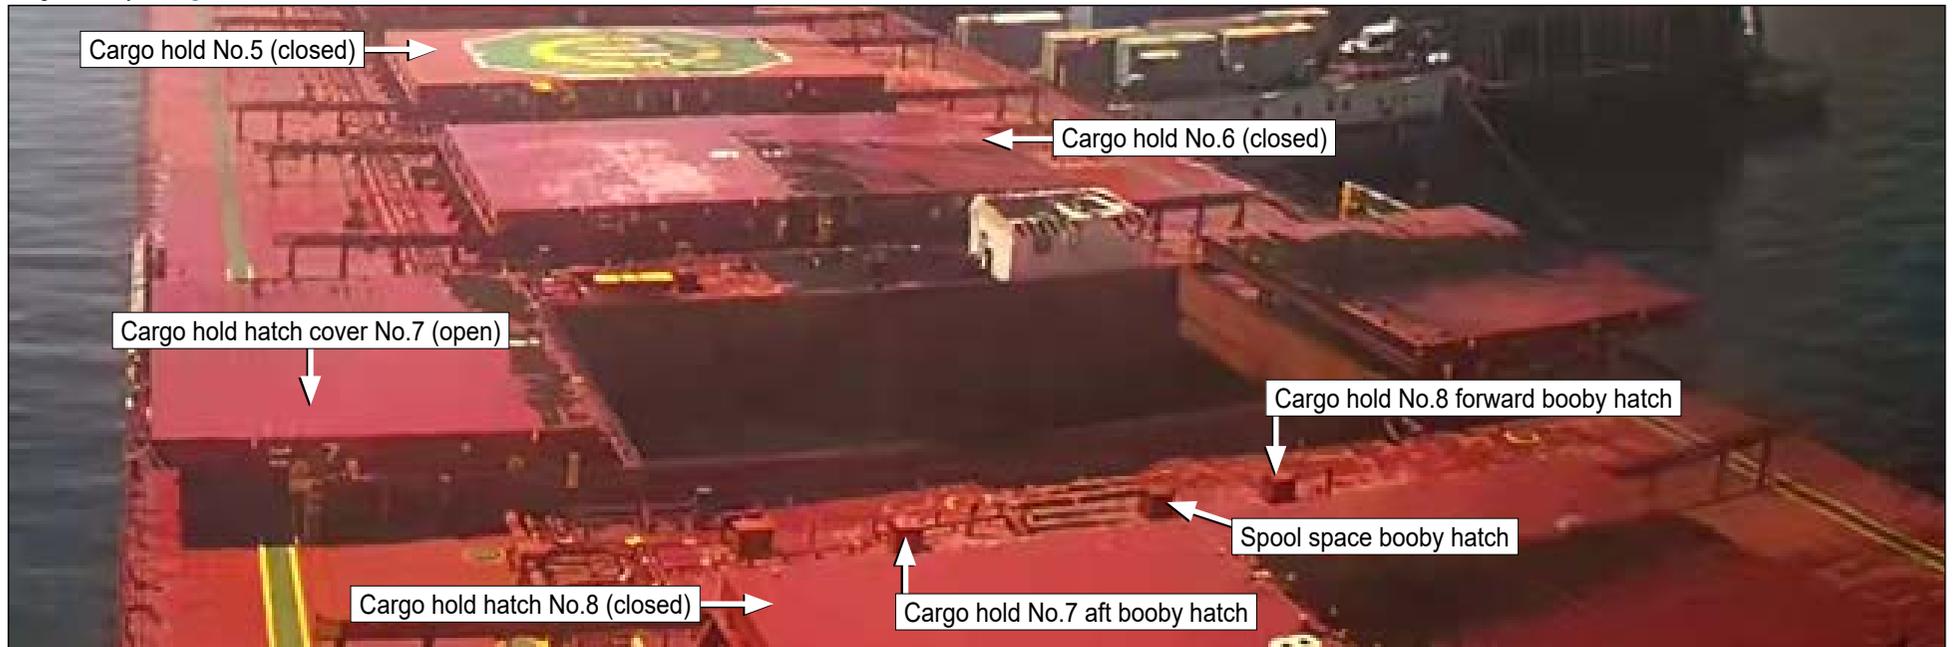
Each cargo hold had hydraulically operated transverse sliding hatch covers and personnel access via booby hatches; one at the forward end of the hold (**Figure 5**), the other at the aft end.

**Figure 5:** Cargo hold No.7 and cargo hold No.8

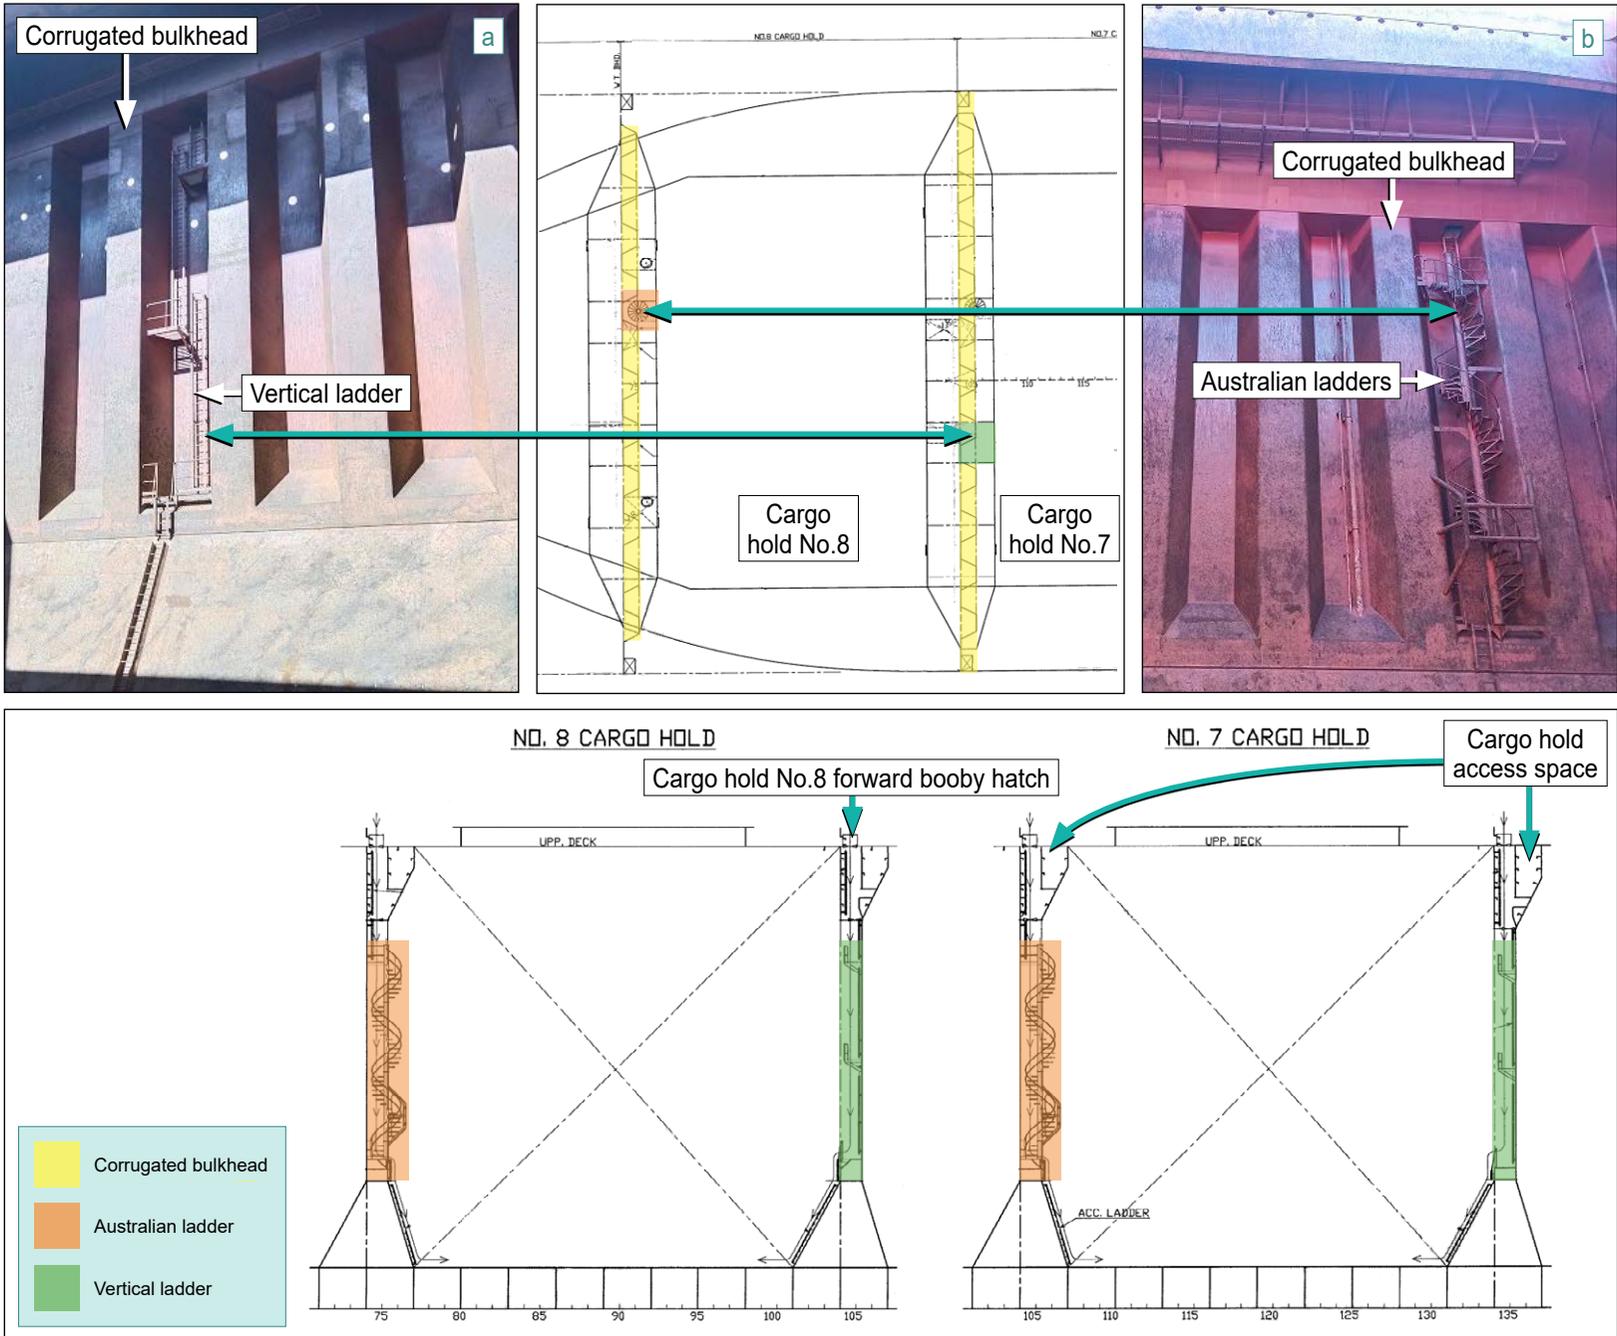
Below each booby hatch was a vertical ladder that led to a cargo hold access space. The forward cargo hold access spaces led to further vertical ladders that descended into the hold (**Figure 6a**). The aft cargo hold access spaces led to spiral staircases (known as Australian ladders) that descended into the holds (**Figure 6b**). The Australian ladders were the normal means of personnel access into the holds, while the vertical ladders were for emergency escape (see section 1.5.7).

**Figure 6:** Cargo hold access ladders, showing (insets) view to aft (a) and view to forward (b) of the corrugated bulkhead
