Report on the investigation of the  
engine room fire and subsequent fatality on board  
the liquefied petroleum gas/ethylene carrier

***Moritz Schulte***

in Antwerp, Belgium

on 4 August 2020

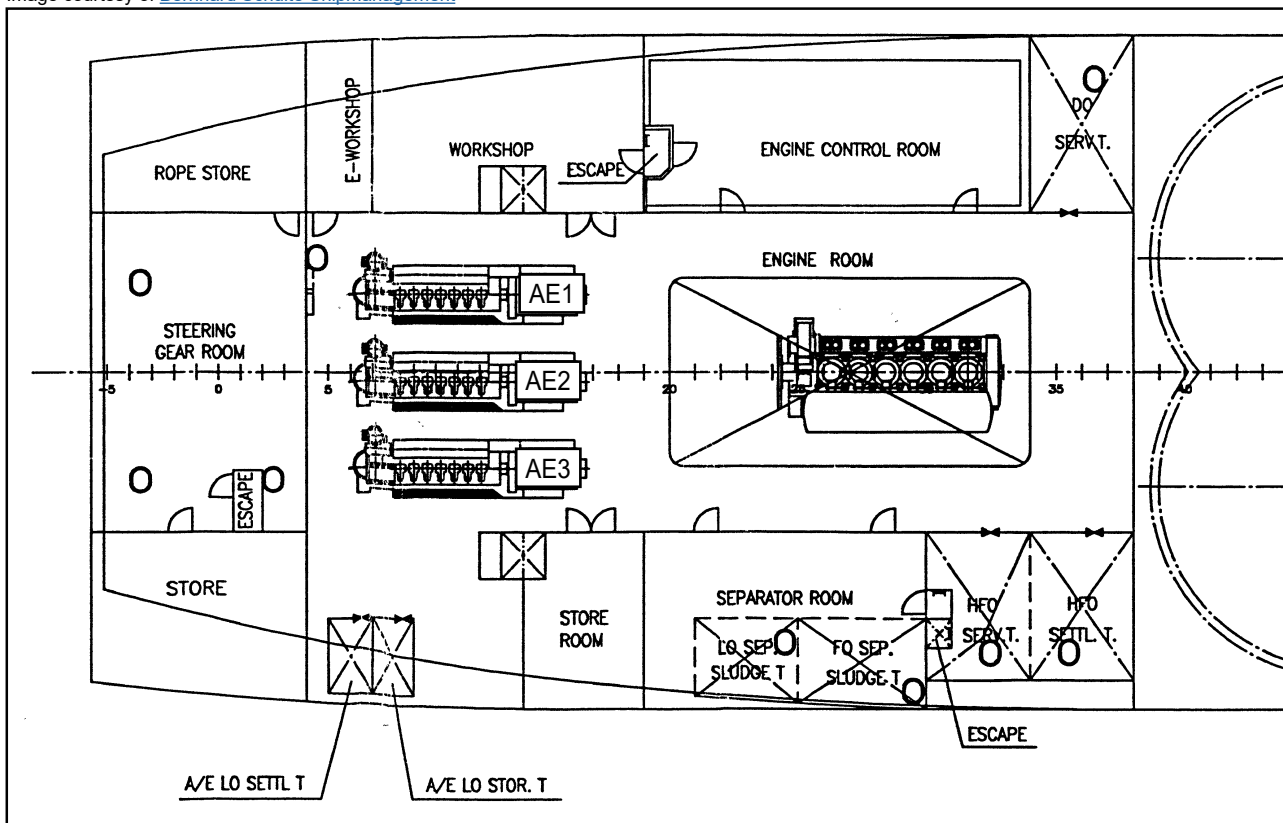
**Figure 1:** A Platform and engine control room

Between about 0800 and 0815, the ER team gathered in the engine control room (ECR) on the port side of A Platform (**Figure 1**) for a routine toolbox talk to discuss the jobs for that day. The team comprised the second engineering officer (2/E), third engineering officer (3/E) Rajendra Naidu Ponnada, the fourth engineering officer (4/E), who was also the duty engineering officer, the electrical technical officer (ETO), a fitter and an ER wiper. The chief engineering officer (C/E), although not directly involved in the meeting, was also in the ECR inputting information into the machinery planned maintenance system (PMS). The vessel's two gas engineers did not participate in the meeting.

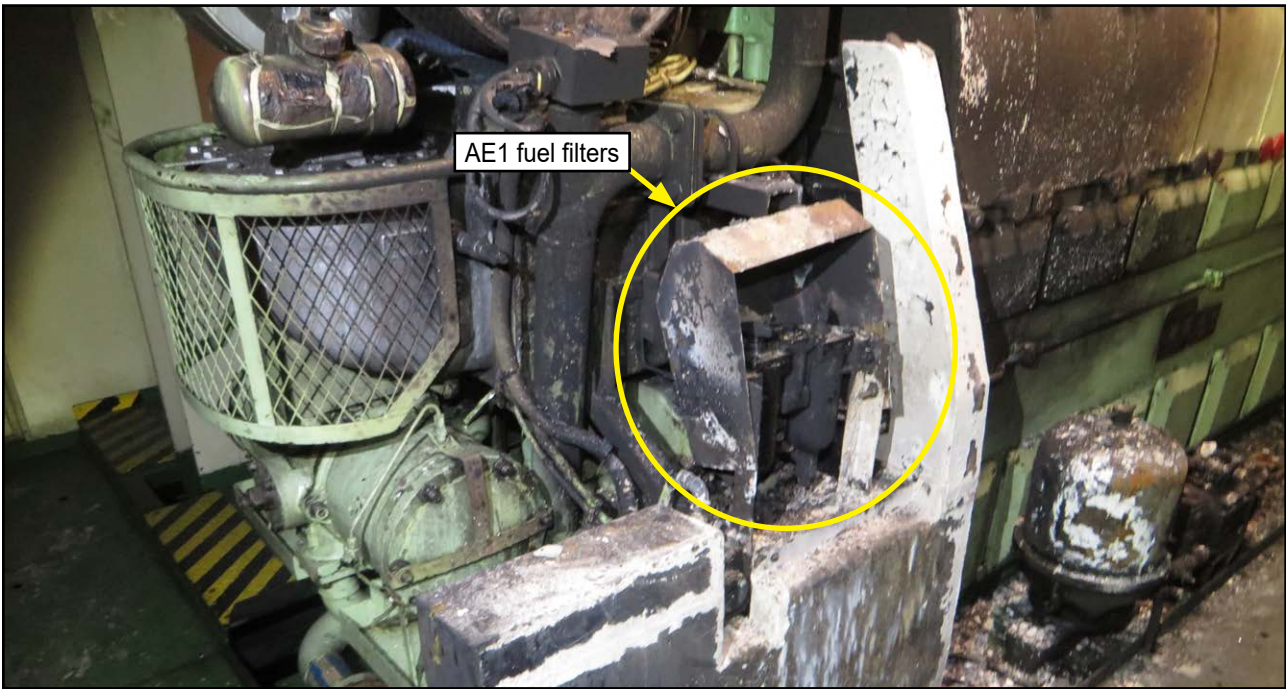
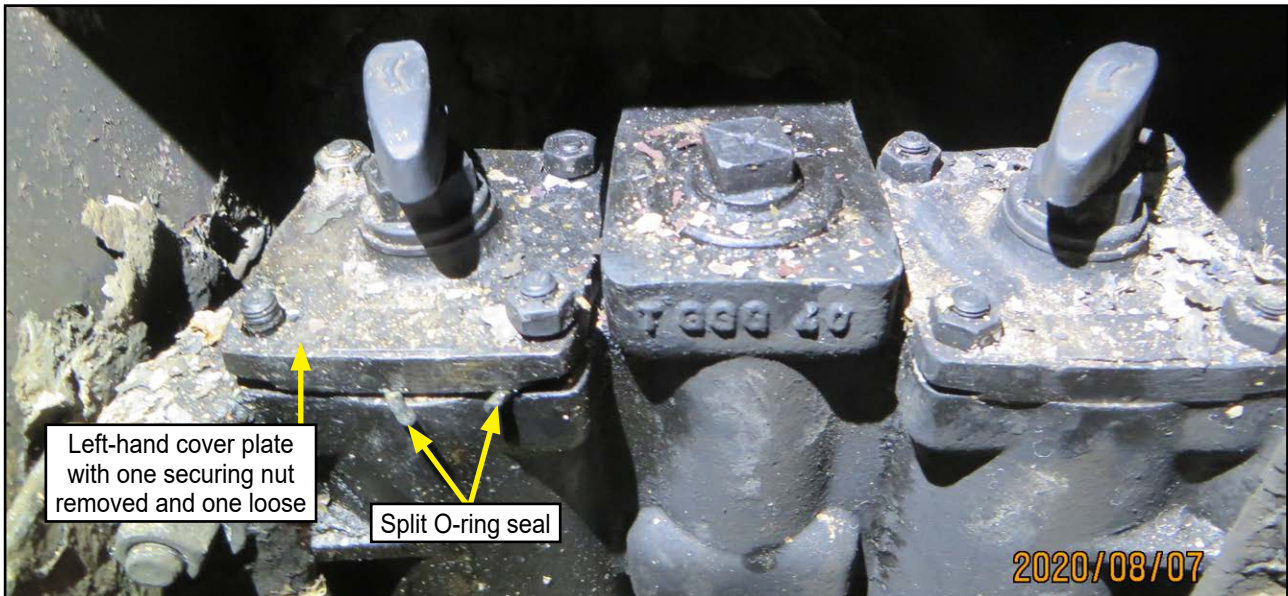
Figure 6: Post-fire AE1 fuel filters

- The 3/E slackened the rear two nuts and removed the front left-hand nut securing the fuel filter cover plate. As he was undoing the front right-hand nut, the 5.5 bar fuel system pressure lifted the cover and forced the O-ring seal out of its recess, causing it to split (**Figure 6**).
- The marine gas oil (MGO) sprayed out over a large area, covering the 3/E and reaching the running AE2's turbocharger and exhaust pipework insulated cover (**Figure 3**). Soon after, the fuel ignited and thick black smoke began to emanate from the AE2 exhaust insulation.

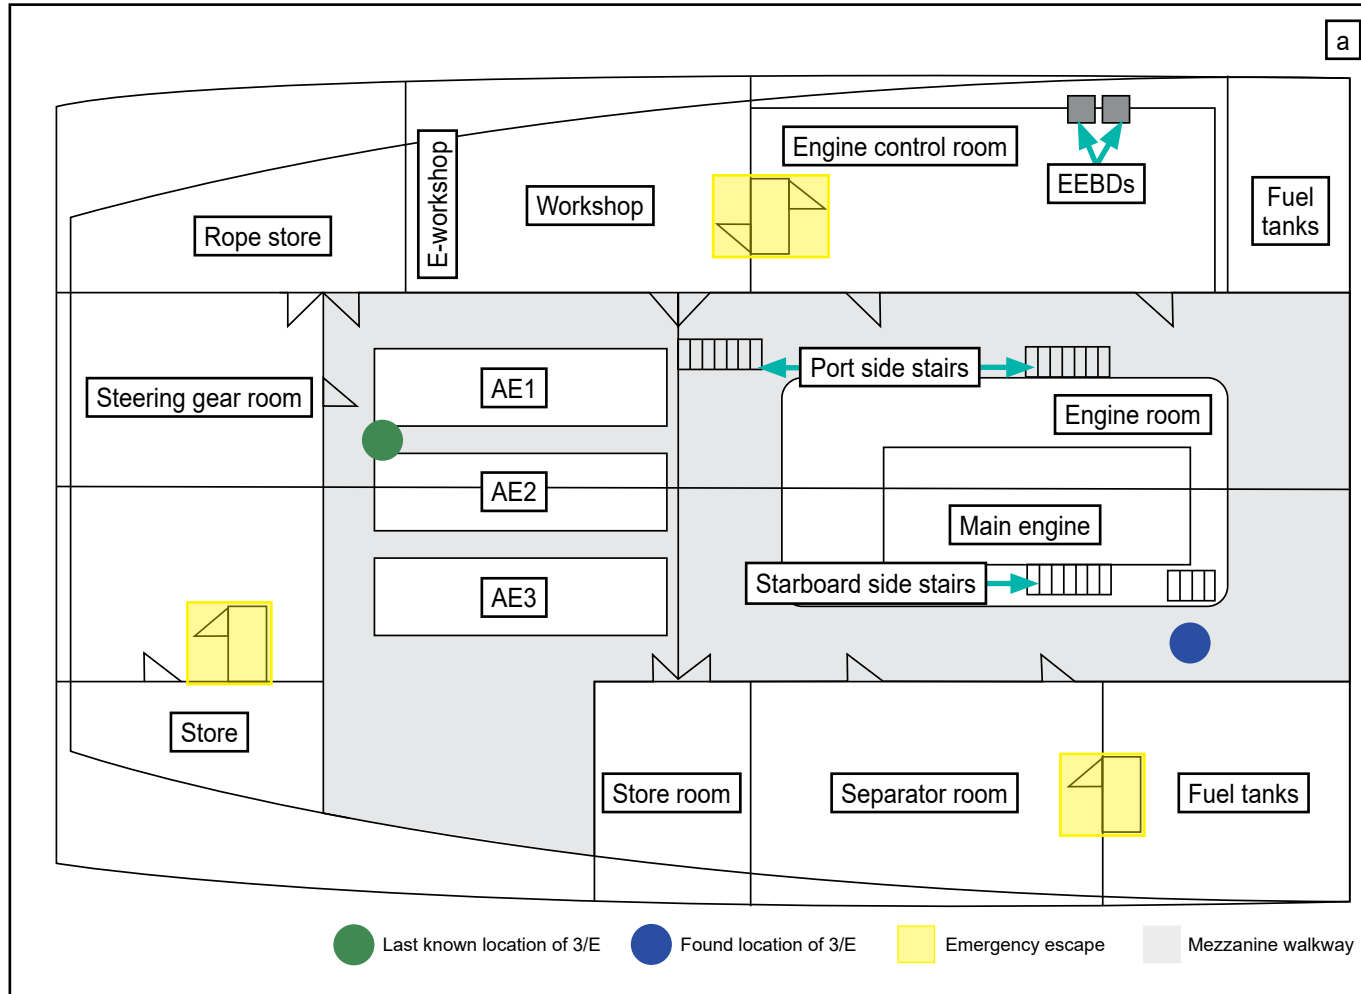
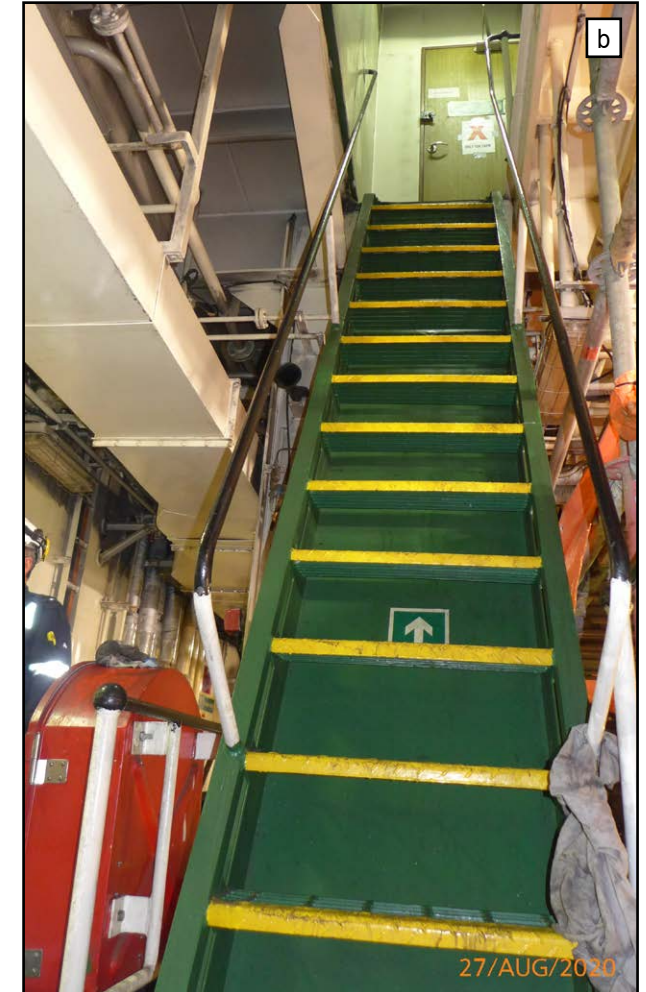
Figure 7: A Platform (a) and port side stairs leading to main deck (b)

The wiper heard the fire alarm from inside the workshop and, looking outside, saw thick black smoke. He escaped to the muster station via the port side main stairs (**Figures 7a and 7b**) instead of the workshop's emergency escape, holding his breath and using the handrail for guidance. He did not see any flames or the 3/E.

On the port side of the ER an enclosed escape trunking containing a vertical steel ladder extended from a combined workshop and ECR entrance up to the main deck (**Figure 7a**).

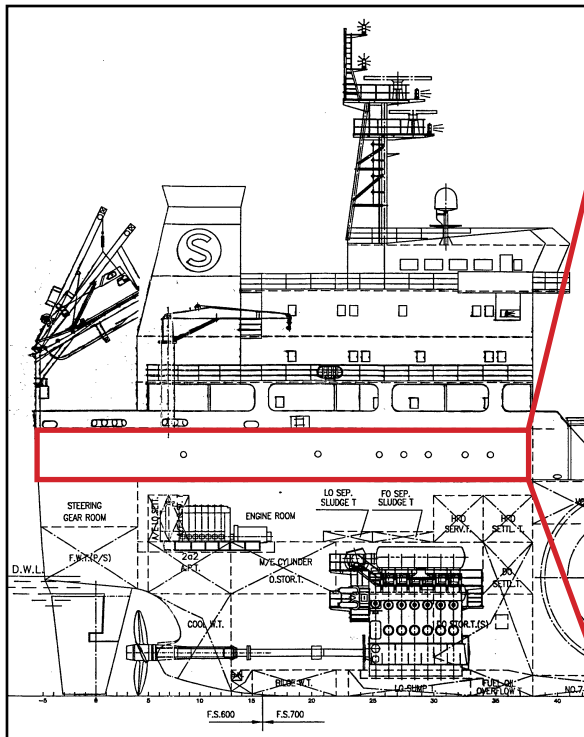
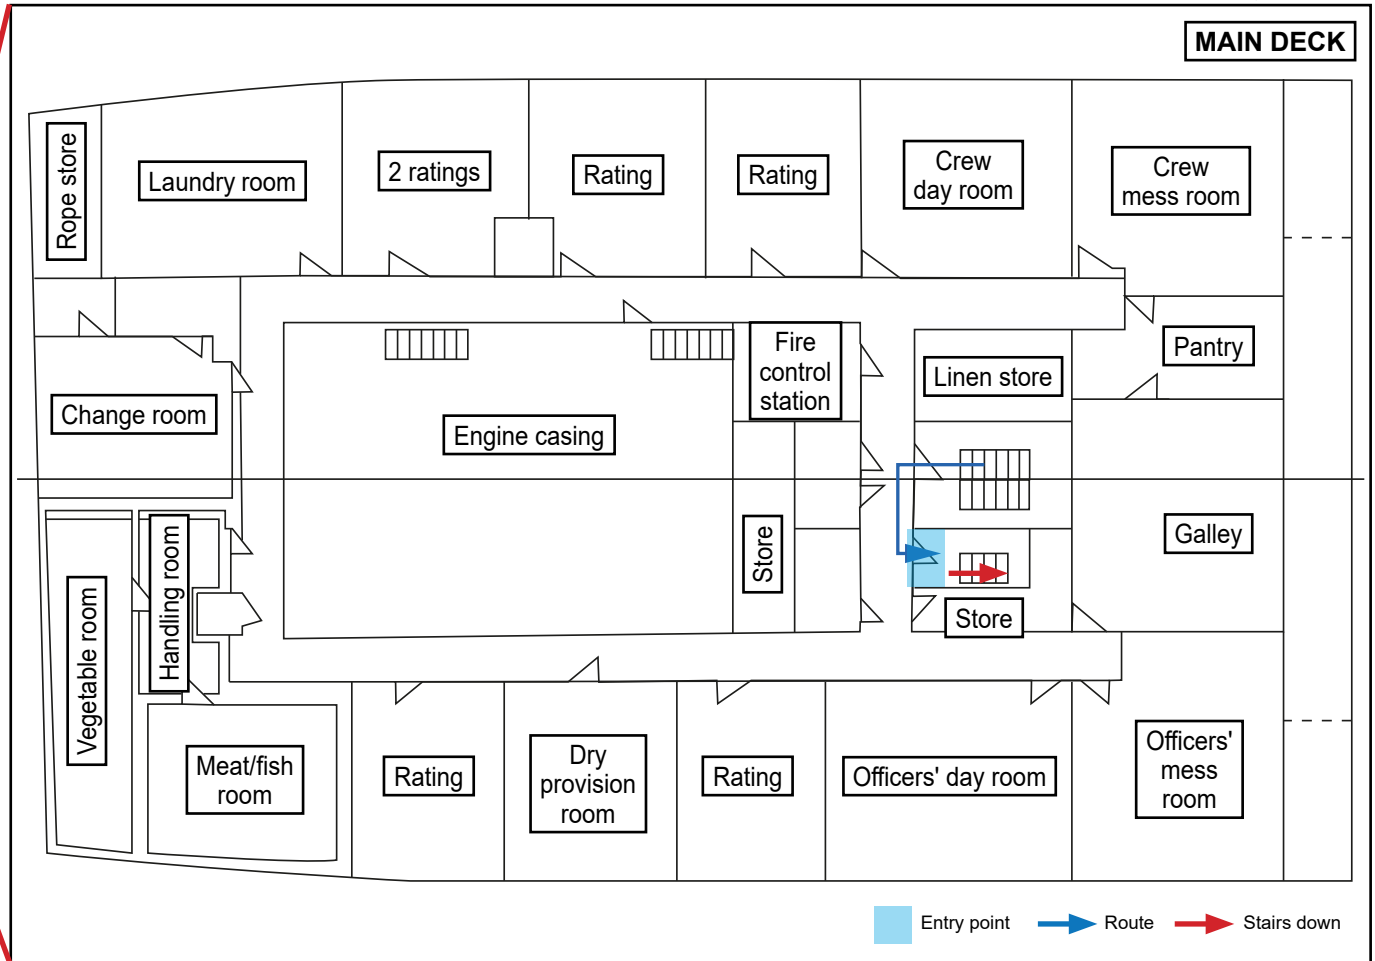
**Figure 9:** Third attempted entry from secondary entrance near officers' day room

At 0944, the 2/E decided to lead the search and rescue team and he and the fitter, who had replaced his BA cylinder, entered the ER via the secondary entrance near the officers' day room (**Figure 9**). The 2/E, connected to a lifeline, descended the starboard stairs to A Platform. In thick smoke, and with no visibility, the 2/E and the fitter turned and followed the starboard walkway aft past the separator room and towards AE3 (**Figure 10**). The 2/E found that AE3 was still running and stopped it locally from its aft end. Through the smoke, the 2/E could see small flames under the turbocharger at the aft end of AE2 and used a CO<sub>2</sub> fire extinguisher to put these

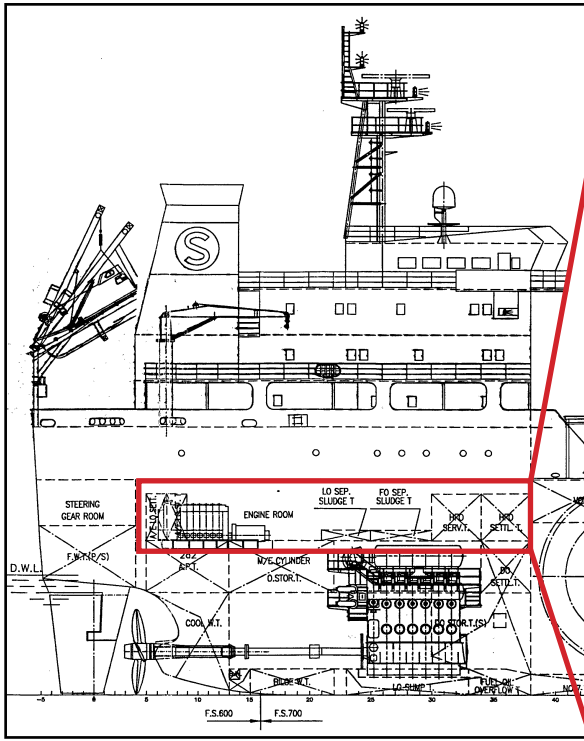
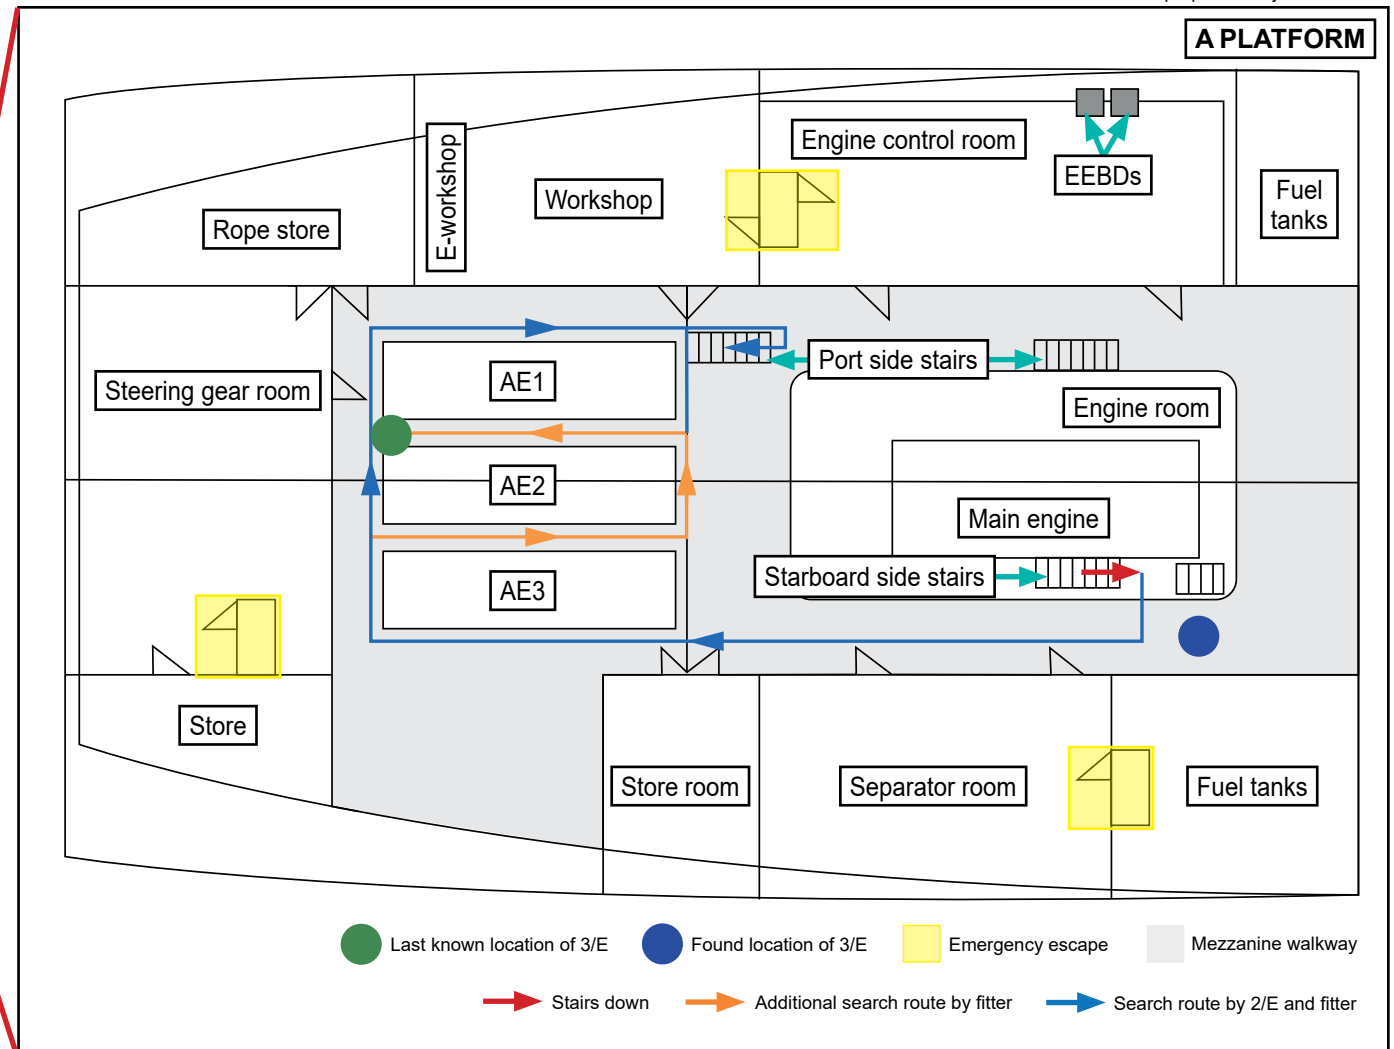
Figure 10: Second engineer's route from starboard access stairwell

out before he walked around AE1. Meanwhile, the fitter walked between AE2 and AE3 and then around the forward end of both AE2 and AE1, meeting the 2/E at the aft end of AE1.

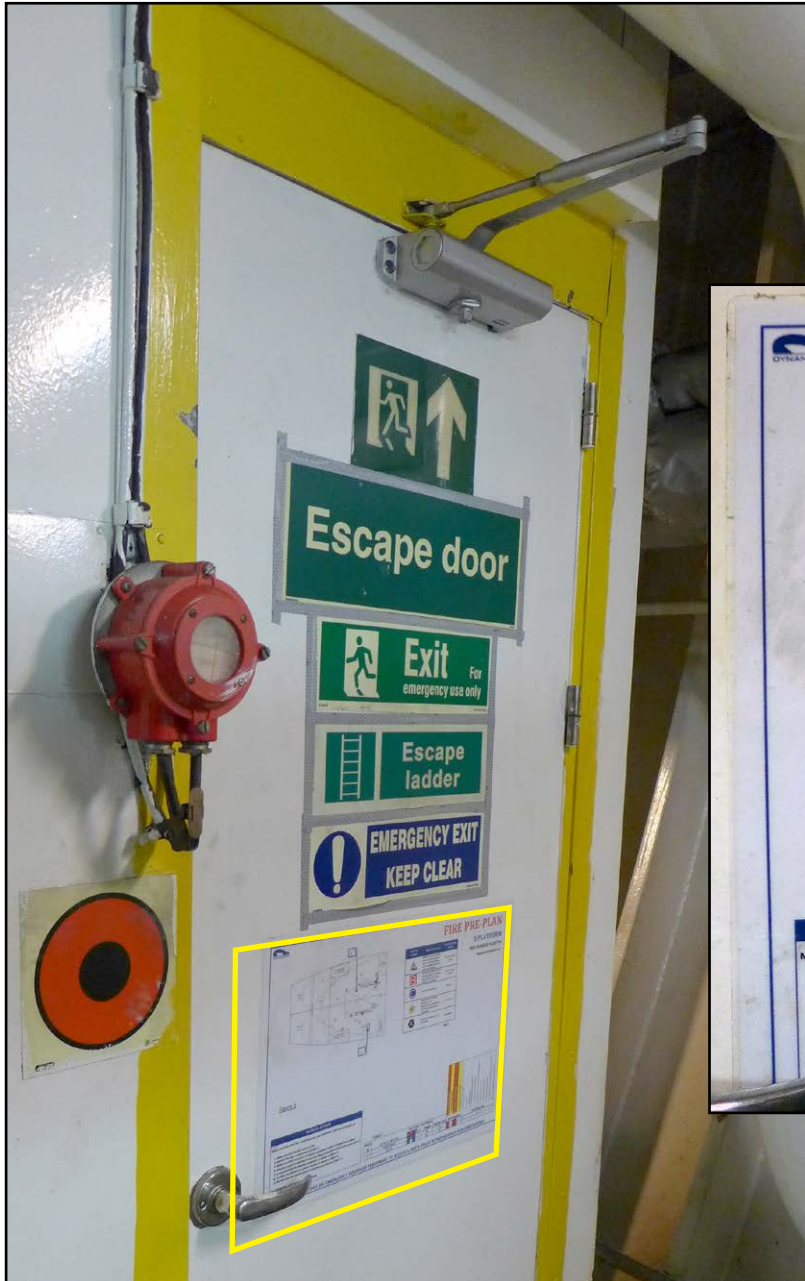
Figure 12: B Platform emergency escape door and escape information

On the starboard side of the ER was an enclosed escape trunking containing a steel vertical ladder that ran from the bottom plates to the main deck via the separator space. The ladder was accessed at each level via a steel escape door that displayed emergency escape fire pre-plan information (**Figure 12**).

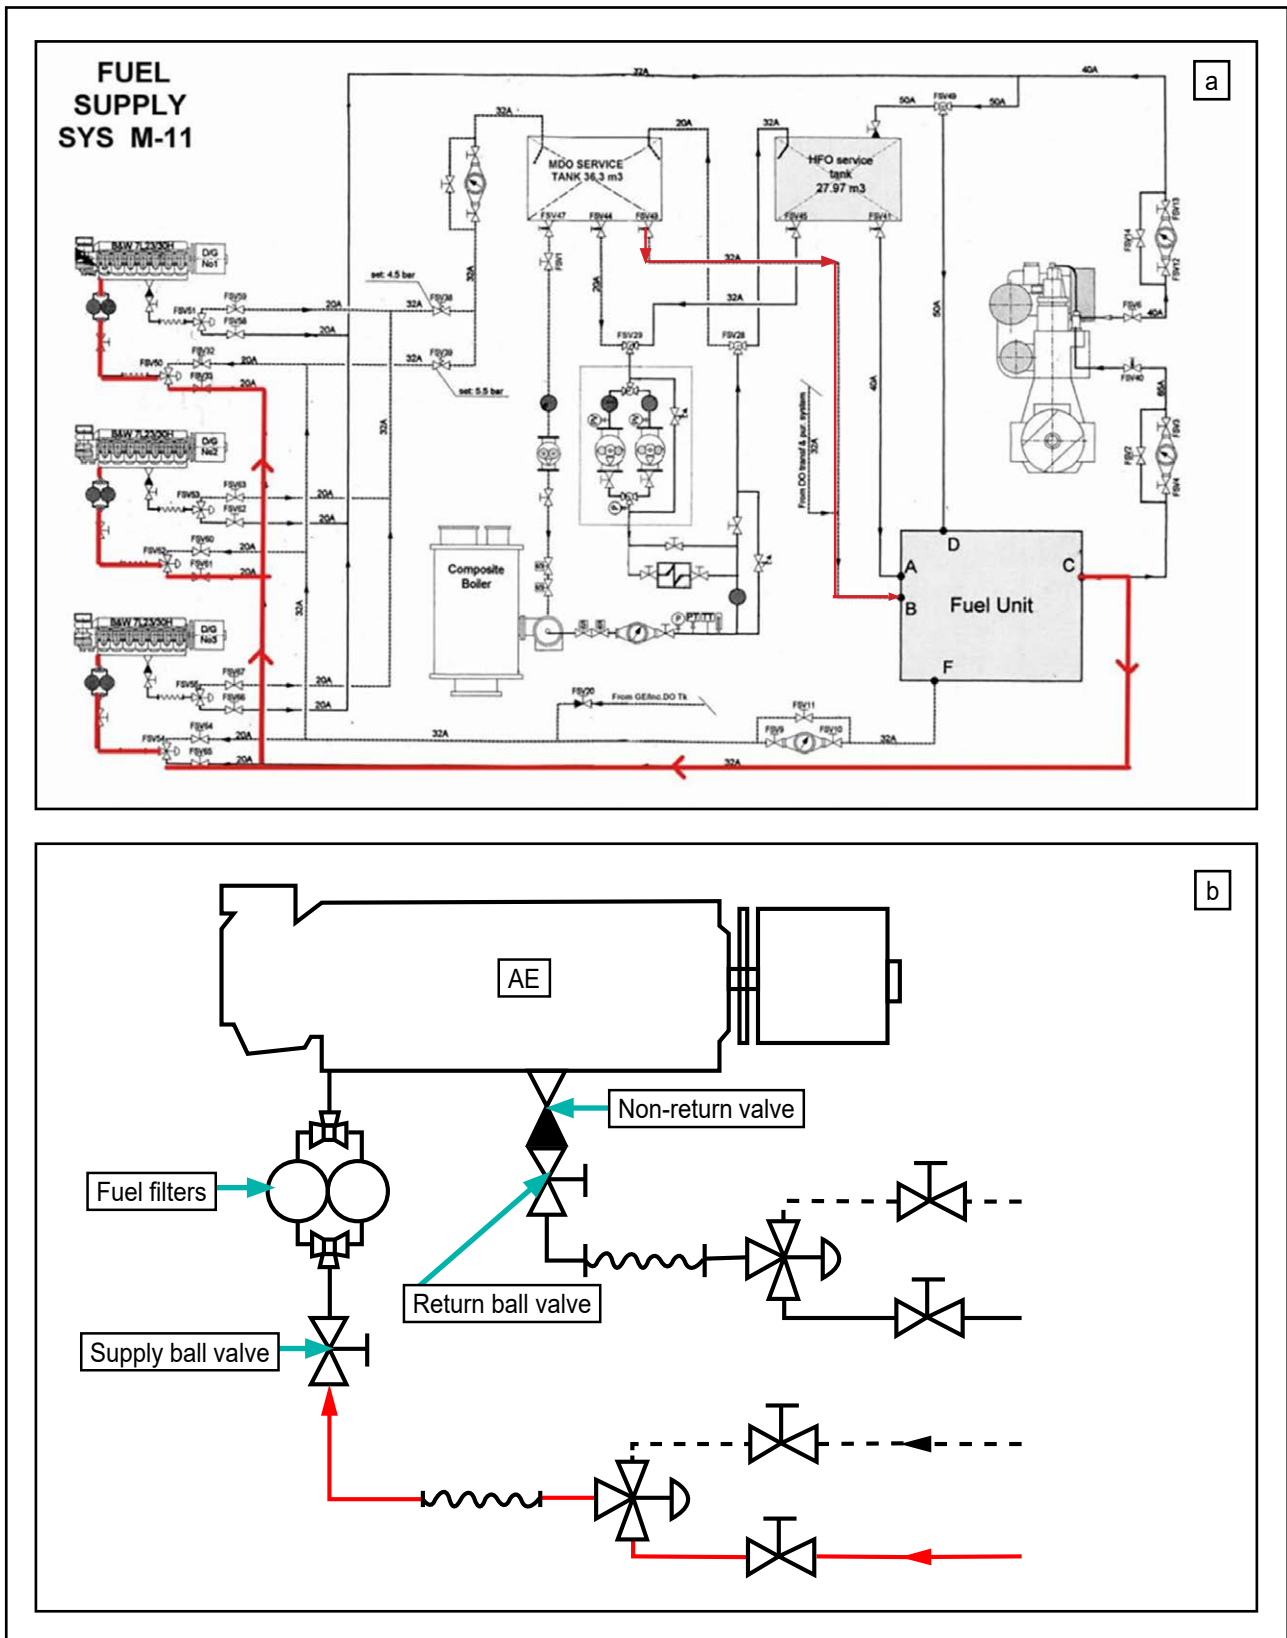
**Figure 13:** Fuel supply from MGO service tank to AE via fuel unit (a) and fuel supply to AE (b)

From the MGO service tank the fuel entered the fuel unit, which boosted and filtered the fuel (**Figure 13a**). The final filtration was provided by the AEs' engine-mounted duplex fuel filters. Isolating ball valves were fitted to the fuel supply and returns for each engine and non-return valves were also fitted to the return lines (**Figure 13b**).

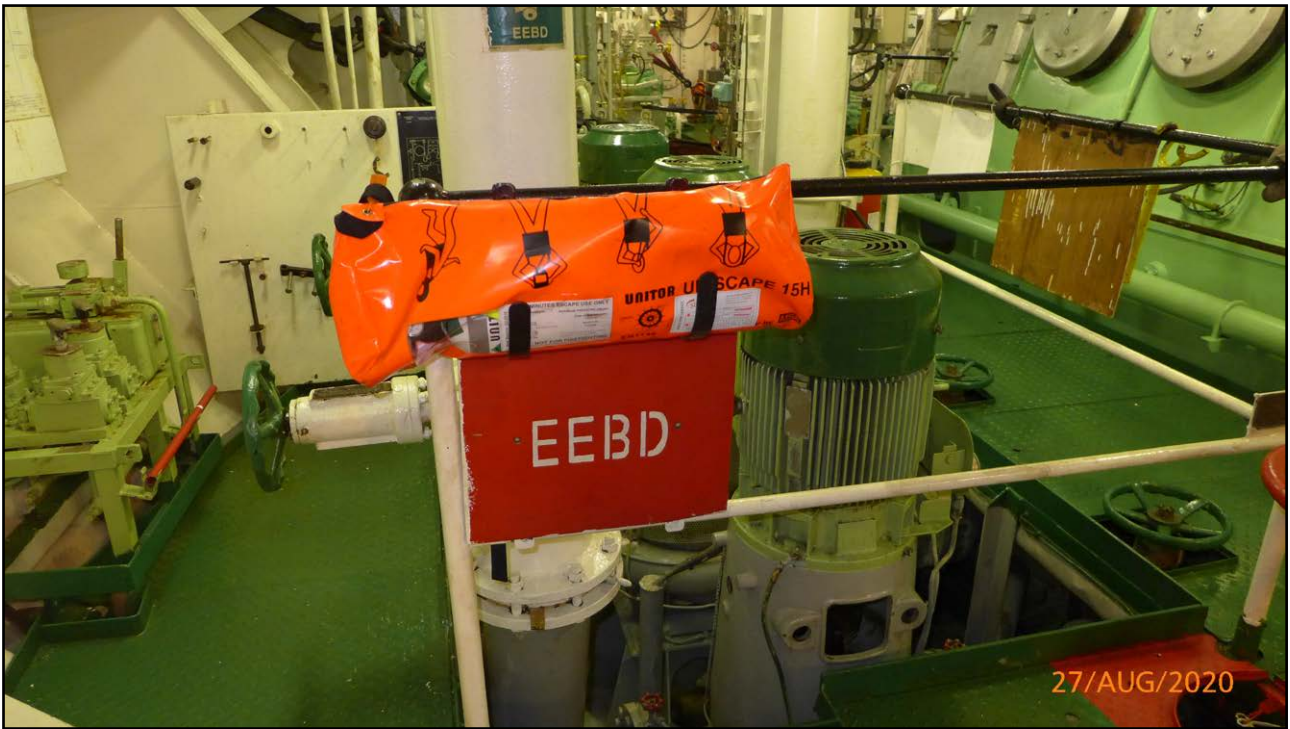
**Figure 24:** EEBD location at the entrance to the bottom deck emergency escape

*Moritz Schulte* was built in 2002 and was equipped with six EEBDs. One each was placed at the entrance doors to the port and starboard emergency escapes on the bottom deck of the engine room (**Figure 24**). Two EEBDs were located in the ECR on A Platform and two in the CCR on the poop deck.

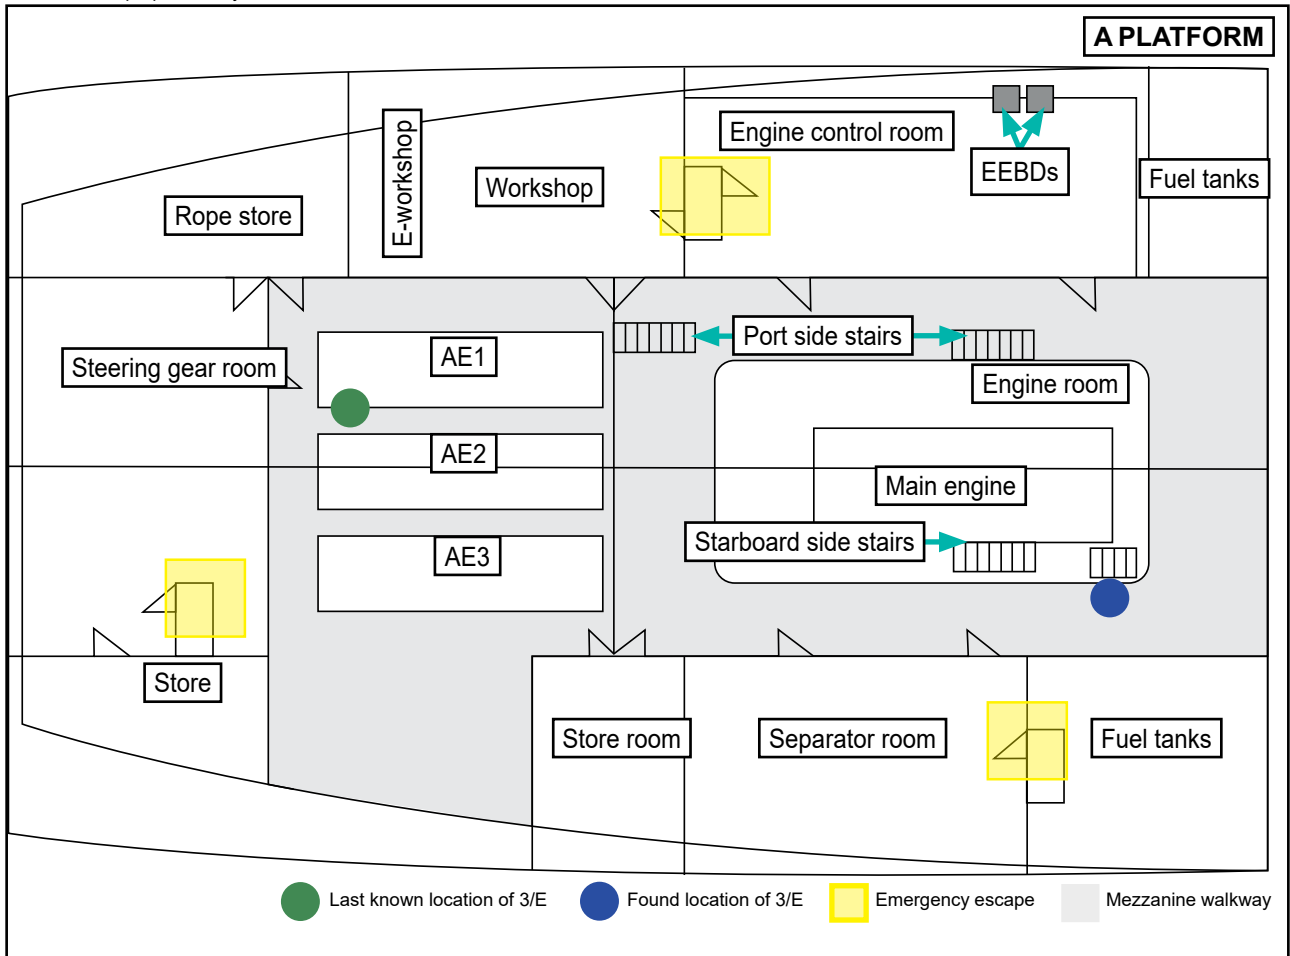
**Figure 25:** A Platform fire control and safety plan

The ER escape routes and locations of the EEBDs were clearly marked on *Moritz Schulte*'s fire control and safety plan. When the 4/E and the fitter began their escape from A Platform, their nearest EEBD was in the ECR (**Figure 25**).
